WEEKLY INCIDENT SUMMARY

Week ending Friday 10 December 2021

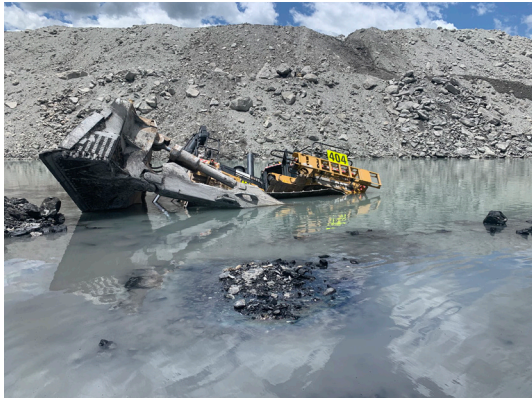
INCIDENT TYPE	SUMMARY	COMMENTS TO INDUSTRY
Dangerous incident IncNot0041252 Open cut coal Roads or other vehicle operating areas

While reversing a dozer on the coal floor, the dozer slipped sideways into water about 2m deep. The operator was able to exit the vehicle and was uninjured.

Mine operators must have controls in place to manage the risks posed by water bodies near vehicle operating areas. Consideration should be given to the potential for slumping and voids to form, particularly following significant rainfall. The risk of drowning in a submerged vehicle must be considered in such circumstances. When water accumulates near mobile plant operating areas during periods of heavy rain, controls must be put in place to protect operators from the risk of drowning.

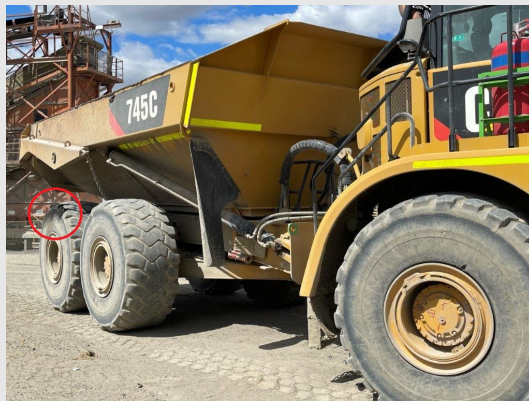
Dangerous incident
IncNot0041253
Surface Extractives
Roads or other
vehicle operating
areas

An articulated dump truck operator raised the tray to clear some hung-up product. The tub made contact with overhead 11kV power lines. The operator was unaware of the contact but did notice a flash at the right rear tyre. As he drove away he noticed a flat tyre and stopped. An inspection identified a split in the tyre and burn marks on the tyre and on the ground near the power lines.

The potential for interaction between mobile plant and overhead power lines must be included in the risk assessment and principal hazard management plan for roads or other vehicle operating areas. When raising trays, buckets or booms in areas not designated for loading or dumping, operators must check their surroundings for hazards such as overhead powerlines.

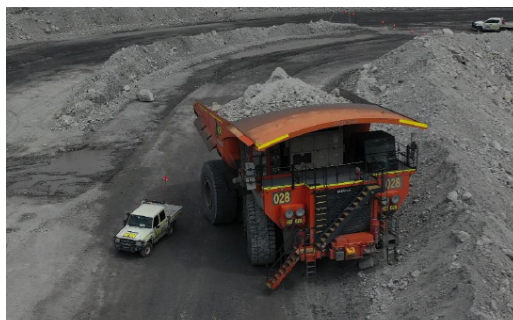
Dangerous incident
IncNot0041221
Open cut coal
Roads or other
vehicle operating
areas

A light vehicle stopped at an intersection to give way to an approaching truck. A second truck came up behind the light vehicle. The truck operator failed to see the light vehicle with enough time to stop and had to veer into a windrow to avoid a collision.

This incident is under investigation, additional information may be released in future.

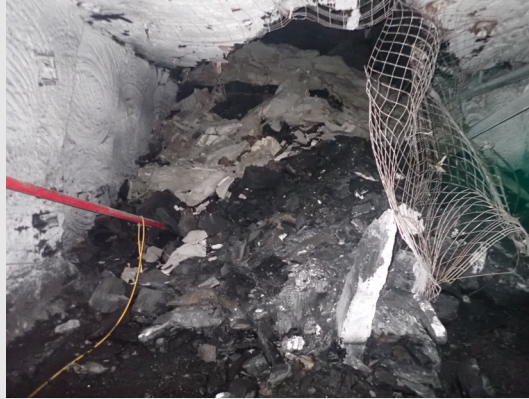
Dangerous incident
IncNot0041247
Underground coal
Ground or strata

A roof fall of about 15m occurred on a travel road intersection and impeded passage on the travel road. All workers were safely withdrawn from the panel. The roadway had been driven four months earlier.

Geological mapping should be conducted as soon as possible once roadways are driven, to ensure support installed is appropriate for conditions. When monitoring devices are replaced, it should be confirmed they are reading correctly and the frequency of routine readings should be increased. This should be included in the trigger action response plan (TARP).
