WEEKLY INCIDENT SUMMARY

Week ending Friday 7 January 2022, including the Christmas period.

CM9 reference	DOC22/11013
Mine safety reference	ISR22-01
Date published	14 January 2022
Approved by	Deputy Chief Inspector Office of the Chief Inspector

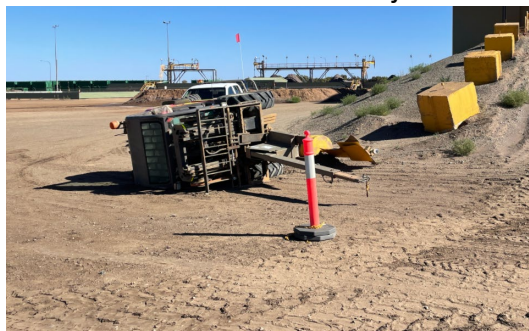
INCIDENT TYPE	SUMMARY	COMMENTS TO INDUSTRY
Dangerous incident IncNot0041307 Coal processing plant Roads or other vehicle operating areas	While travelling back to the workshop, a forklift stopped to give way to another vehicle. As the forklift moved off it hit the give way sign and overturned. The operator was wearing a seatbelt at the time of incident and was uninjured.	Mine operators should communicate this incident to their workers and reinforce relevant controls and the use of seatbelts. Equipment operators should maintain awareness of the environment around them and, before commencing travel should check their surrounds for hazards. Refer to: Safety Alert- SA13-09 Seatbelt saves forklift driver

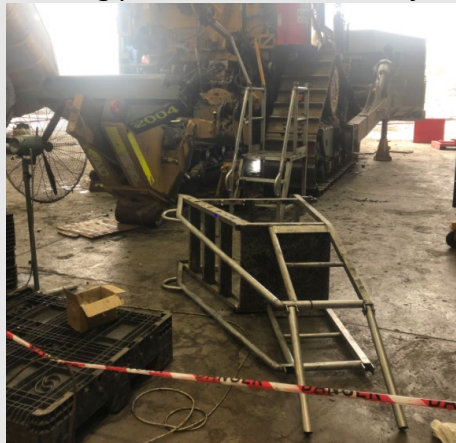
Dangerous incident
IncNot0041333
Open cut coal
Hazards identified
by mine operator

An apprentice was assisting to remove a ripper box from a dozer. The left tilt cylinder was removed and when the pin was knocked out of the right tilt cylinder, the ripper box rotated and hit a work platform. The apprentice fell from the working platform and was uninjured.

When planning tasks workers must consider how components can move and adequately plan to control this risk.

Isolation procedures should include the management of stored energy including gravity, and consider the rotation of components.

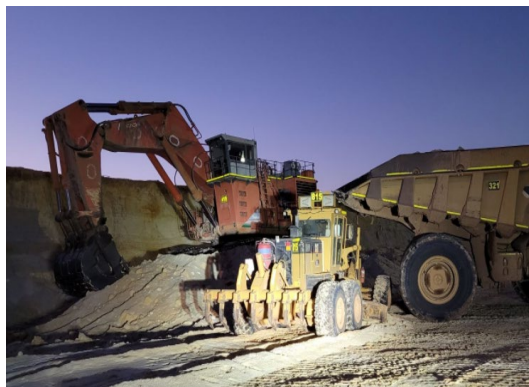
Dangerous incident
IncNot0041356
Metals
Roads or other
vehicle operating
areas

An excavator half-loaded a dump truck and needed to reposition. Operating procedures required the truck to exit the loading area, complete a loop and park at the new loading point. Instead, the truck operator drove out and immediately reversed into the new load point.

As the truck drove out, a grader entered the load area to clean up. When the truck reversed, the pos 6 tyre hit the grader frame.

Positive communications procedures were not followed.

A collision occurred at the site between a truck and dozer 48 hours earlier.

When an incident occurs, mine operators must investigate, review and revise control measures to prevent a reoccurrence ([Work Health and Safety \(Mines and Petroleum Sites\) Regulation 2014 clause 10 Review of control measures](#)).

Plant operators must establish positive communications before entering the work area of other mobile plant.

Workers have a legal obligation to follow procedures such as positive communications.

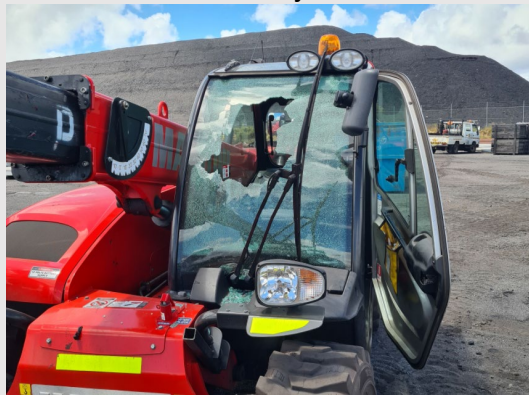
Dangerous incident
IncNot0041361
Coal processing
plant
Hazards identified
by mine operator

A worker was using a telehandler to move scrap steel to a bin. An old cyclone was picked up on the tynes and while crowding back, it slipped from the fork tynes and landed on a pump impeller. A bracket from the cyclone snapped off and was propelled through the toughened windscreen of the telehandler, landing on the dashboard. The worker was not injured.

When conducting lifting operations, workers must ensure the equipment is correctly set up for the task and that loads are secure before commencing.

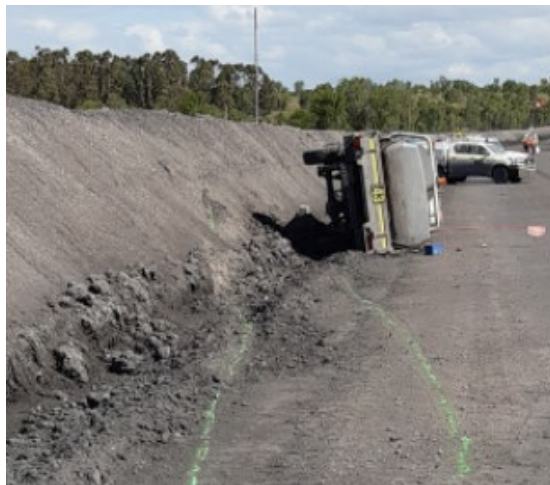
Dangerous incident
IncNot0041363
Open cut coal
Roads or other
vehicle operating
areas

A contractor was travelling in a ute when the driver tried to retrieve something from their crib bag. The distraction resulted in the ute running up onto the left-hand side windrow and rolling onto its side. No workers were injured.

Mine operators should communicate this incident to workers and reinforce relevant controls and rules when driving. Drivers should remain focused on the task at hand and not be distracted while driving. Drivers should find a safe place to stop and address any issues, rather than while driving.

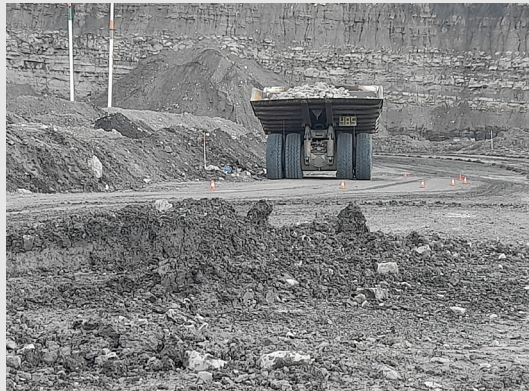
Dangerous incident
IncNot0041369
Open cut coal
Roads or other
vehicle operating
areas

A dump truck operator was instructed by a dozer operator to tip at an alternate dump. The truck left the dump and began travelling loaded down a ramp. The truck gained speed to 60km/h before the operator applied the service brake. The truck then travelled through an intersection unable to stop, making contact with the centre island before coming to a stop on the left hand side of the haul road.

When there is a deviation from normal operating practices, workers must assess the risk and put appropriate controls in place. At all times, workers must maintain control of their vehicles. Workers must be regularly trained on the operating parameters of mobile plant, such as the speed range that retarders can operate on haul trucks.
