# WEEKLY INCIDENT SUMMARY

Week ending Friday 20 May 2022

This incident summary provides information on reportable incidents and safety advice for the NSW mining industry. To report an incident to the NSW Resources Regulator: phone 1300 814 609 24 hours a day, 7 days a week.

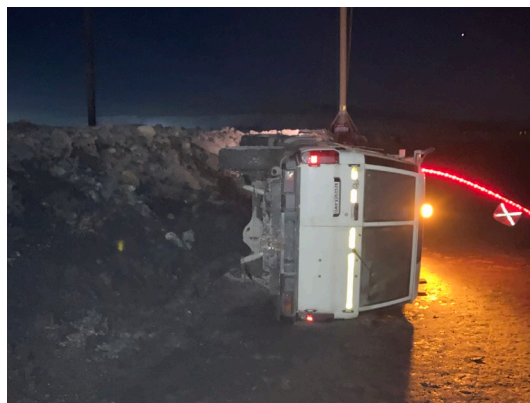
Dangerous incident  
IncNot0042181  
Open cut coal mine  
Roads or other  
vehicle operating  
areas

A mine supervisor had a micro sleep while driving along a light vehicle road. The vehicle drove up onto a windrow and rolled onto the driver's side. The supervisor was not injured. The supervisor failed to preserve the scene and arranged for the vehicle to be righted and taken to a park-up area.

Further investigations have commenced. Supervisors must be aware of their obligations when an incident or injury occurs. This includes preservation of the incident scene and notification requirements.

Note that the [Work Health and Safety Act 2011 Section 39](#) does permit any required action to assist injured persons, make the scene safe and to comply with police or inspector directions.

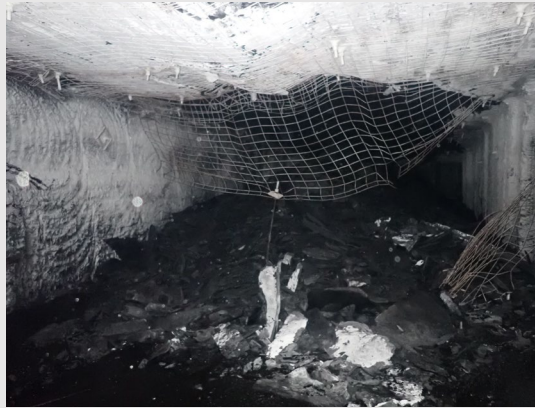
Dangerous incident  
IncNot0042170  
Underground coal  
mine  
Ground or strata

A fall of roof occurred, extending above a bolted horizon. The roadway was supported with bolts and mesh. The fall was about 15 metres long, partial width and extended 500mm above the centre bolts.

Mine operators should have a process in place to identify changes in roof structure and the required support in that area (TARPS). Strata support should be

designed with a suitable factor of safety.

Workers must be trained in the correct installation of support to ensure 'gloving' does not occur and the chemical is correctly mixed. Regular verification of encapsulation needs to be completed and any bolt installation that does not meet the requirements of the support rules should be replaced. Statutory officials must verify support placement is as per the support rules.

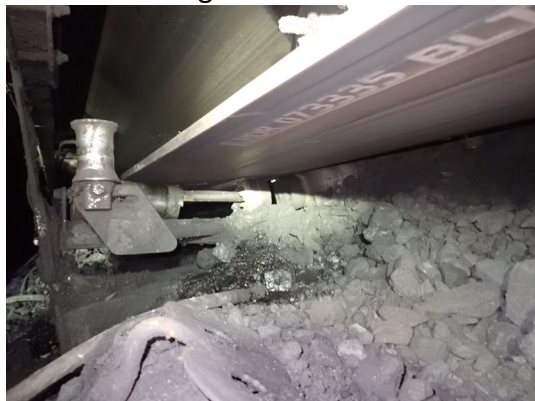
Dangerous incident  
IncNot0042169  
Underground coal  
mine  
Fire or explosion

A deputy smelled and witnessed smoke coming down a drift in an underground coal mine and contacted the control room.

A dolly car operator immediately started an inspection and identified a small flame and smoldering coal under the drift belt. The fire was immediately extinguished.

An idler had collapsed, and the belt was rubbing on the frame. Excess coal around the roller had ignited.

Workers conducting inspections on conveyors must diligently inspect for fire risks such as accumulation of coal, failing or collapsed idlers and contact between conveyor belts and fixed structures.

Mine operators must have systems in place to assess issues and plan a response to avoid the risk of fire, including immediately stopping the conveyor when necessary. No worker should be hesitant to stop a conveyor if it poses a fire risk.
