FIRES ON MOBILE PLANT

July – September 2021

Title: Fires on mobile plant, July – September 2021

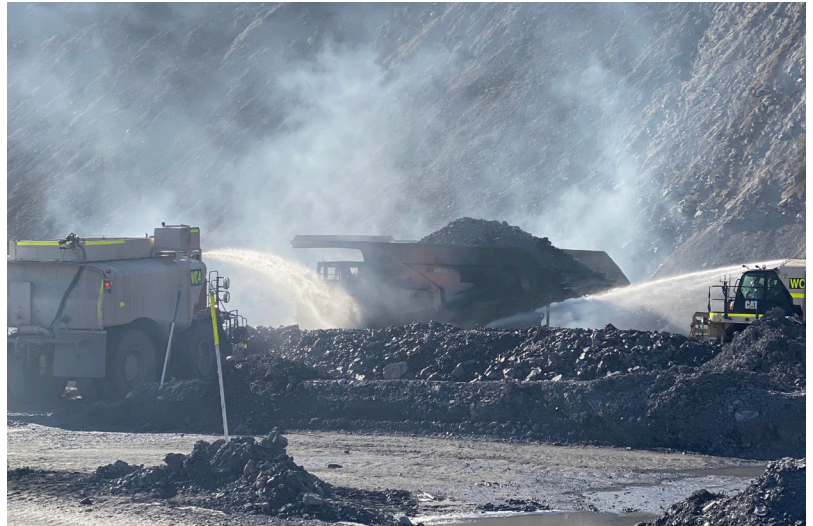
Figure 1: Haul truck fire

This incident is a reminder of how quickly a fire can propagate and the importance of fit-for-purpose access systems and operator training for emergency situations. Training should include the use of primary and secondary access systems.

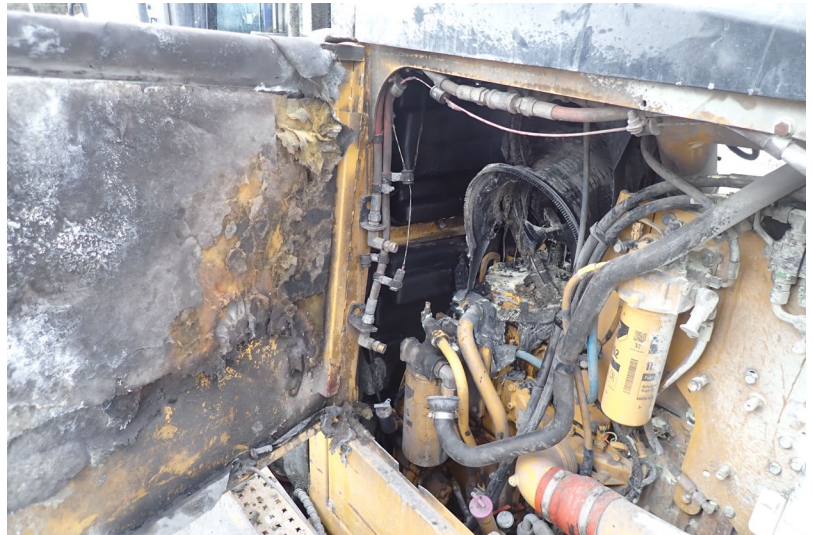
Figure 2: Grader fire damage and location

This incident is a reminder of the importance of quality maintenance and fit for purpose replacement parts.
