# INVESTIGATION INFORMATION RELEASE

## Unplanned initiation of explosives at Peak Gold Mine

**Incident date:** 18 May 2022

**Location:** New Cobar 25L North down hole stope, Peak Gold Mine, Cobar NSW.

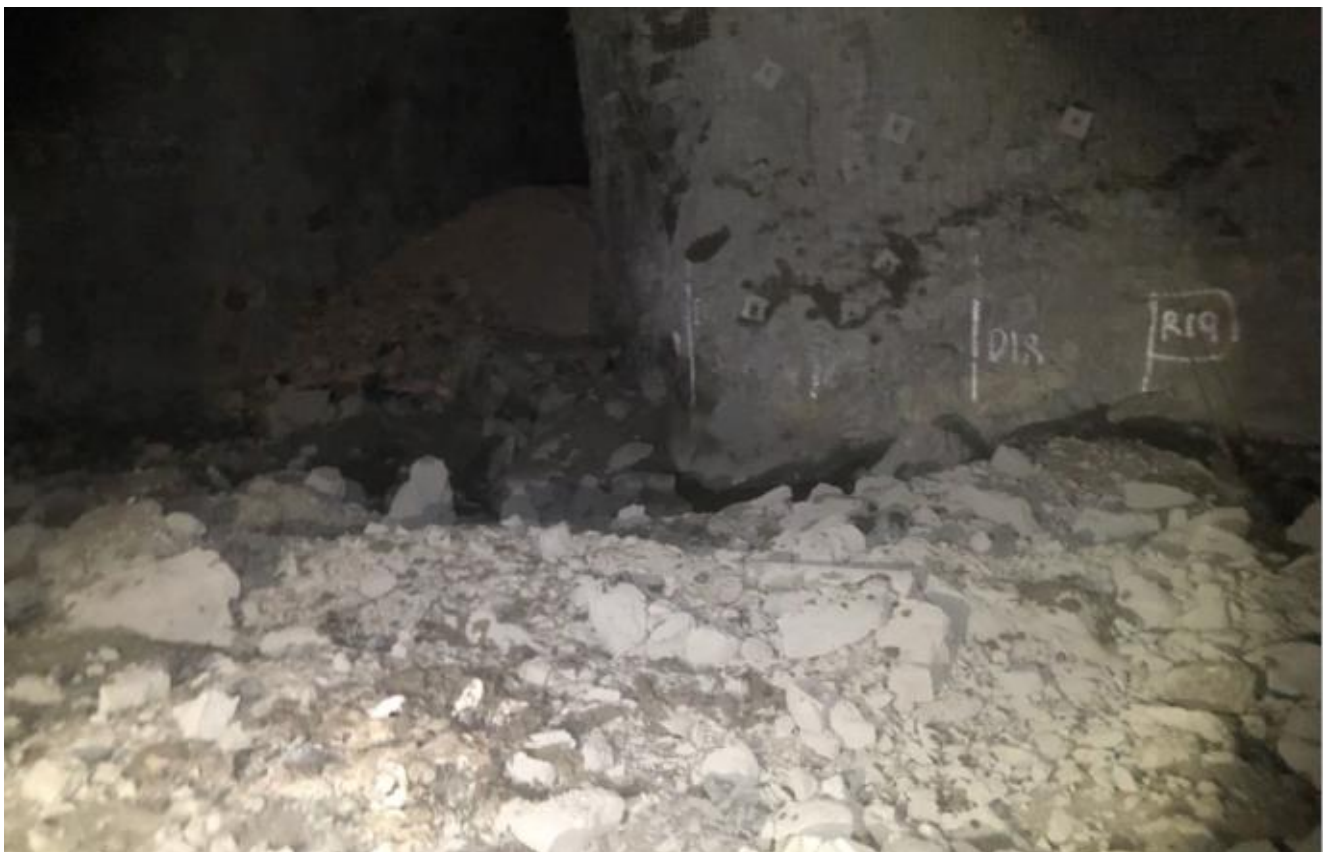
During the re-entry post-firing it was identified that the 25L Nth production stope had not been disconnected from the mains firing line and there had been an unplanned initiation of some electronic detonators in the stope.

Figure 1: Post-incident photo of 21L showing floor heave in line with mark-up of the charge holes (painted on wall).

The immediate apparent cause of the incident was the application of a 240V AC current to the I-Kon III electronic detonators resulting in the unplanned initiation of some electronic detonators.

It is recommended that mine operators review their blasting risk assessments, management plans and operating procedures with the understanding that it is possible to initiate electronic detonators with 240V AC power and / or other non-approved initiation methods.
