WEEKLY INCIDENT SUMMARY

Week ending Friday 27 May 2022

Mine safety reference ISR22-21

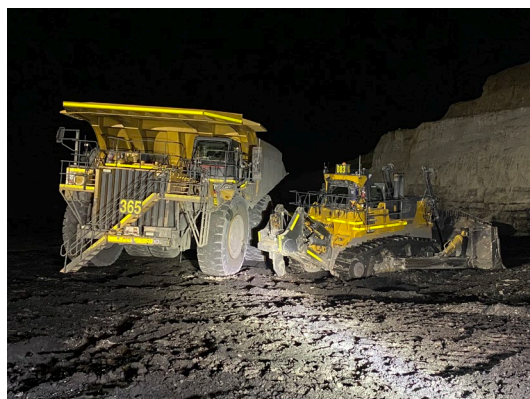
INCIDENT TYPE	SUMMARY	COMMENTS TO INDUSTRY
Dangerous incident IncNot0042247 Open cut coal Roads or other vehicle operating areas	A dozer reversed into a haul truck when it was cleaning up on a loading bench. There were no injuries reported, however the truck received minor damage.	Where administrative controls such as Positive Communication can not be reliably implemented, mines must consider alternative controls such as segregation.

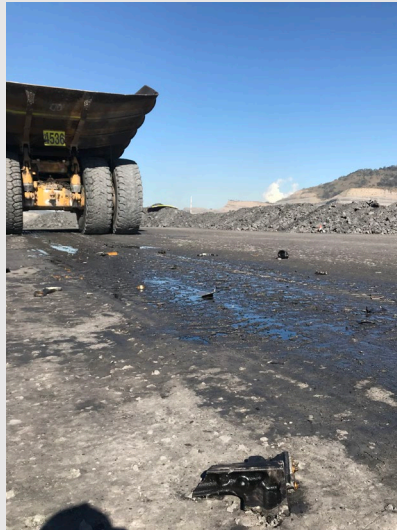
Dangerous incident
IncNot0042256
Open cut coal mine
Fire or explosion

A haul truck had dumped a second load for a shift and was leaving the dump. The operator smelled something burning then saw flames around the back of the cabin. The operator shut down the truck and unsuccessfully attempted to deploy the fire suppression system. The operator then escaped safely. The fire was extinguished with the aid of a water cart and on-board fire suppression.

Upon inspection, it was discovered that a significant mechanical failure resulted in a large hole in the bottom of the engine which initiated the fire. The truck was recently down for maintenance. A further examination of the truck found that the emergency ladder access gate was extremely stiff and not easily opened. The operator did not use this means of egress.

Following the maintenance and repair of mobile plant, the plant should be inspected, tested and verified as fit-for-purpose before being returned to service. Mine operators should also confirm that emergency access systems are included in routine maintenance inspections on all plant. Fire suppression activation buttons should be easy to activate in an emergency situation. Devices such as R clips or tamper ties must be easily removed.
