WEEKLY INCIDENT SUMMARY

Week ending Friday 22 July 2022

This incident summary provides information on reportable incidents and safety advice for the NSW mining industry. To report an incident to the NSW Resources Regulator: phone 1300 814 609 24 hours a day, 7 days a week.

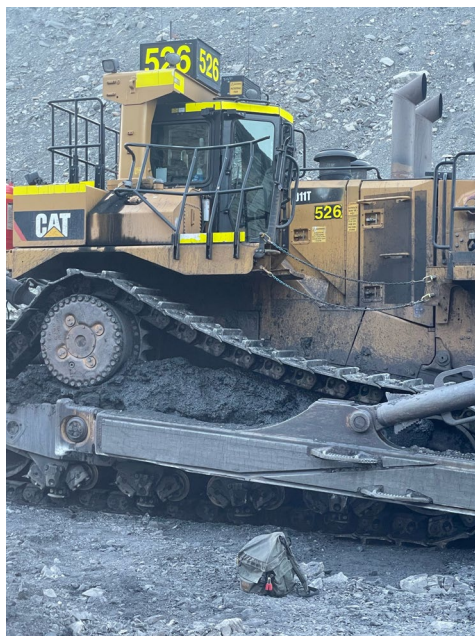
INCIDENT TYPE	SUMMARY	COMMENTS TO INDUSTRY
Dangerous incident IncNot0042611 Open cut coal mine	An excavator and dozer collided when the dozer travelled into the swing zone of the excavator. The excavator slewed and the bucket hit the handrail of the dozer adjacent to cabin.	To control the risk of collision, mine operators should have robust controls in-place for when equipment enters the swing radius of excavating equipment, such as ceasing movement and grounding the bucket. Operation should not recommence until positive communication has confirmed the swing radius is clear of equipment. Where possible, collision avoidance technology should be integrated into mobile equipment to help control the risk of collision.

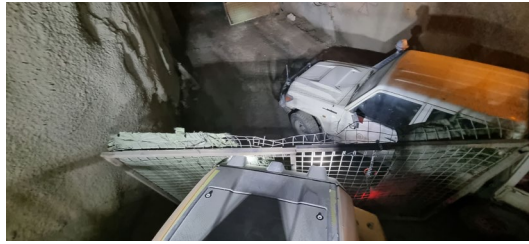
Dangerous incident
IncNot0042642
Underground
metals mine

A vent brattice door (tarp over steel mesh) was blown off its hinges past a light vehicle before coming to rest against an IT loader. An operator in the area got into the light vehicle as a precaution when the air pressure changed.

The mine was in shutdown mode and two primary fans were switched off, causing a spike in ventilation, which caused the door to be forced of its mounts.

When changes to ventilation systems are made, vent modelling should be conducted to ensure the changes do not pose a risk to workers in the mine.

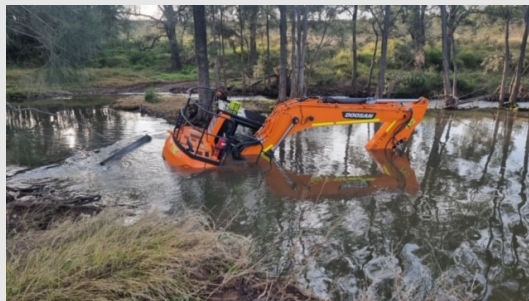
Dangerous incident
IncNot0042647
Underground coal
mine

A 14-tonne excavator was being trammed across a creek at a crossing on a concrete causeway. The creek was flowing with water at the time and the excavator operator trammed off the concrete causeway, resulting in the excavator tipping forward. The operator dropped the bucket to the ground to stabilise the excavator.

As water entered the cab, the operator exited the cab and waded through the water to the edge of the creek crossing.

All bodies of water present unknown hazards and should be avoided where possible. Where water crossings are created, a means of delineating the edge should be included in the design to allow safe passage.

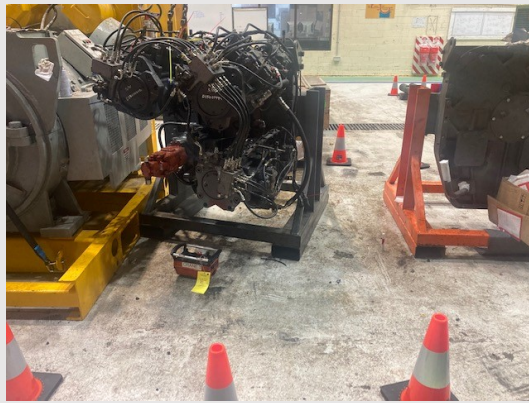
Dangerous incident
IncNot0042663
Open cut coal mine

A worker was using a gantry crane to position a pump drive. The crane was holding weight but had not lifted the drive off the ground.
While a tradesperson was between the load and another piece of machinery, the pump drive moved, causing the tradesperson to be pinned.
The remote for the crane was placed on the ground at the time.
A second tradesperson hit the E-Stop and the pinned tradesperson was freed.

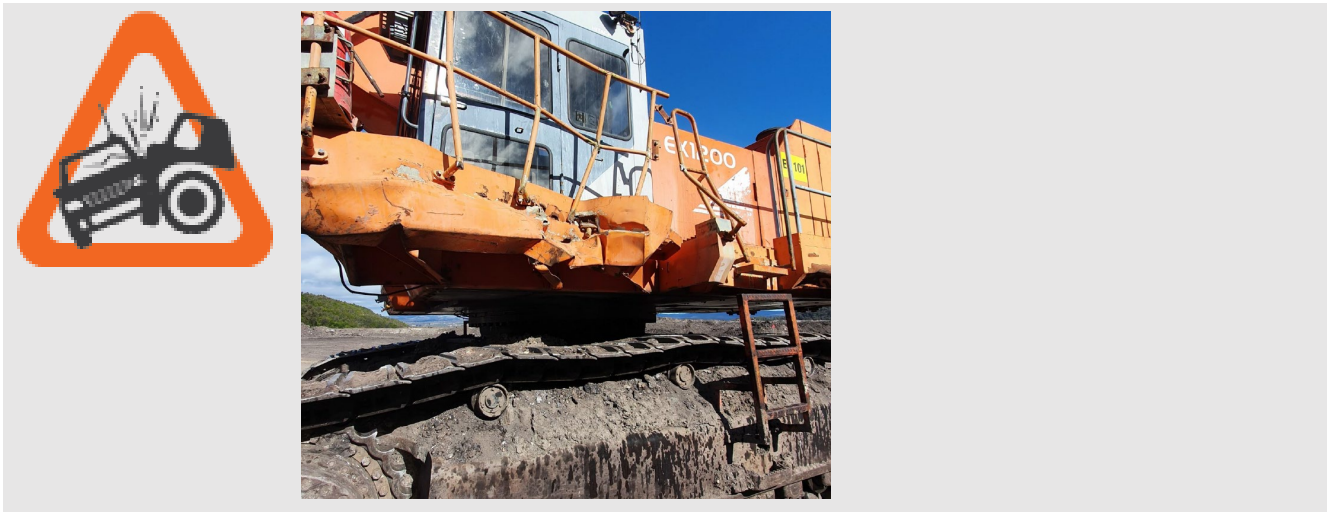
Dangerous incident
IncNot0042627
Open cut coal mine
Roads or other
vehicle operating
areas

An excavator was being tracked off the bench at the end of a shift. After two failed attempts of positive communications, the excavator tracked behind an operating dozer regardless. The dozer then reversed, hitting the walkway on the excavator.

Positive communications must be confirmed before moving plant into the operating area of other mobile plant.
Plant operators should never rely on the assumption that other operators will see them when moving.
