# SAFETY ALERT

**DATE: August 2022**

## Stranded worker rescued from active tailings dam.

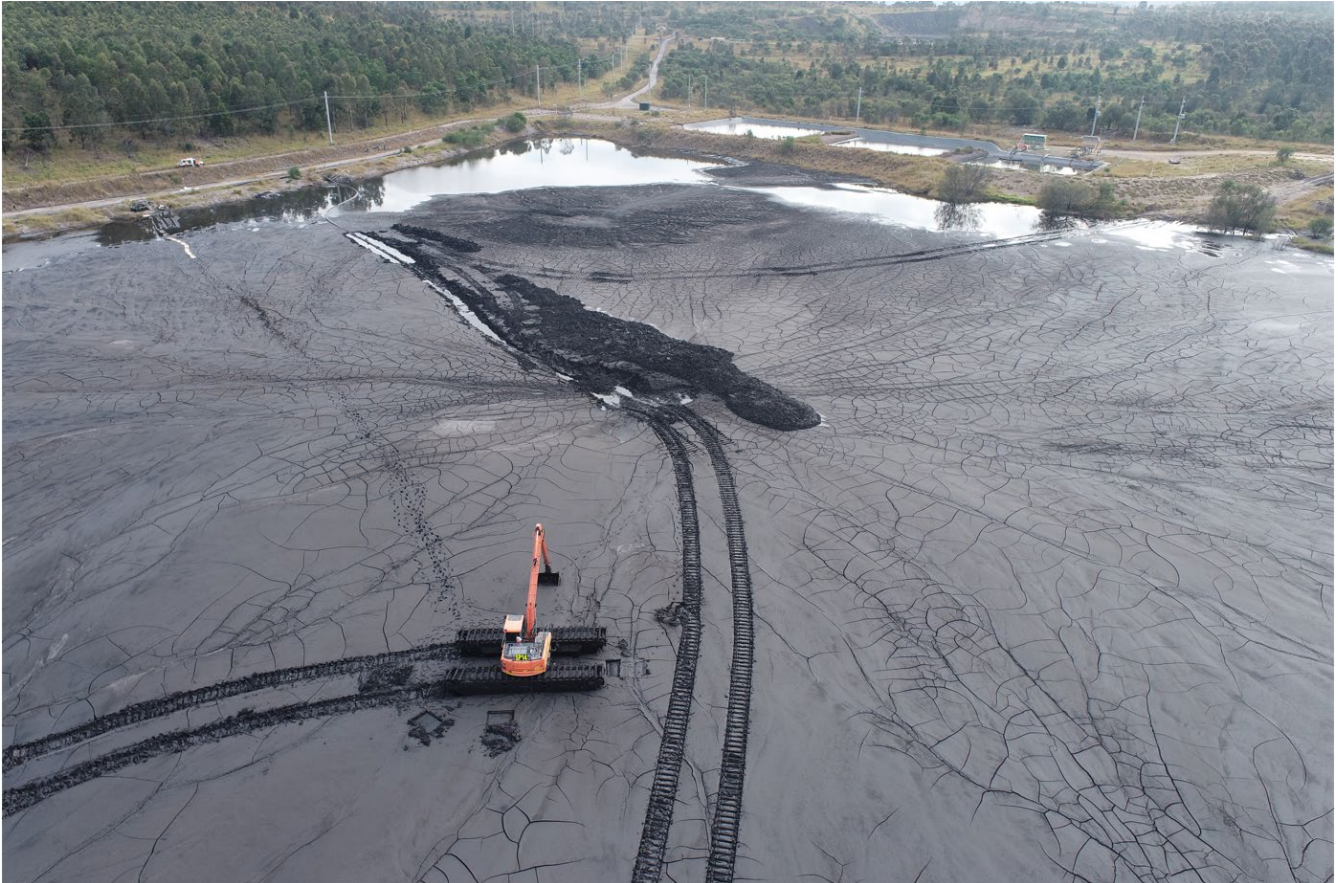
The excavator was immobilised after one of its tracks was damaged. The rescue plan for the excavator operator relied on the ATV, but the ATV could not gain traction across the tailings and was unable to travel far from the shore before having to return.

1. The capability of the rescue vehicle was not tested before the amphibious excavator started work on the active tailings dam.
2. The risk assessment and rescue/emergency plan for the amphibious excavator task did not consider contingency plans beyond the use of the rescue vehicle.

3. An assessment of risks to the rescue team entering the active tailings dam occurred but did not include a geotechnical assessment of the tailings material.

Figure 1: Amphibious excavator stranded on the active tailings dam.

1. carry out a risk assessment on works undertaken on active tailings dams. The risk assessment should include considering:
  - a. rescue/emergency procedures including contingency plans if the primary means of rescue fails.
  - b. the inclusion of a geotechnical assessment of the tailings material.
2. carry out capability testing of rescue devices (or rescue vehicles), before work on tailings dams begins
3. require all equipment brought on site for works on tailings dams to pass the mine's introduction to site process and be fit for purpose.
