**NSW
Resources
Regulator**

Quarterly safety report

April to June 2022

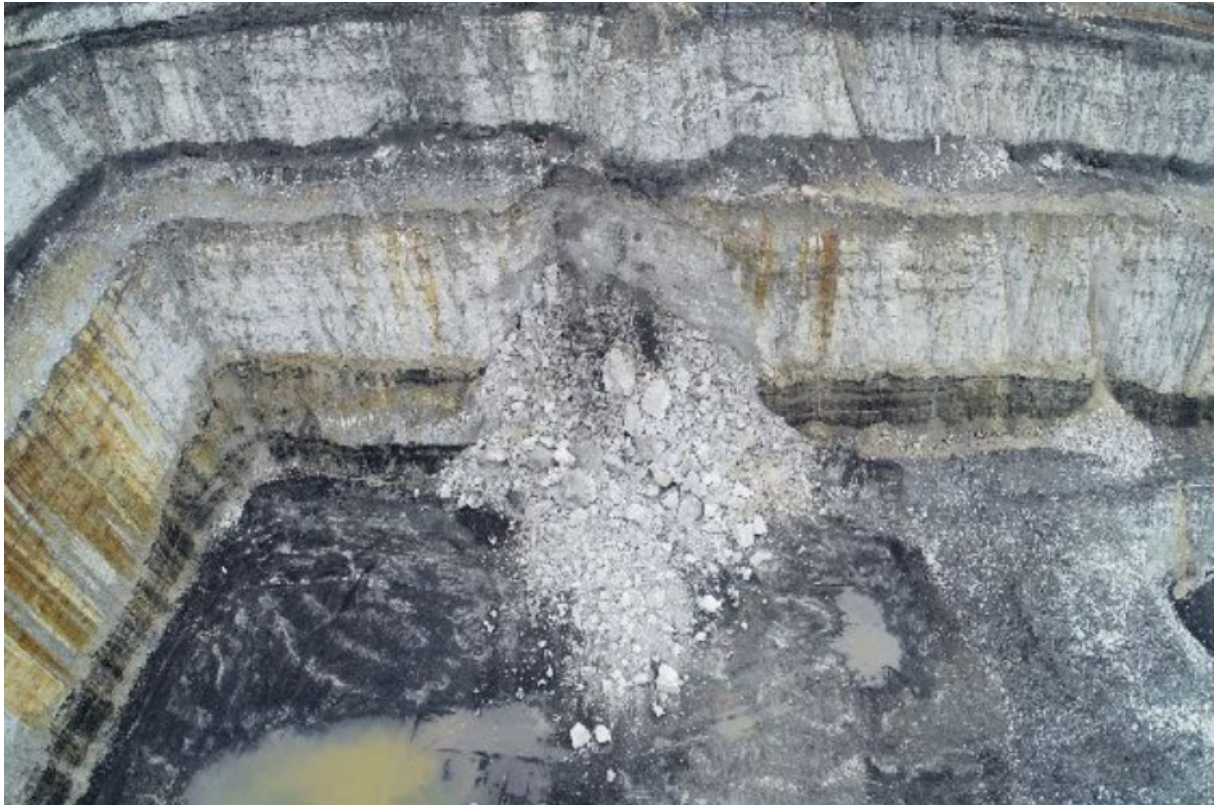
DANGEROUS INCIDENT - HIGHWALL FAILURE

A highwall failed and material breached the exclusion control zone in a known geotechnical hazard area. A grader was operating in the area at the time. The operator felt a vibration, noticed dust and quickly drove away from the highwall. The worker was clear of the falling material.

Below: Photograph showing the extent of the failure

Recent highwall failures in NSW mines have resulted in material overwhelming catchment bunds and exclusion zones. Mine operators should ensure an adequate exclusion zone is established based upon the maximum reasonable potential of a failure occurring, including the potential for a failure to extend through to adjacent jointing/faults. Mine operators should also ensure water egress is minimised to highwall crests to reduce the potential of a failure occurring. Refer to [Safety Bulletin: SB20-01 Failure of highwalls, low walls and dumps.](#)

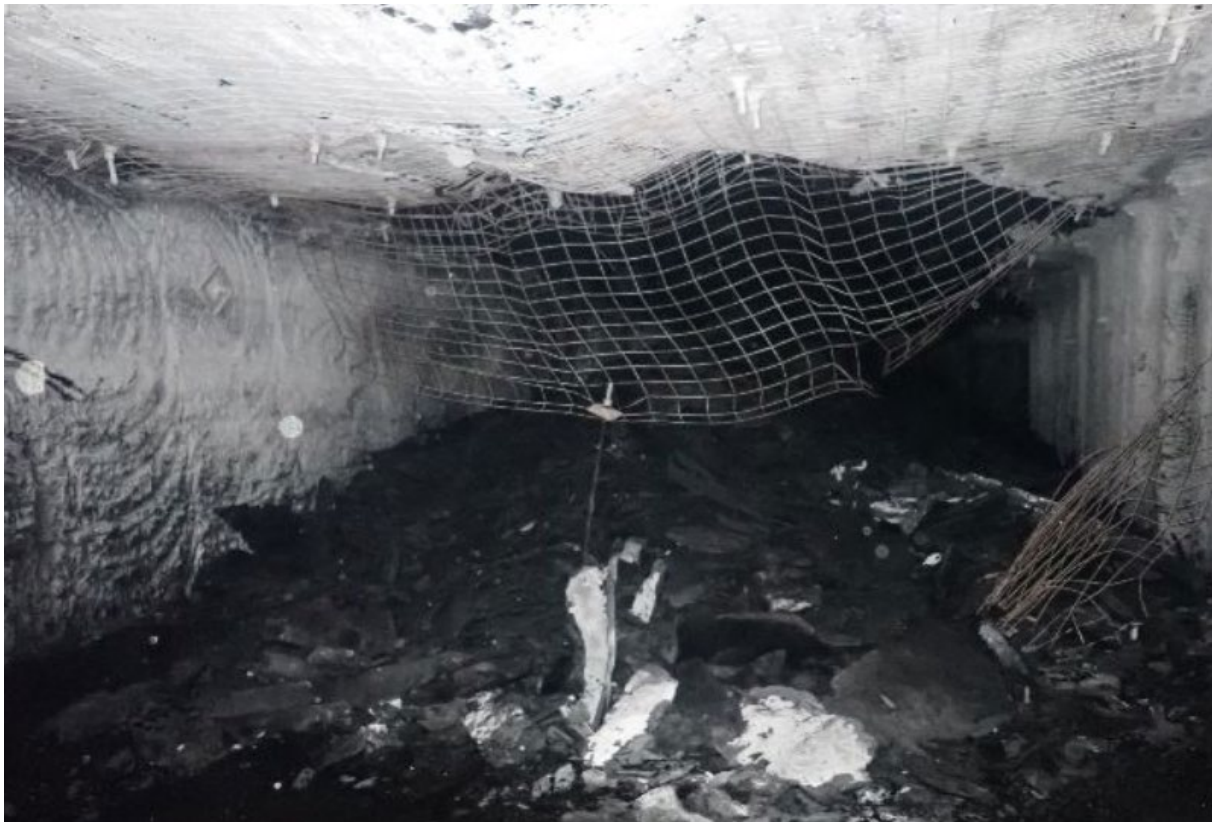
DANGEROUS INCIDENT - ROOF FALL

A fall of roof occurred, extending above a bolted horizon. The roadway was supported with bolts and mesh. The fall was about 15m long, partial width and extended 500mm above the centre bolts.

Below: Extent of the fall debris

Mine operators should have a process in place to identify changes in roof structure and the required support in that area (TARPS). Strata support should be designed with a suitable factor of safety. Workers must be trained in the correct installation of support to ensure 'gloving' does not occur and the chemical is correctly mixed. Regular verification of encapsulation needs to be completed and any bolt installation that does not meet the requirements of the support rules should be replaced. Statutory officials must verify support placement is as per the support rules.

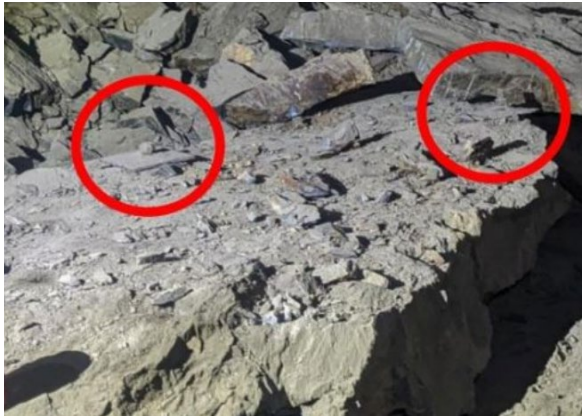
DANGEROUS INCIDENT - CORRODED BOLTS LEAD TO FALL OF GROUND

A fall of ground occurred when corroded roof bolts failed. The fall of material was estimated to be 1.5 tonnes. Nobody was in the area at the time.

Below: Plates still in place.

Underground mine operators should review the adequacy of support that was installed historically under different support regimes. The review should check that the age of installed support is taken into account and that the support continues to be effective.

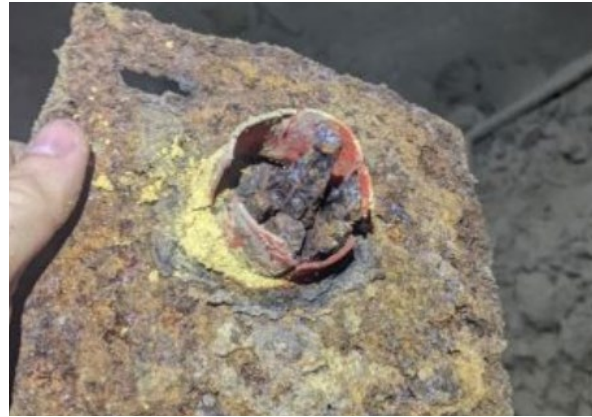
Below: Close up of corrosion damage.

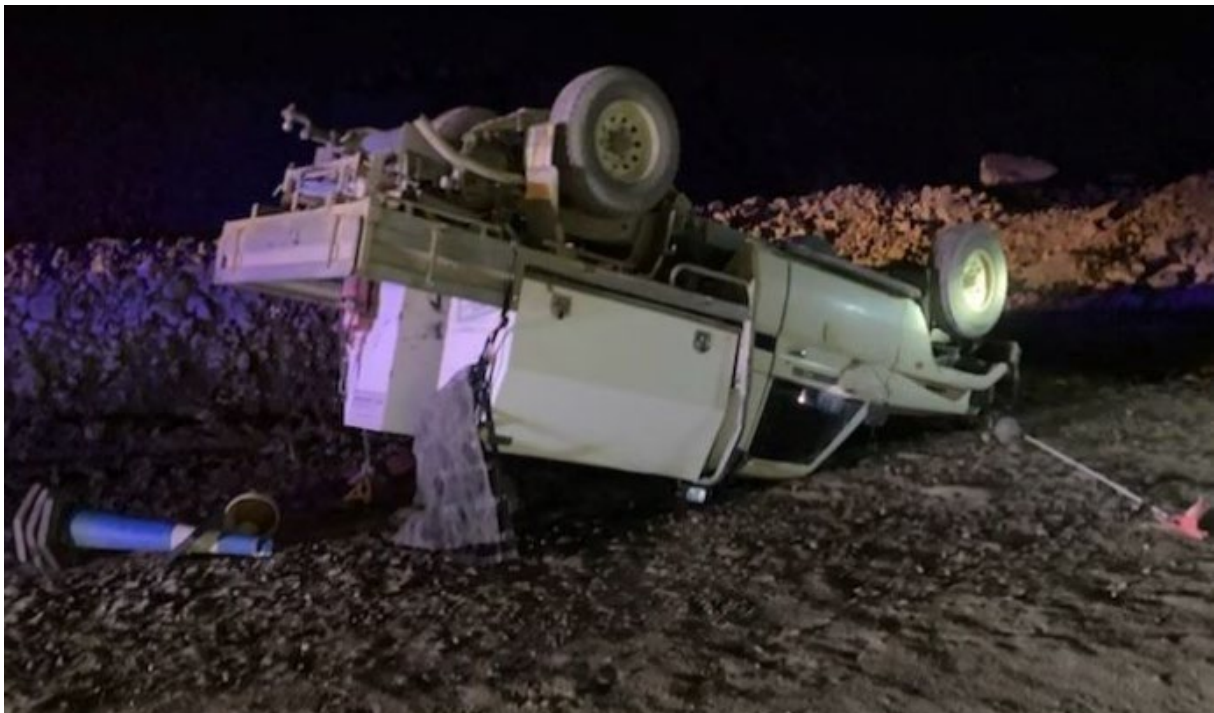
DANGEROUS INCIDENT- DISTRACTION LEADS TO OVERTURN

A light vehicle was travelling along a haul road. The operator was distracted by an open lid on a toolbox and has driven up a windrow and rolled onto the roof. The driver exited the cab of the vehicle with no injuries.

Below: The overturned light vehicle

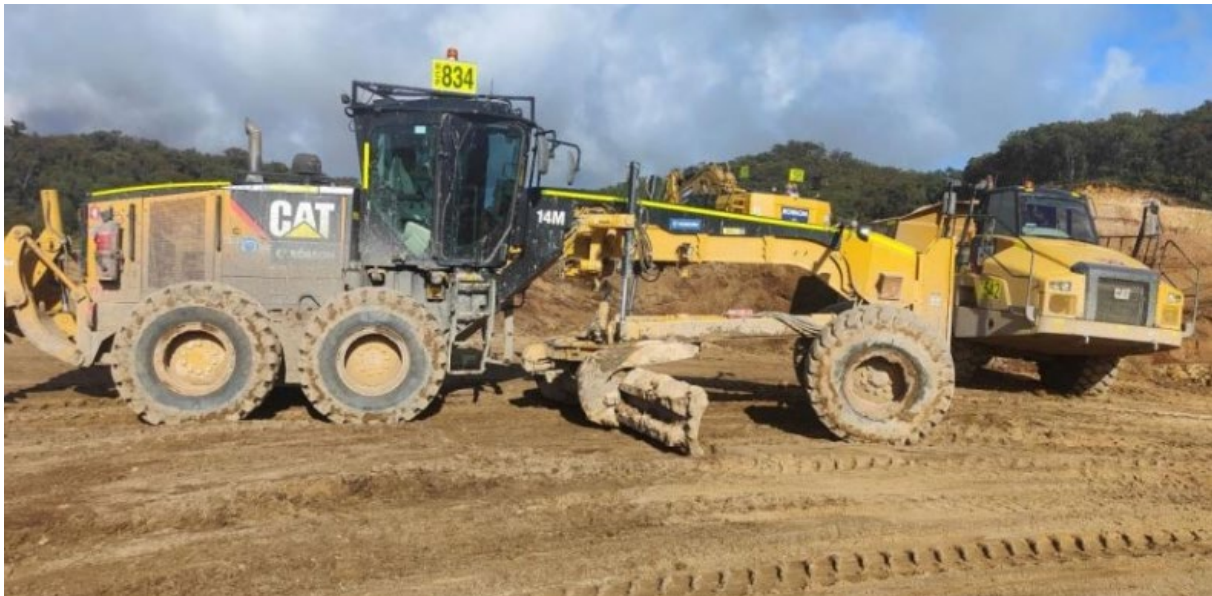
DANGEROUS INCIDENT - MICROSLEEP LEADS TO COLLISION

A grader collided with a stationary dump truck after the operator suffered a microsleeper. Nobody was injured and the damage was minor.

Below: Area of wet ground and position of haul truck

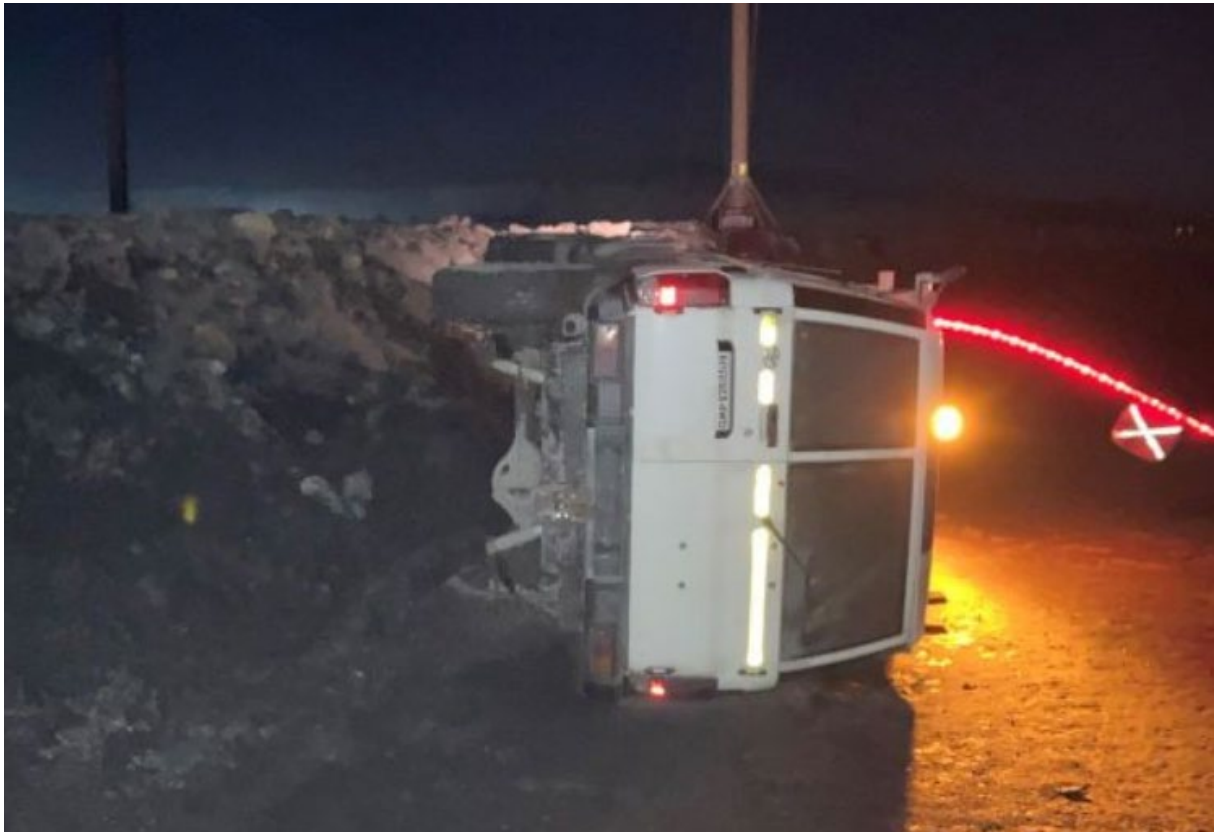
DANGEROUS INCIDENT - MICROSLEEP LEADS TO VEHICLE OVERTURN

A mine supervisor had a microsleeper while driving along a light vehicle road. The vehicle drove up onto a windrow and rolled onto the driver's side. The supervisor was not injured. The supervisor failed to preserve the scene and arranged for the vehicle to be righted and taken to a park-up area.

Below: The light vehicle after rolling

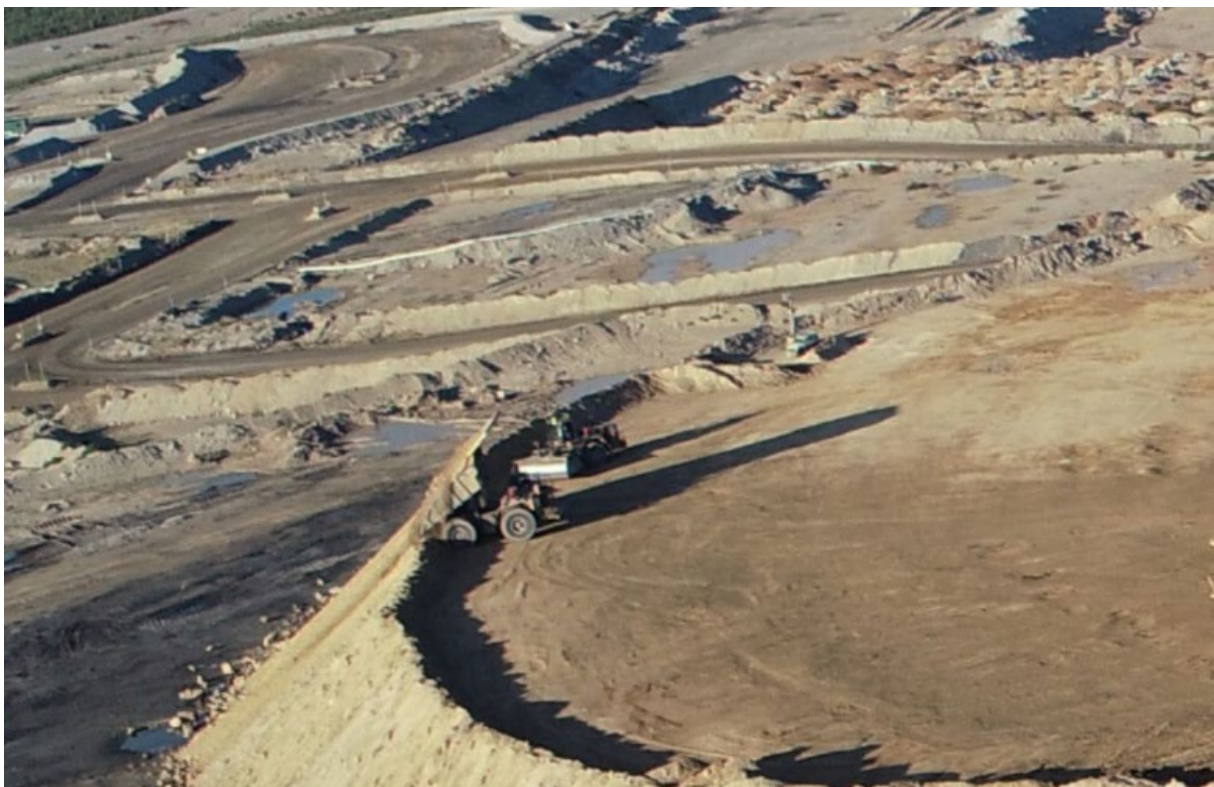
DANGEROUS INCIDENT - HAUL TRUCK BREACHES WINDROW

Below: The haul truck (centre left) over the windrow

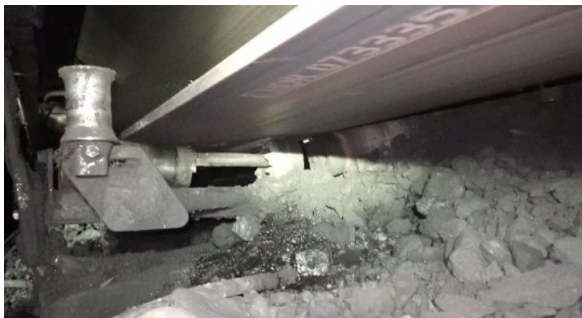
DANGEROUS INCIDENT - FLAMES IN COAL UNDER DRIFT BELT

Below: Coal build up under the belt.

Workers conducting inspections on conveyors must diligently inspect for fire risks such as accumulation of coal, failing or collapsed idlers and contact between conveyor belts and fixed structures. Mine operators must have systems in place to assess issues and plan a response to avoid the risk of fire, including immediately stopping the conveyor when necessary. No worker should be hesitant to stop a conveyor if it poses a fire risk.

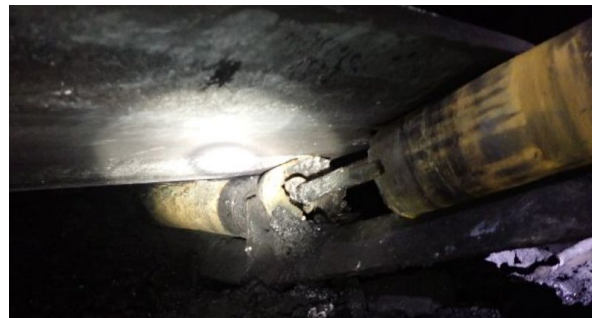
Below: Contact point under the belt.

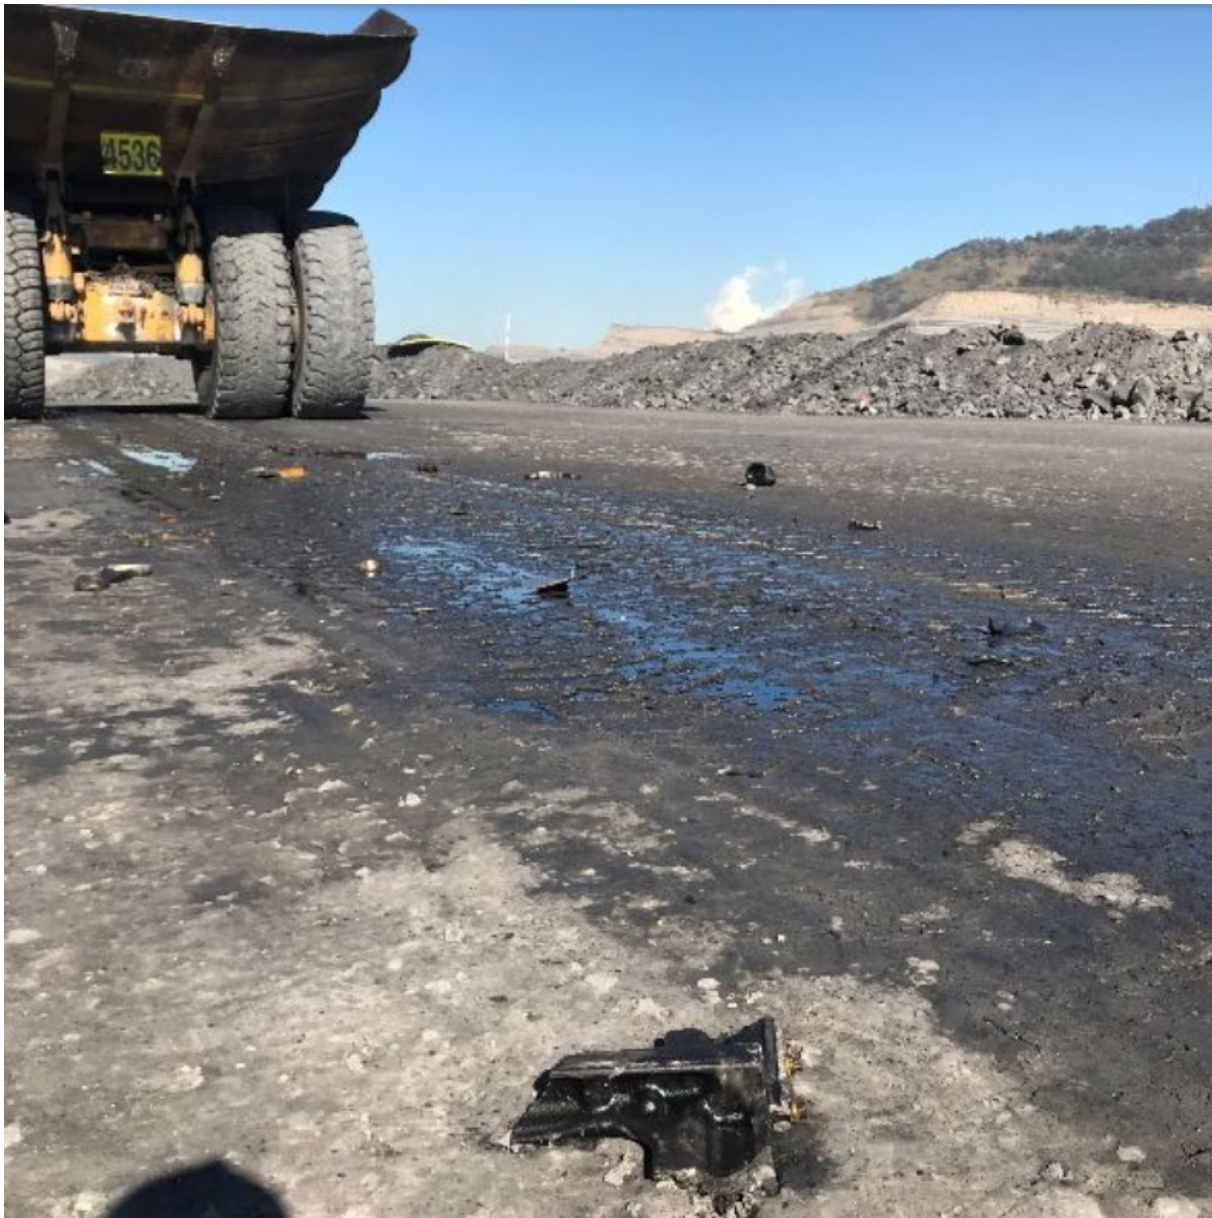
Below: Parts of the haul truck on the road

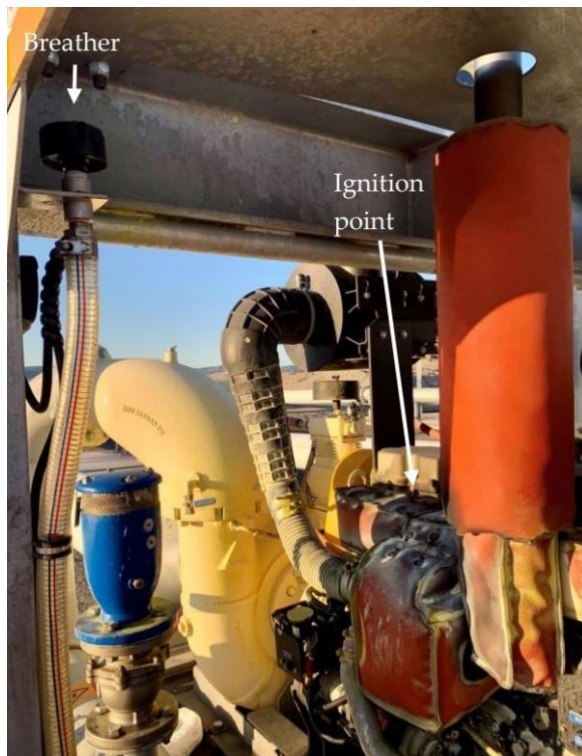
Below: Ignition point on pump

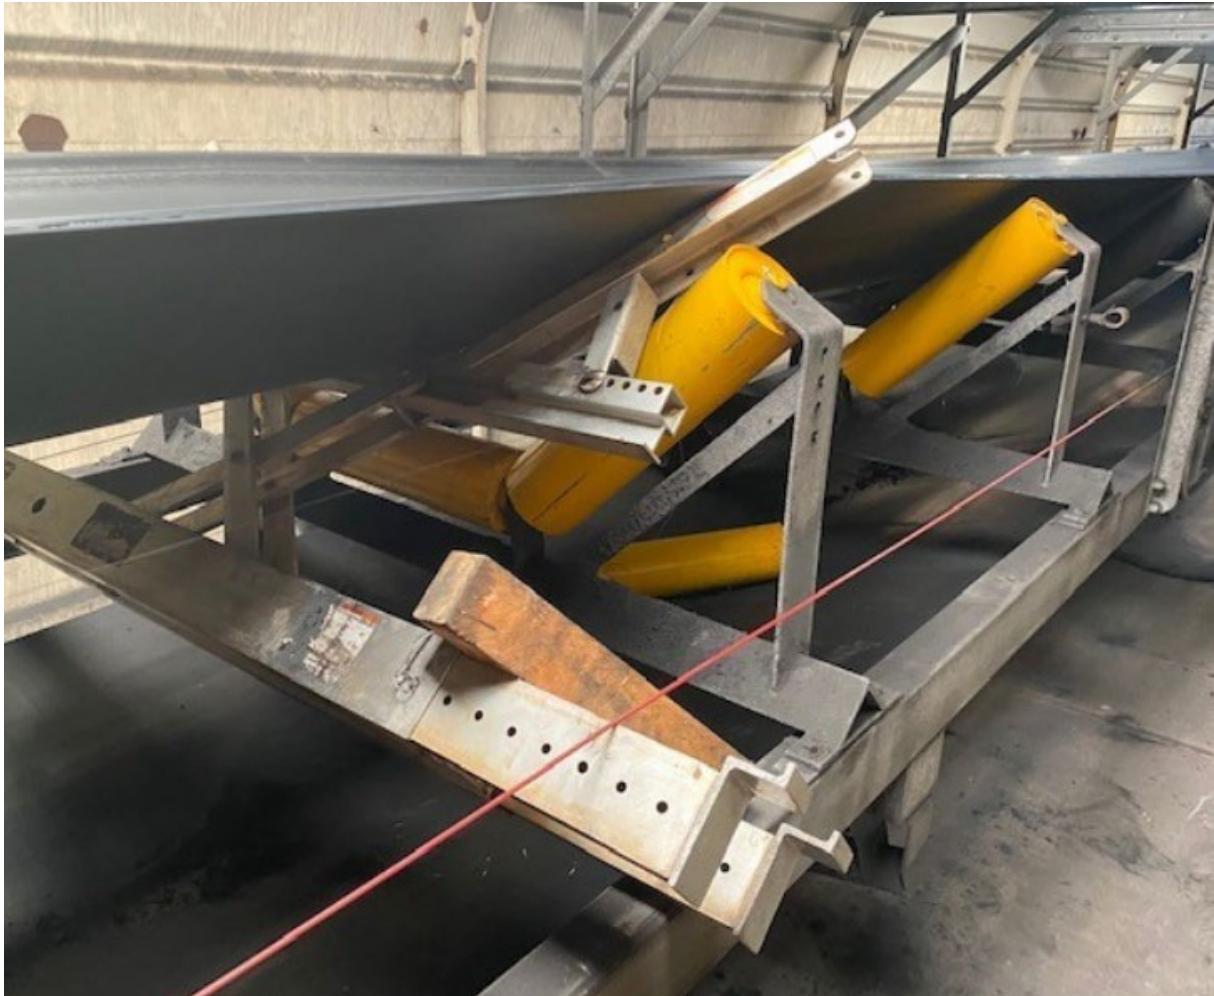
Below: Lifters caught under the belt.

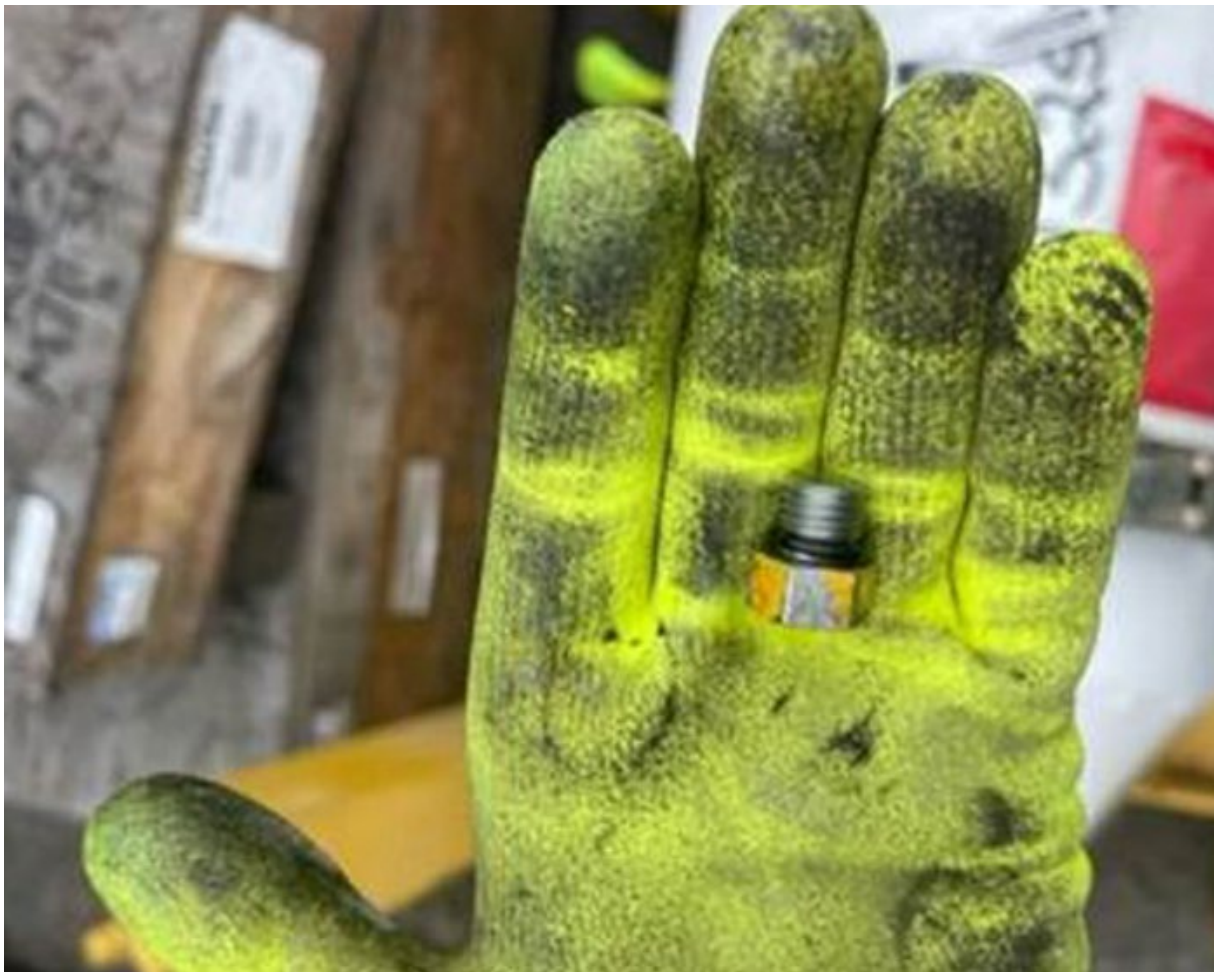
SERIOUS INJURY - RELEASE OF PRESSURE

Below: Close up of the ejected plug.
