# WEEKLY INCIDENT SUMMARY

Week ending Friday 16 September 2022

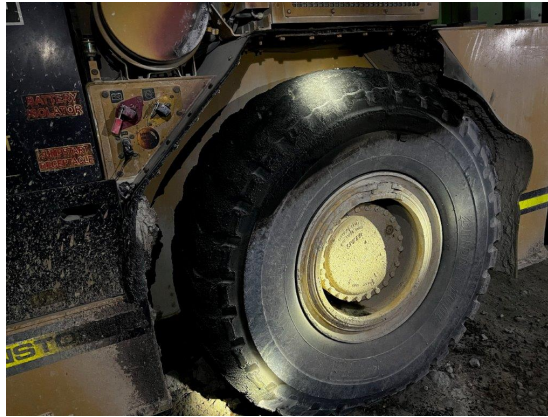
INCIDENT TYPE	SUMMARY	COMMENTS TO INDUSTRY
Dangerous incident IncNot0042991 Underground metals mine Roads or other vehicle operating areas	<p>A concrete agitator was travelling down a decline when a fire started behind the position 1 tyre. An emergency was called for all underground workers to retreat to refuge chambers.</p> <p>Emergency response attended the scene and extinguished the fire.</p> <p>After removing the position 1 tyre, it was found that the position 1 brake pack oil cooling line was capped off. This resulted in excessive heat generating from the brake pack. It was suspected that the brake oil cooling line was capped off during an off-site service and was reconnected before returning to site.</p>	<p>Following the maintenance and repair of mobile plant, plant should be inspected, tested and verified as fit-for-purpose before being returned to service.</p> <p>Safety critical systems such as braking should be inspected, maintained and tested in accordance with the manufacturer's recommendations.</p>

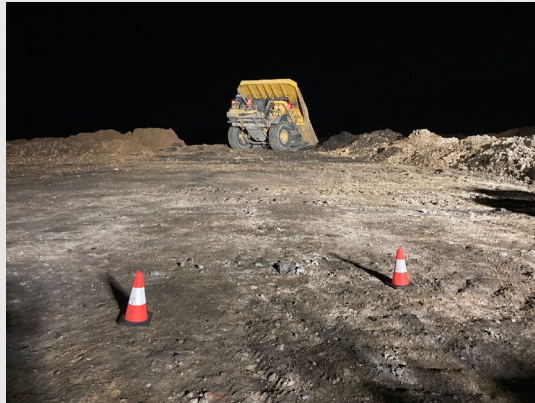
Dangerous incident  
IncNot0042993  
Open cut coal mine  
Roads or other  
vehicle operating  
areas

As a truck was tipping a load at a tip head, the material beneath the rear of the truck began to fail. The operator exited the truck and the ground continued to slump until the truck was at a 45-degree angle front to rear. The tip head was about 12 m high.

When designing a dump, ground stability should be a primary consideration. Material consistency, wet conditions and water management should be factored into the design. Inspections should verify dump integrity. Areas identified that do not meet the design standard should be demarcated, communicated to the workforce and remediated to meet the standard.

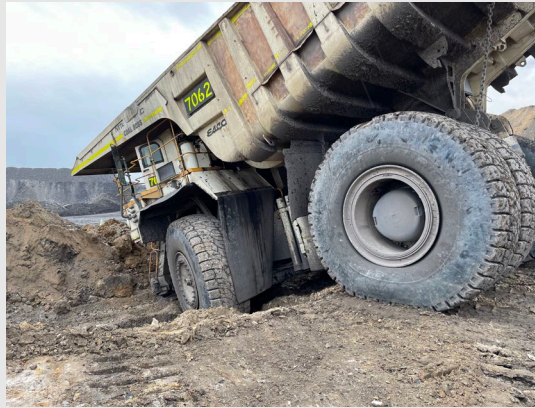
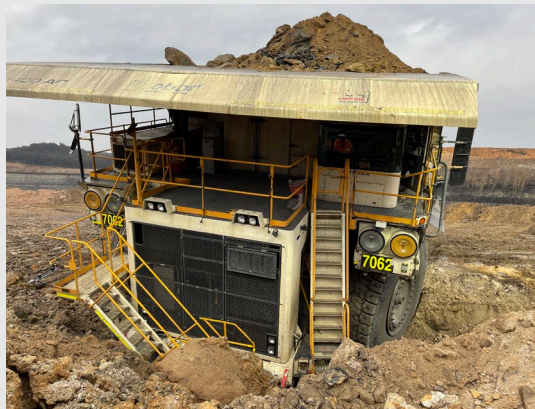
Dangerous incident  
IncNot0043023  
Open cut coal mine

A loaded dump truck was delivering waste rock to a dump. While turning to reverse to the dump face, the truck drove into an unprotected slot that was dug by a dozer. The slot was about 15 m

long, 10 m wide and 3 m deep. The slot had no edge protection established on either side.

Hazards created by earthworks should be suitably bunded to protect mobile plant from accessing unsafe areas.

Supervisors should communicate changes to operating areas and ground surface to all machinery operators entering the area. Mine operators should review the adequacy of their communication arrangements on shift.
