# Safety Alert

## Operator unable to activate fire suppression system during emergency

## Safety Alert SA22-06

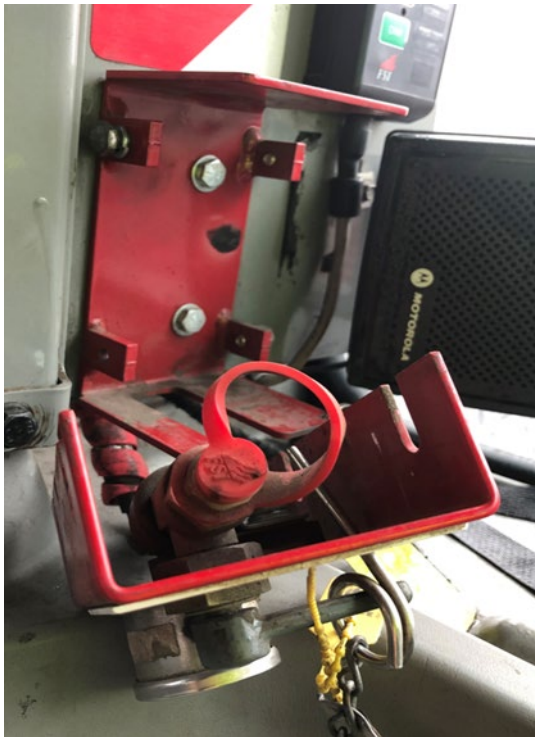
When a fire occurred on a dozer, the operator tried to activate the fire suppression system when the panel cover separated from the mounting bracket, forcing the operator to abandon the plant.

Figure 1 - Actuator panel separated from the mounting bracket

- the safety pin ring pull was looped over the valve handle (see figure 1)
- inspections of other plant with loss of pressure (LOP) systems were inconsistent with safety pin and anti-tamper tie orientation. Some also had the ring pulls looped over the valve handle.

- instruction decals (stickers) placed next to the LOP actuation points gave incorrect instructions for activating the system
- there were only 3 fasteners securing the actuator panel to the mounting bracket (see figure 1)

- the fasteners on the left-hand side were difficult to access because of the adjacent cabin structure
- the cover panel had slots rather than holes, which allowed the separation to occur if the fasteners weren't sufficiently tight

1. review or develop a site standard for fire suppression system actuator panel configuration. This standard should:
  - a. be developed in consultation with the fire system supplier and workforce
  - b. ensure that removal of safety pins occurs without interference from other components
  - c. have anti-tamper tags that do not impede operation in an emergency
  - d. include the tensioning of fasteners for mounting the panel
  - e. be documented and made available for reference during inspection and maintenance activities for both mine and contract maintenance personnel.
2. conduct an audit of plant and check all relevant fire suppression system panels are compliant with the site standard
