Quarterly safety report

July to September 2022

About this report

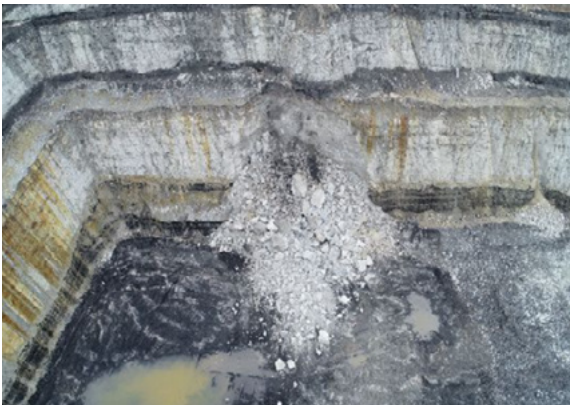
Picture 1.
Material from the highwall failure.

Summary: A highwall failed and material breached the exclusion control zone in a known geotechnical hazard area. A grader was operating in the area at the time. The operator felt a vibration, noticed dust and quickly drove away from the highwall. The worker was clear of the falling material.

Comments to industry: Recent highwall failures in NSW mines have resulted in material overwhelming catchment bunds and exclusion zones. Mine operators should ensure an adequate exclusion zone is established based upon the maximum reasonable potential of a failure occurring, including the potential for a failure to extend through to adjacent jointing/faults. Mine operators should also ensure water egress is minimised to highwall crests to reduce the potential of a failure occurring. Refer to [Safety Bulletin: SB20-01 Failure of highwalls, low walls and dumps](#)

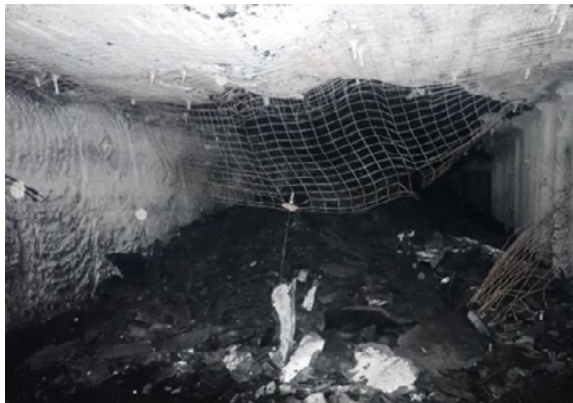
Picture 2.
Extent of the fall debris.

Summary: A fall of roof occurred, extending above a bolted horizon. The roadway was supported with bolts and mesh. The fall was about 15m long, partial width and extended 500mm above the centre bolts.

Comments to industry: Mine operators should have a process in place to identify changes in roof structure and the required support in that area (TARPS). Strata support should be designed with a suitable factor of safety. Workers must be trained in the correct installation of support to ensure ‘gloving’ does not occur and the chemical is correctly mixed. Regular verification of encapsulation needs to be completed and any bolt installation that does not meet the requirements of the support rules should be replaced. Statutory officials must verify support placement is as per the support rules.

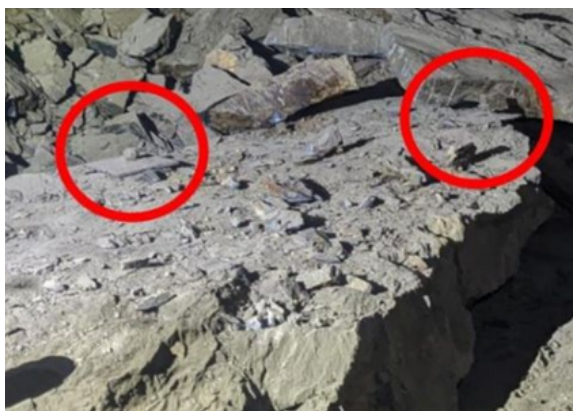
Picture 3.
Showing plates still in place.

Summary: A fall of ground occurred when corroded roof bolts failed. The fall of material was estimated to be 1.5 tonnes. Nobody was in the area at the time.

Comments to industry: Underground mine operators should review the adequacy of support that was installed historically under different support regimes. The review should check that the age of installed support is taken into account and that the support continues to be effective. Refer to [Fall of ground risks at NSW underground metalliferous mines](#)

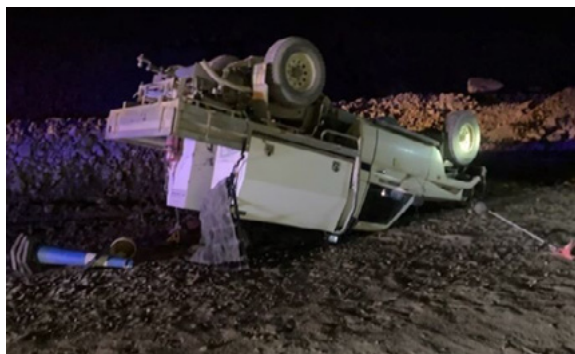
Picture 5.
The overturned light vehicle.

Summary: A light vehicle was travelling along a haul road. The operator was distracted by an open lid on a toolbox and has driven up a windrow and rolled onto the roof. The driver exited the cab of the vehicle with no injuries.

Comments to industry: Workers must always remain focused on controlling their vehicle. If a situation develops that requires their attention, such as an open toolbox, operators should safely stop the vehicle before addressing the issue.

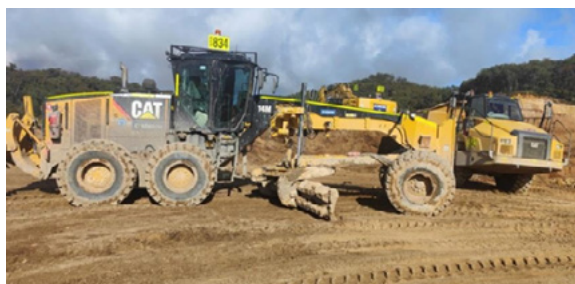
Picture 6.
Vehicles after collision.

Summary: A grader collided with a stationary dump truck after the operator suffered a microsleeep. Nobody was injured and the damage was minor.

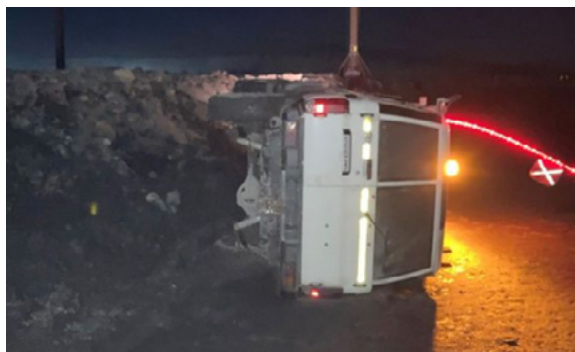
Picture 7.
Light vehicle after rolling over.

Summary: A mine supervisor had a microsleeep while driving along a light vehicle road. The vehicle drove up onto a windrow and rolled onto the driver's side. The supervisor was not injured. The supervisor failed to preserve the scene and arranged for the vehicle to be righted and taken to a park-up area.

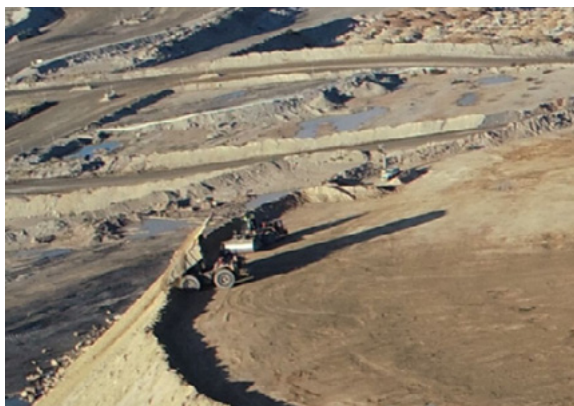
Picture 8.
Haul truck (centre left) over windrow.

Summary: A haul truck operator was reversing at an angle into a corner to tip its load when the right side rear wheels pushed through a windrow, causing the truck to bottom out on the windrow. The driver safely exited the truck.

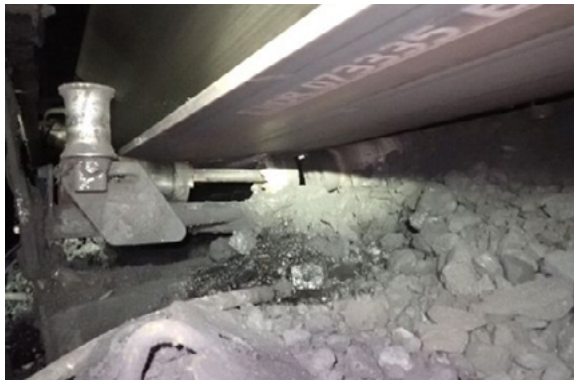
Picture 9.
Coal build up under belt.

Summary: A deputy smelled and witnessed smoke coming down a drift in an underground coal mine and contacted the control room. A dolly car operator immediately started an inspection and identified a small flame and smoldering coal under the drift belt. The fire was immediately extinguished. An idler had collapsed and the belt was rubbing on the frame. Excess coal around the roller had ignited.

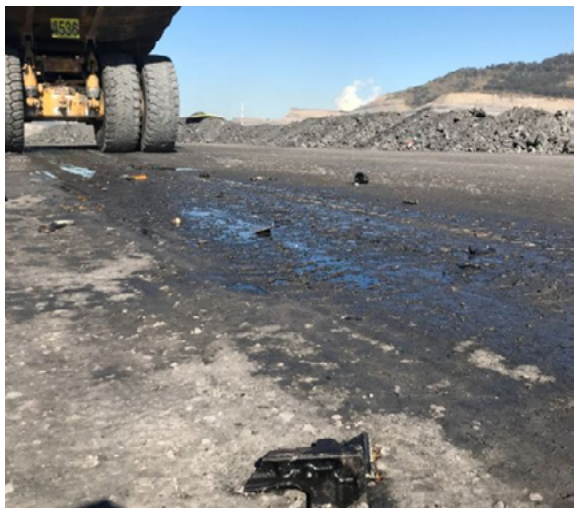
Picture 11.
Parts of the haul truck on the road.

Summary: A haul truck had dumped a second load for a shift and was leaving the dump. The operator smelled something burning then saw flames around the back of the cabin. The operator shut down the truck and unsuccessfully attempted to deploy the fire suppression system. The operator then escaped safely. The fire was extinguished with the aid of a water cart and on-board fire suppression. Upon inspection, it was discovered that a significant mechanical failure resulted in a large hole in the bottom of the engine which initiated the fire. The truck was recently down for maintenance. A further examination of the truck found that the emergency ladder access gate was extremely stiff and not easily opened. The operator did not use this means of egress.

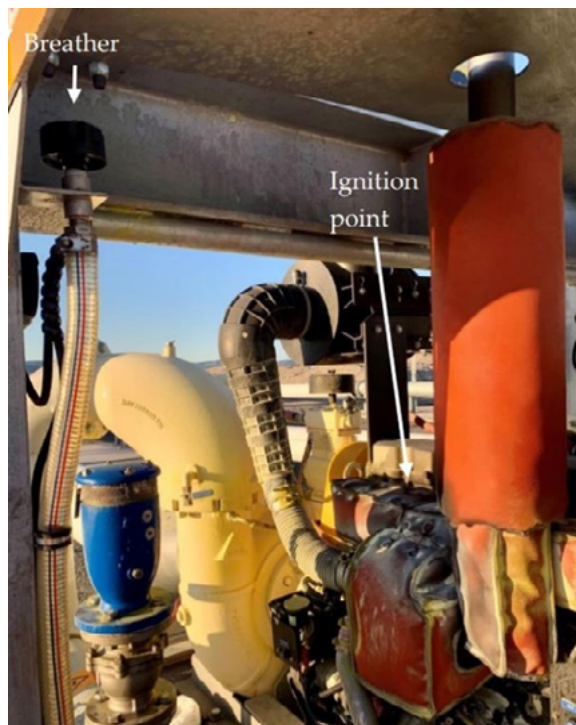
Picture 12.
Ignition point on pump.

Summary: A diesel pump was being refuelled during commissioning. The auto-fill nozzle clicked off indicating the system was full. The fuel gauge indicated the tank was 87% full, so the operator pushed the nozzle back on and held it in position to continue filling the diesel tank. The operator noticed diesel flowing from the breather, so they disconnected and reeled the hose back to the truck. Fuel contacted the exhaust lagging and ignited. The flame was extinguished using a fire extinguisher.

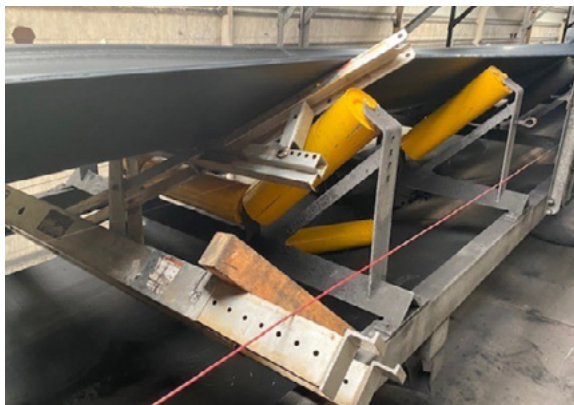
Picture 13.
Showing lifters caught under the belt.

Summary: A conveyor belt moved approximately 300 mm when a splice clamp was released. The movement caused the conveyor lifters to topple over near where a roller change was being carried out. The belt was isolated at the time of the incident and the counterweight was on the deck. There were no injuries.

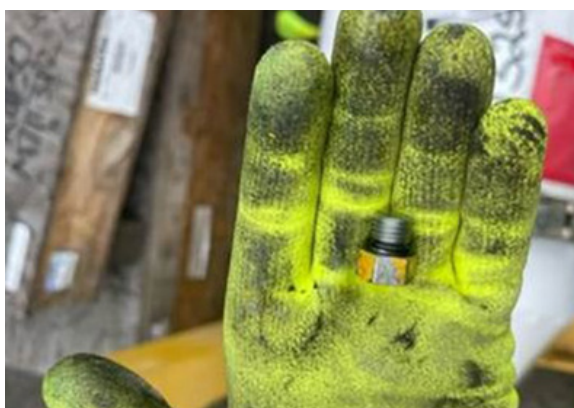
Picture 14.
Close up of the ejected plug.

Summary: A mechanical technician removed a plug from the right-hand rear strut of a dump truck believing it was a grease port. The plug was tapped into the chamber of the strut and the technician was using a hand ratchet and socket. The plug was forced out under pressure (approximately 170-200 psi). The technician was just outside the direct line of fire of the plug and was covered in fluid from the strut. The plug was found on the ground a couple of metres away from the technician.
