Investigation information release

Loader falls into stope

Location: Perilya Potosi operation, Broken Hill, NSW

Investigation information release IIR22-08

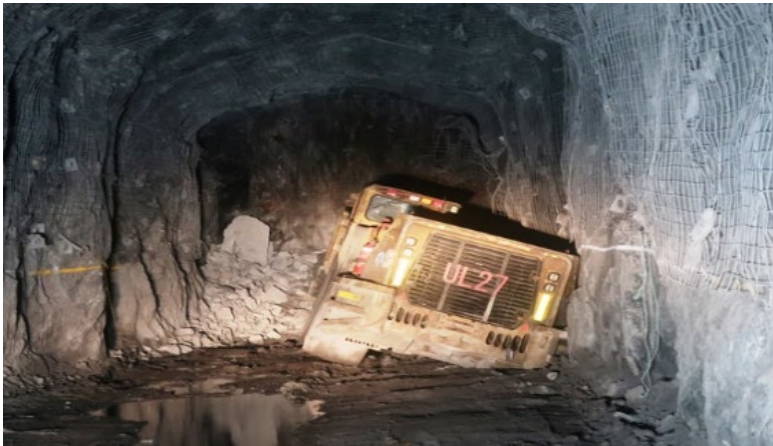
A loader operator was extracting material from a previously fired development heading at the 16 NPE 3400 north on the 16 level at the Potosi underground mine. While bogging, the loader operator felt the loader sag to the right and thought there was a flat tyre on the CAT 2900 loader. The operator exited the machine and saw the right-hand side wheels of the loader had dropped into a void that had formed in the floor of the drive. The operator immediately notified the shift supervisor.

Figure 1 Loader in the 16 level 3400 NPE development drive in the void in the floor

Mine operators should ensure that all known voids are documented and the process for any designs including changes to designs are thoroughly reviewed before the plans are approved.

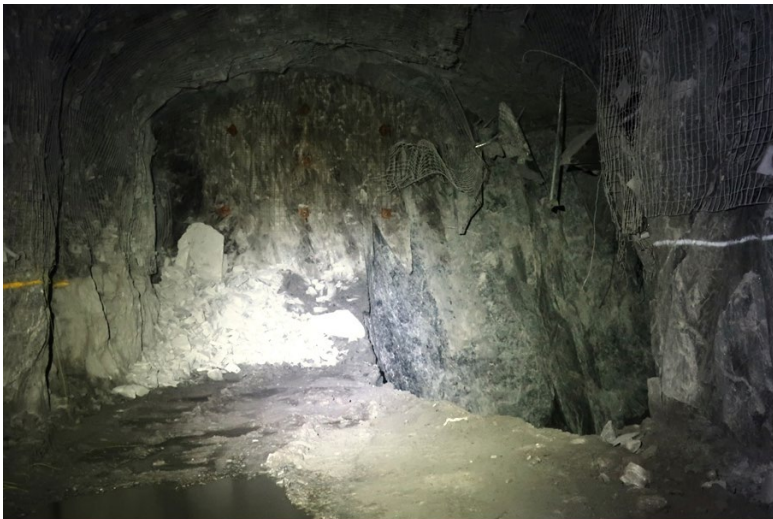
The incident was escalated to the mine's senior management who decided to barricade the area and further investigate the situation on the following shift. During the night, the void which had developed at the development heading, enlarged letting the loader fall about 15 metres into the previously mined stope. The loader came to rest on the level below.

Figure 2. Void opened up on the 16 level 3400 NPE development drive

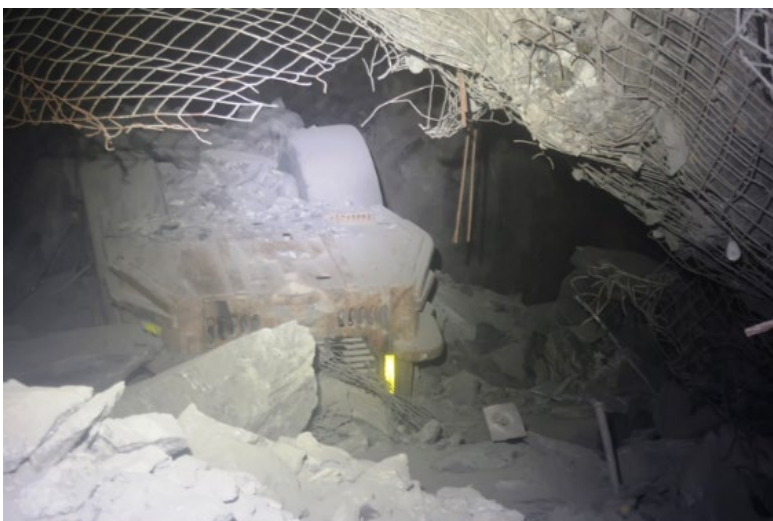
Figure 3. Loader in the 17 level 3400 NPE stope.
