Weekly incident summary

Week ending 3 February 2023

Document control	
CM9 reference	DOC23/24824
Mine safety reference	ISR23-04
Date published	10 February 2023
Authorised by	Deputy Chief Inspector Office of the Chief Inspector

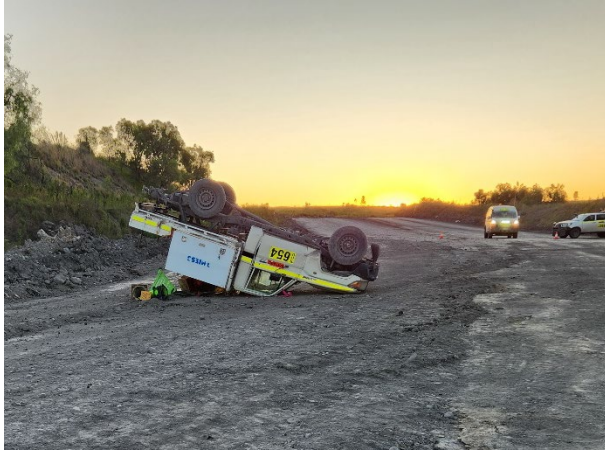
An apprentice was driving a light vehicle on a haul road when it hit a rock and rolled the vehicle. The sun was in the drivers’ eyes at the time of the incident. The worker was uninjured.

Mine operators must ensure that regular inspections are undertaken to ensure that travel roads do not contain unexpected hazards. Workers are reminded to travel at an appropriate speed based on the road and weather conditions.

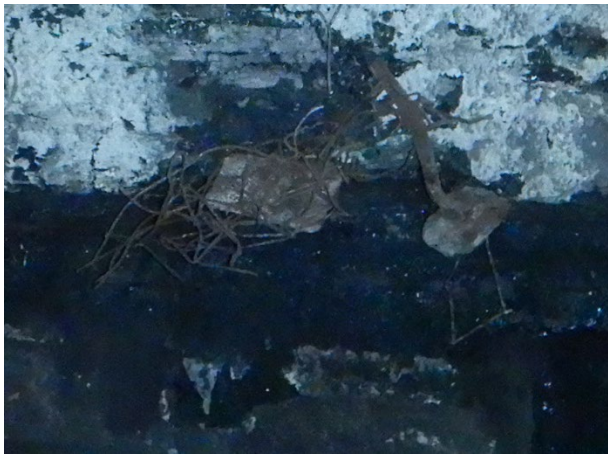
<p>Dangerous incident IncNot0044025</p> <p>Underground coal mine</p>	<p>A coal mine worker was driving a load haul dump (LHD) with a loaded structure pod heading out of a mine. The structure pod and LHD made contact with protruding rib mesh. The rib mesh entered the LHD cabin making contact with the worker's nose and safety glasses.</p> <p>The worker was assessed at hospital where a scan revealed a fracture on the bridge of the nose.</p>

<p>Mine operators must ensure that regular inspections are undertaken to ensure that travel roads do not contain unexpected hazards.</p> <p>Mine workers who regularly travel on roads must report areas where rib or roof support need to be repaired. Processes must be put in place for the timely repair of reported damaged support.</p>
<p>Dangerous incident IncNot0044012</p> <p>Underground coal mine</p> <p>Fire or explosion</p>	<p>A worker was setting up to work on a trailer fitted with a QDS plate in the surface workshop. The QDS plate was detached from the trailer and chocked.</p> <p>While working between the QDS plate and trailer, the QDS plate fell over. It brushed the worker on the left upper arm and shoulder</p>	<p>Workers must ensure components are adequately chocked, supported and/or secured when working in close proximity to plant and equipment that may move.</p> <p>Working around objects that can tip or roll over should be treated the same as working under</p>

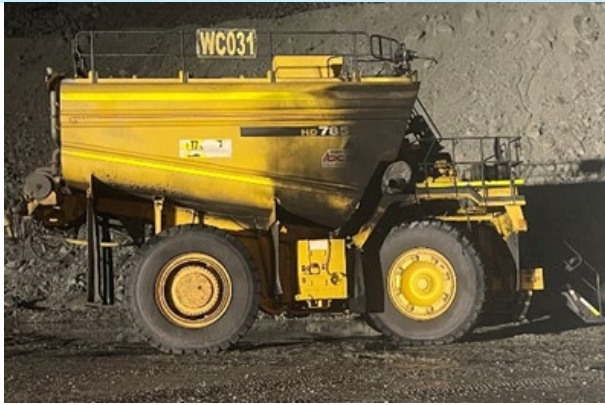
<p>Dangerous incident IncNot0043987 Open cut coal mine Fire or explosion</p>  	<p>The operator of a water cart noticed a strange smell and returned to the workshop. An inspection did not identify any issues. The truck left the workshop heading to a dump when the operator noticed a loss of power and saw smoke in the rear mirrors. The truck was immediately parked up. Flames then started coming from the engine bay around the front of the truck.</p> <p>The fire was extinguished by other water carts.</p> <p>The operator complained of breathing issues and was taken to hospital. After being assessed, the worker was released and returned to the mine to complete their shift.</p>	<p>Maintenance systems must be comprehensive and consider all reasonably foreseeable risks of fire or explosion.</p> <p>When operators report defects or concerns, thorough inspection and testing should be conducted to ensure the plant is safe to operate.</p>

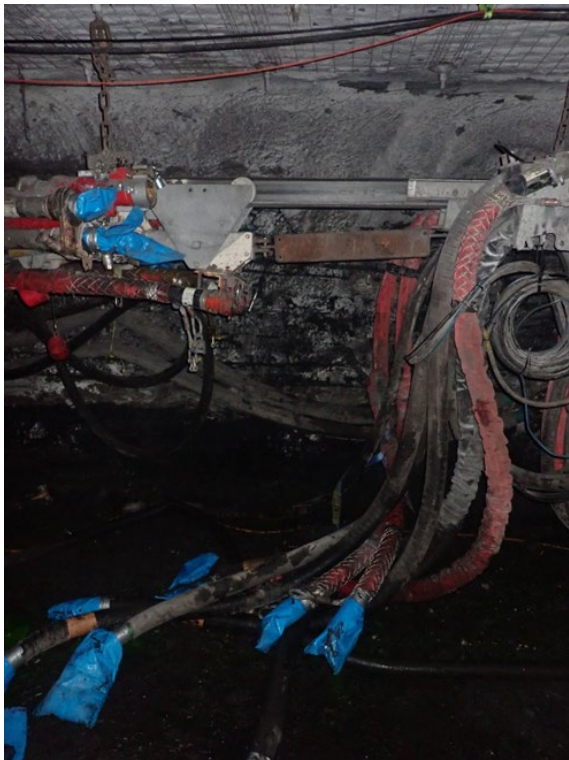
<p>Dangerous incident IncNot0043983 Underground coal mine</p>	<p>A worker was disconnecting compressed air lines while removing a monorail section as part of a longwall relocation. The worker removed a staple on an air hose when the hose whipped around, knocking off the worker's helmet and hitting him into the rib. The worker also suffered abrasions that were treated at hospital. The investigation identified that the air pressure had been isolated but not dissipated.</p>

<p>Inexperienced operators must have appropriate training and supervision.</p> <p>Systems of work should be clear and unambiguous with regards to discharging stored energy before work is undertaken.</p>
<p>Dangerous incident IncNot0043982 Underground coal mine</p>	<p>A worker was operating a rib bolter on a continuous miner when a hose failed. The worker was hit on the forehead and arm with hydraulic oil. The worker was assessed at hospital and cleared of injury.</p>	<p>Mine operators must ensure that hydraulic systems are maintained appropriately to prevent loss of hydraulic fluid under pressure.</p> <p>Controls such as shielding must be considered to protect workers from the risk of fluid release near a workstation or area where workers are likely to be.</p>
