**HUNTER VALLEY  
OPERATIONS**

**HVO WEST PIT  
WS 117 DUMP FAILURE**

**GREG MCCORMACK**  
MANAGER OF MINING ENGINEERING

**KUDRET TUTUK**  
SENIOR GEOTECHNICAL ENGINEER

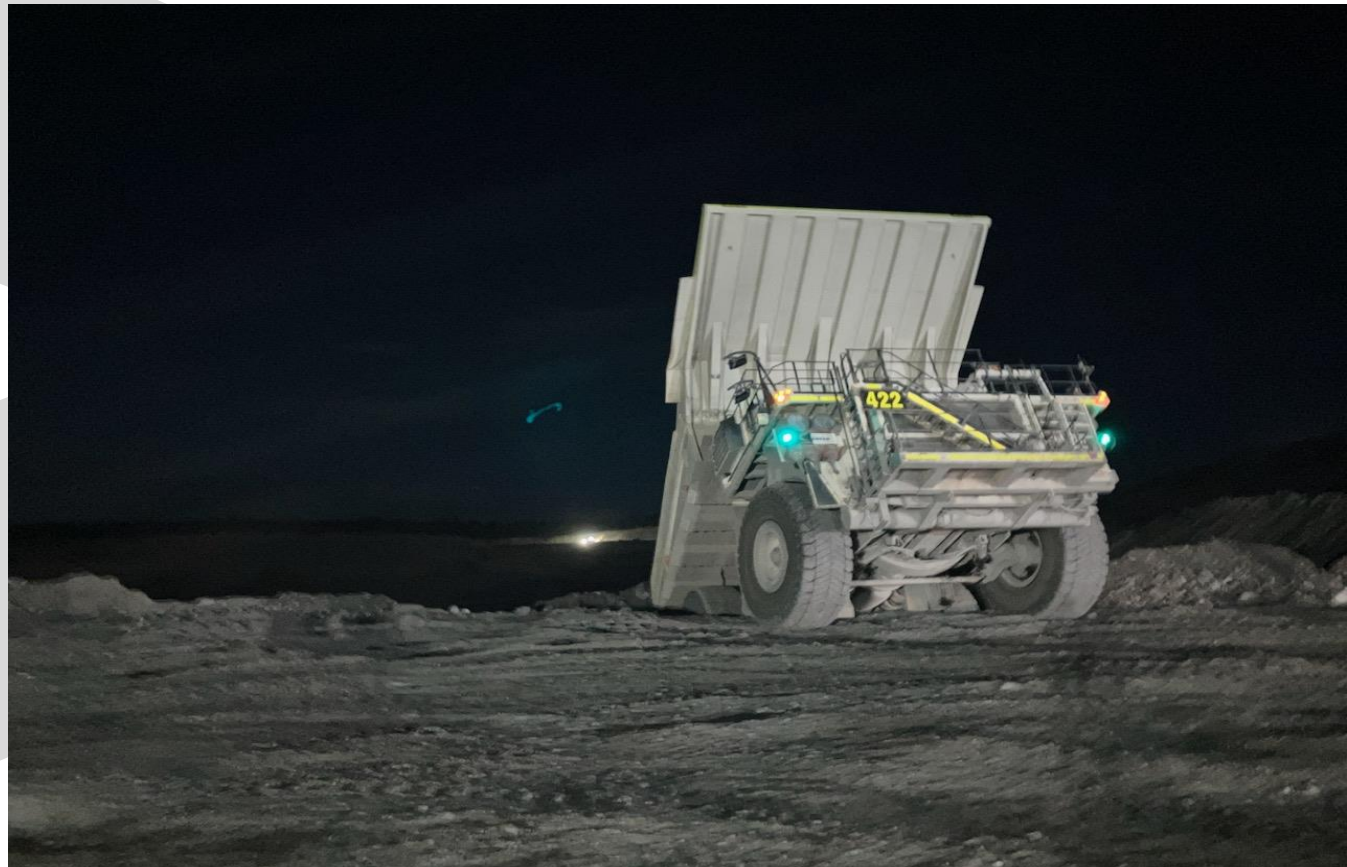
- At approximately 10:30am on 8<sup>th</sup> December the dozer operator on WS 117 Dump identified cracking at the tip head.
- The dump was closed, and the truck fleet relocated.
- After Inspection by the OCE, the direction was to cut down the dump and re-establish the tip head with suitable material under an Orange TARP (double windrows and 5 metre offset).
- Upon completion of rectification works, the OCE inspected the WS 117 Dump and reopened the dump under a Yellow TARP (monitor windrows / conditions).
- The WS 117 Dump activities executed during the shift were recorded in the OCE Shift Report and communicated to the Night Shift Supervisors, the WS 117 dump operator and to the entire Mining Team at Night Shift HCOM.

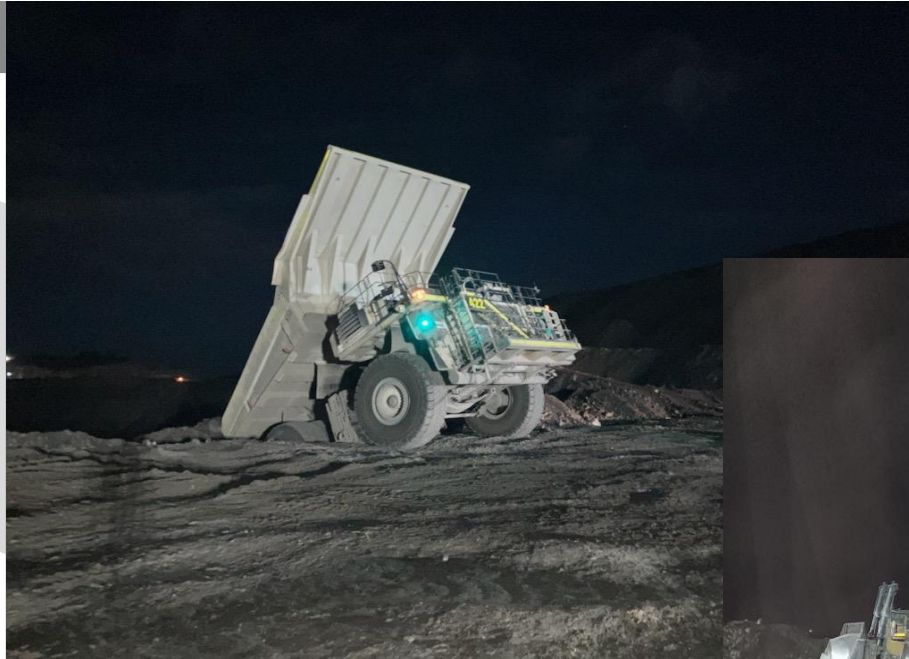
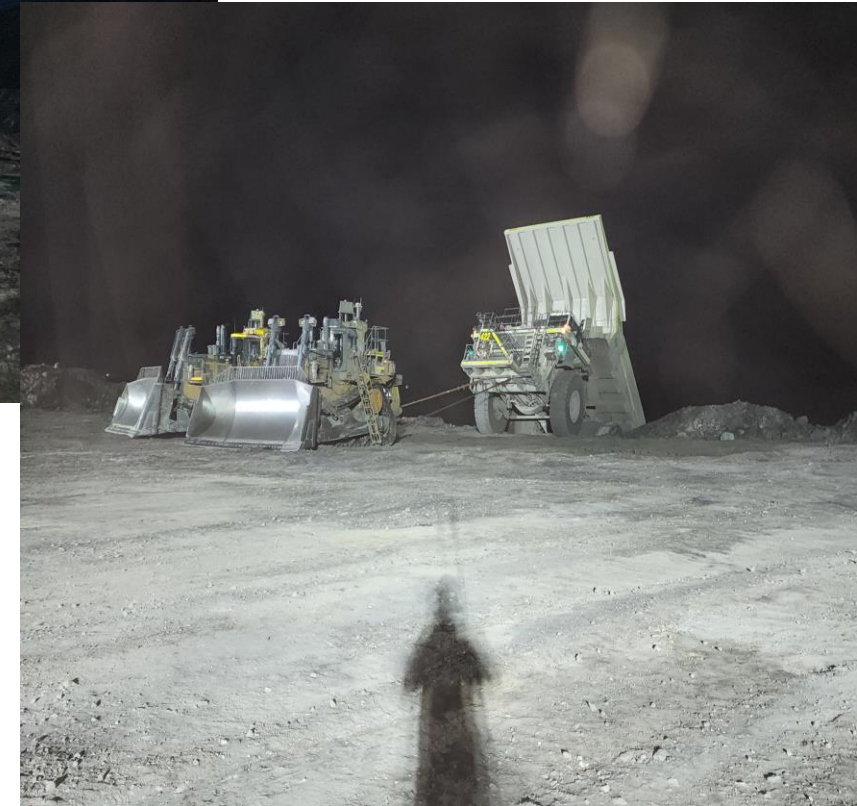
- Just before 1:00am Truck 422, a Komatsu 830E, entered the WS 117 dump and proceeded to the tip head to tip off.
- While tipping off the load, the rear wheels of the truck have sunk when the truck body was half raised.
- The operator of T481 contacted the operator of T422 to inform him “the tip face had failed”.
- The operator of T422 exited the cab and climbed down the emergency ladder the with assistance of the operator of T481.
- **Emergency response was activated, incident scene secured and required notifications undertaken.**
- **Incident investigation initiated:**

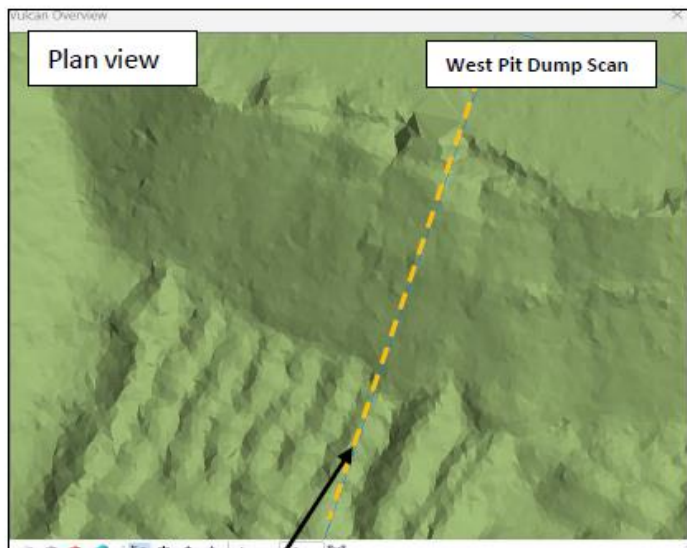
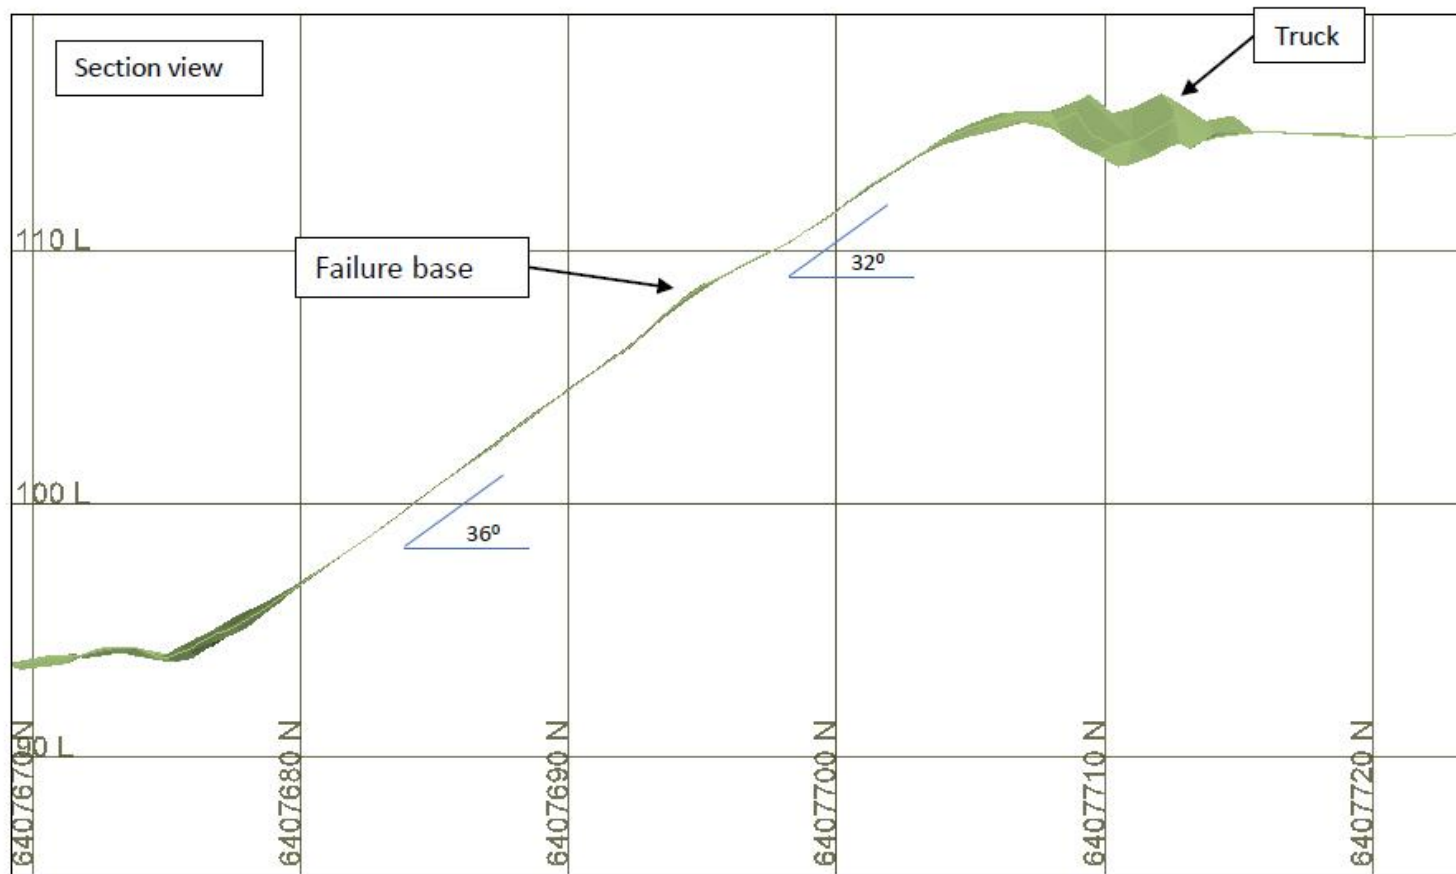
Section line taken for analysis

221209\_WS117\_Dump.00t dump scan was provided for accurate analysis of the area.

Angle of repose changes indicated the base of the failure and the limit of the movement.

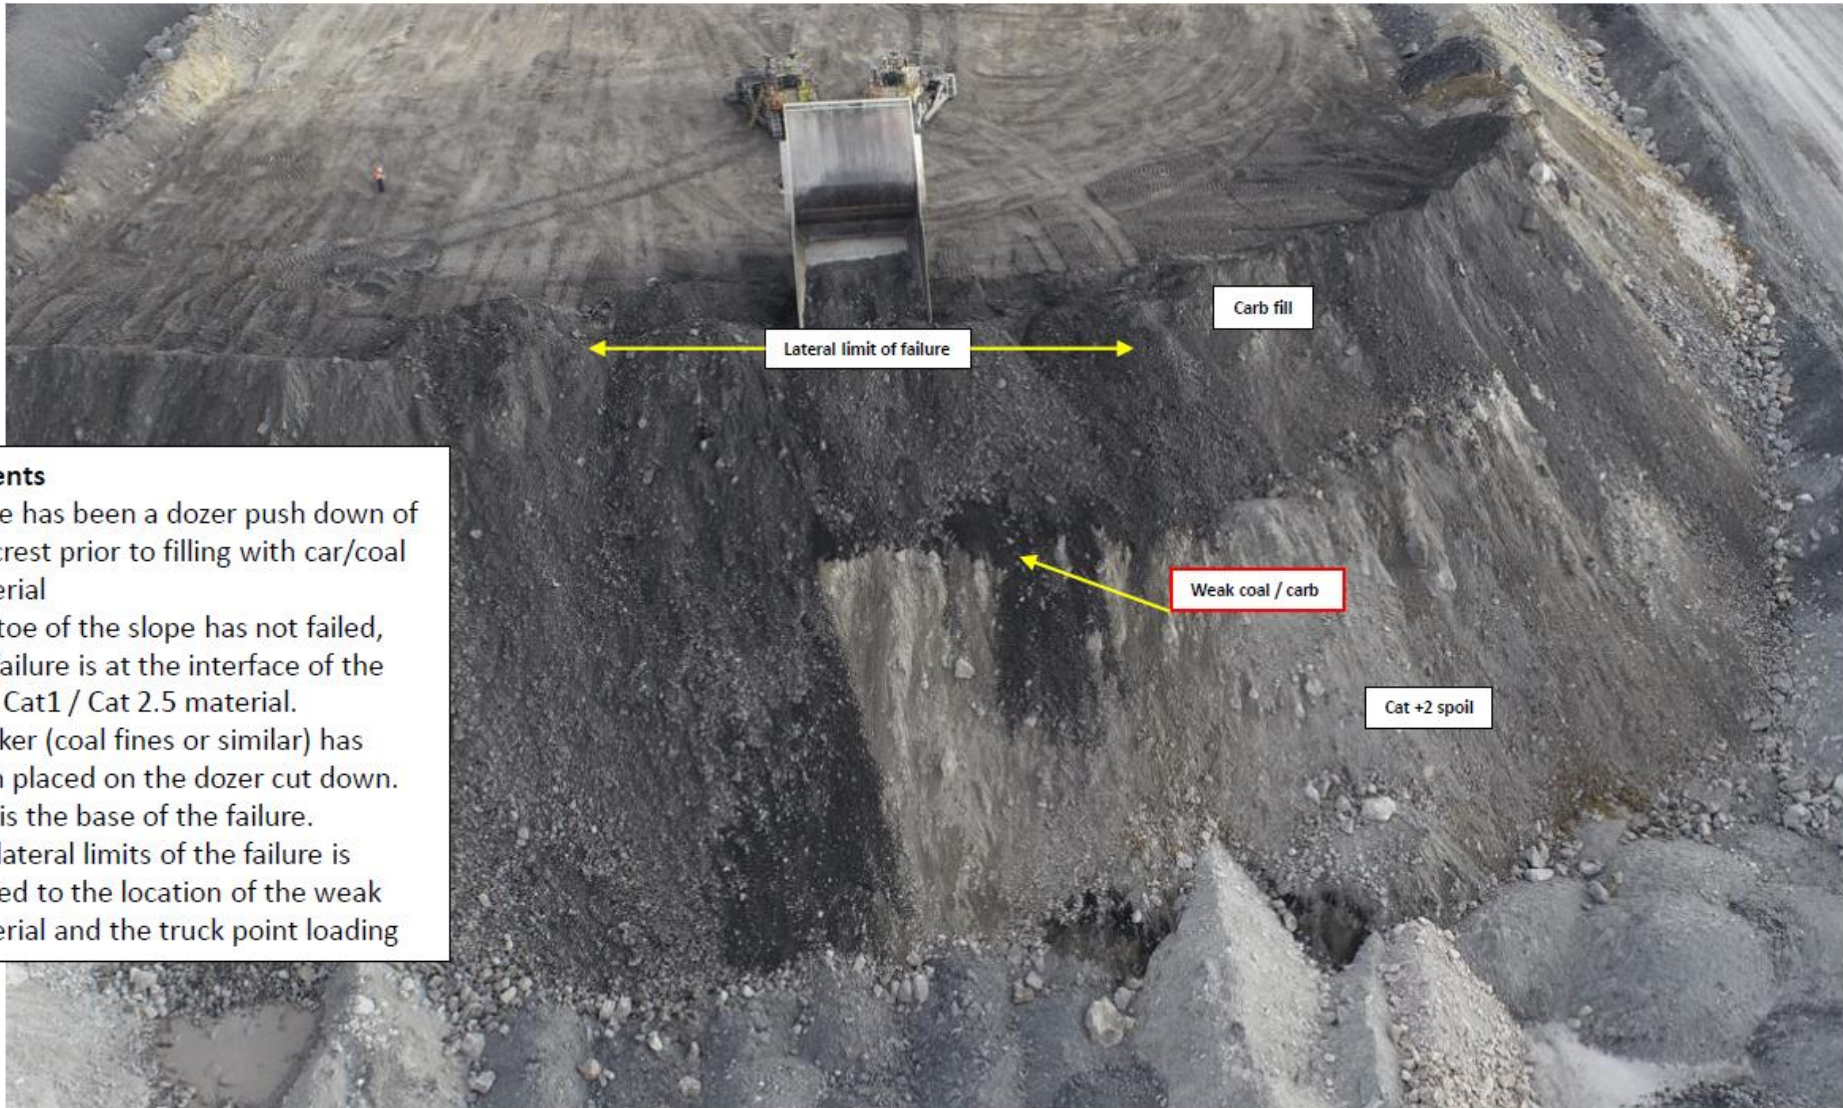
# Image 09/12/2022

- There has been a dozer push down of the crest prior to filling with car/coal material
- The toe of the slope has not failed, the failure is at the interface of the carb Cat1 / Cat 2.5 material.
- Weaker (coal fines or similar) has been placed on the dozer cut down. This is the base of the failure.
- The lateral limits of the failure is limited to the location of the weak material and the truck point loading

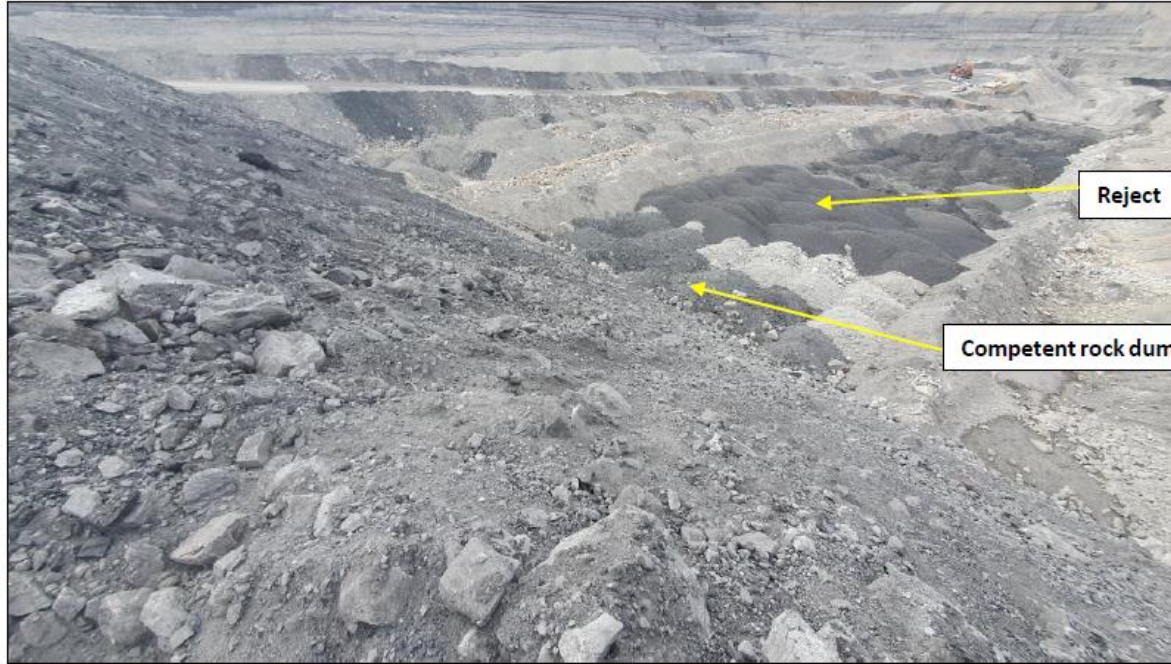
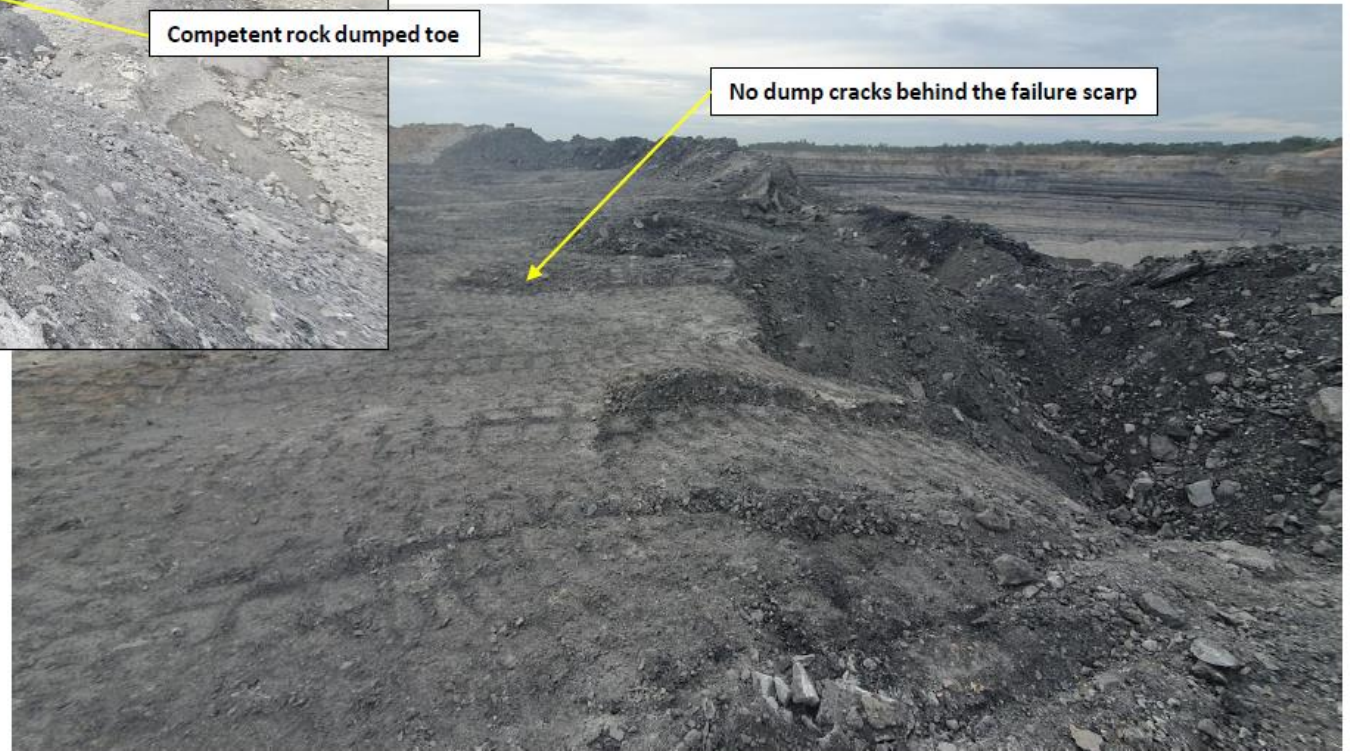
# Image 12/12/2022

- Comments**
- Dump toe is competent rock spoil, no foundation issue at base of current slope.
  - Future dump foundation will contain coarse reject.
  - No cracking at the dump surface indicating the backscarp location was very specific and limited by the dozer cut down.

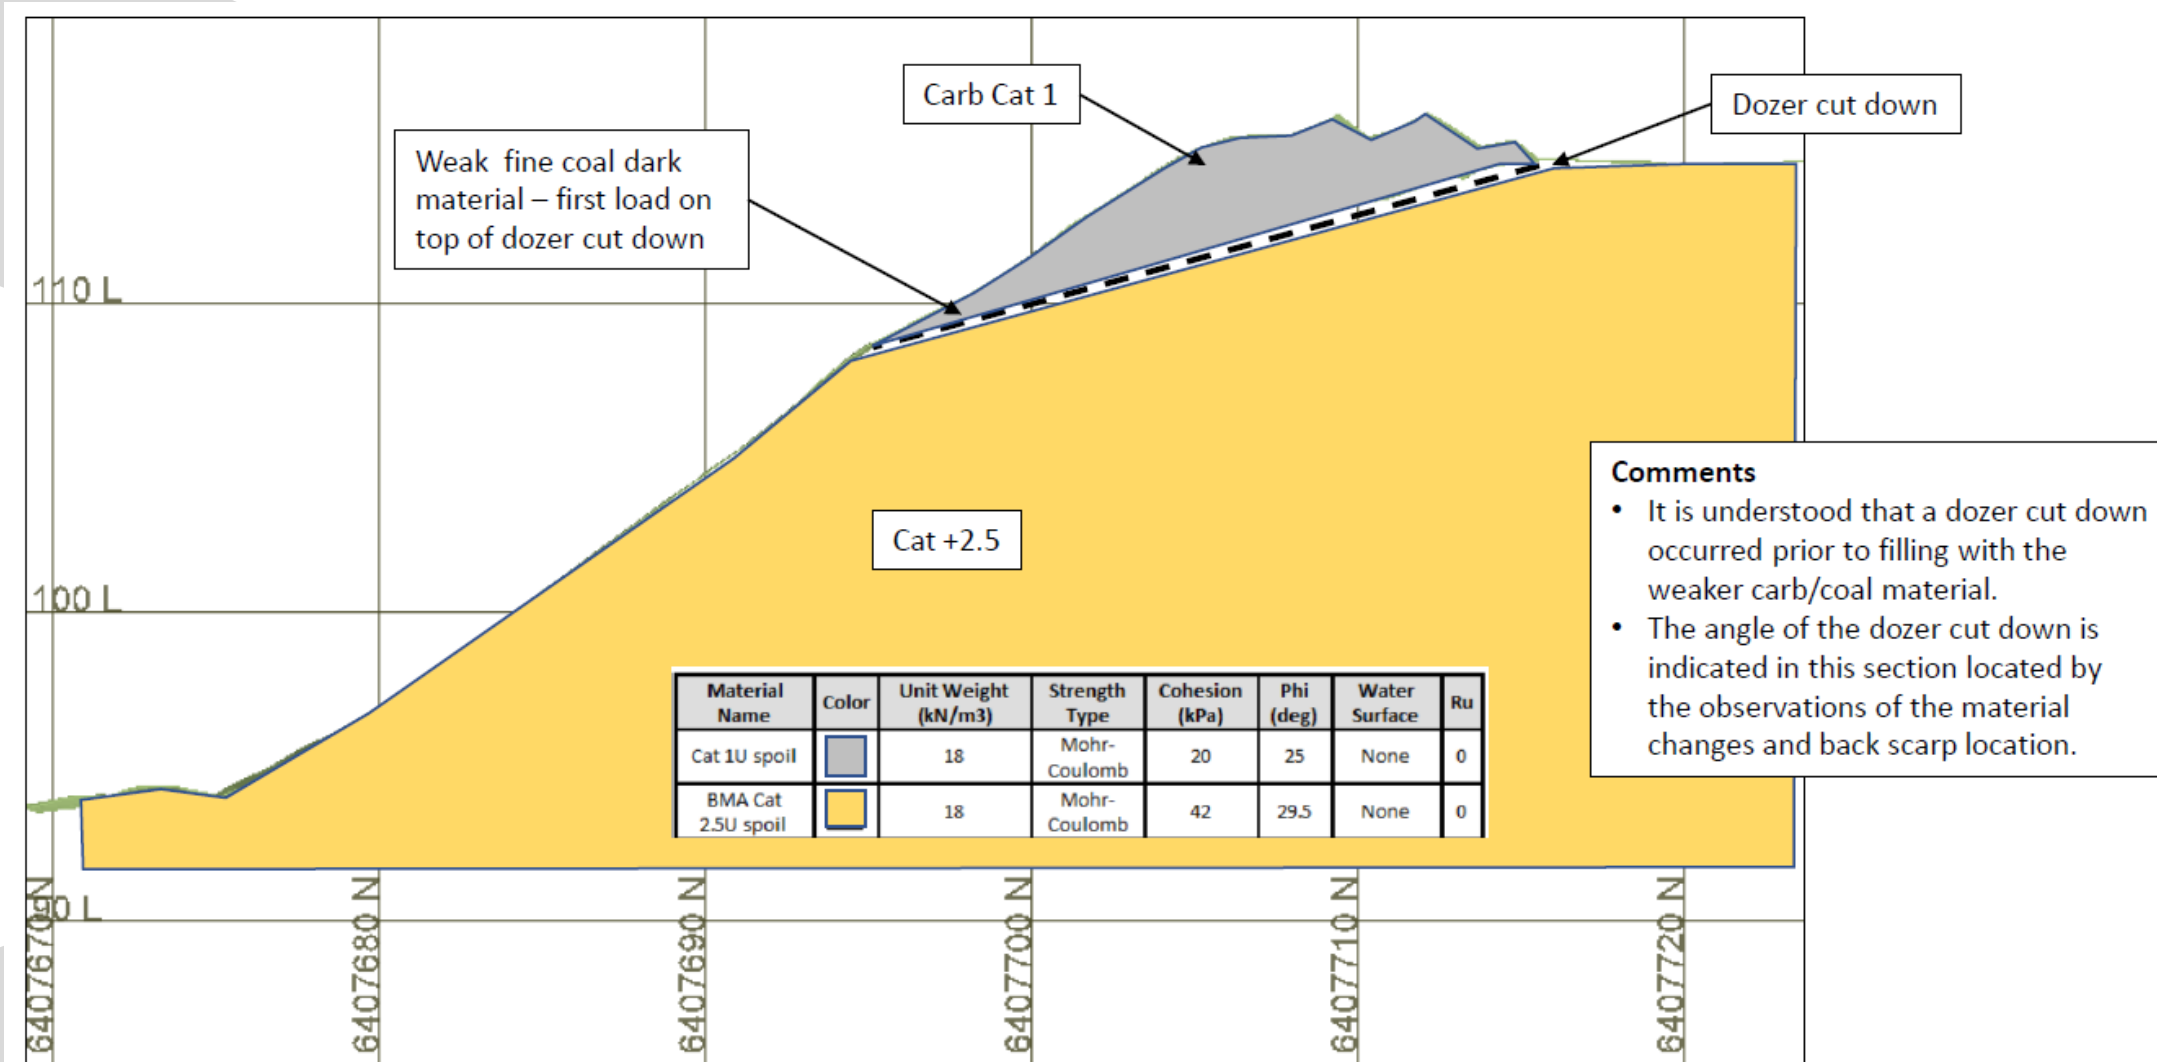
# Schematic of Geometry and Material Placement

1. The observation of dark fine coal at the toe of the dump failure indicates a weak material has been placed on the dozer cut floor which will have further contributed to the failure.
2. The dozer cut down has generated a slope angle for the carb (cat 1) material to be dumped on. This geometry promotes sliding on the material contact interface.
3. The dump was being serviced by two truck fleets at the time of the event. The speed at which material was being placed will have limited the compaction time and therefore strength of the spoil.
4. The trucks were dumping at the tip windrow, this places the load close to the edge and promotes the failure mechanism to develop.

1. When a dump crest is cut down the material placed over the top to re-establish the area should be dumped short and pushed (Orange TARP – Double Windrow / 5 m off-set)
2. Normal dumping processes should not recommence until the dump toe progresses past the toe of the dozer push down.
3. Placement of weak material within the dump system should be accurately controlled so stability is able to be controlled.

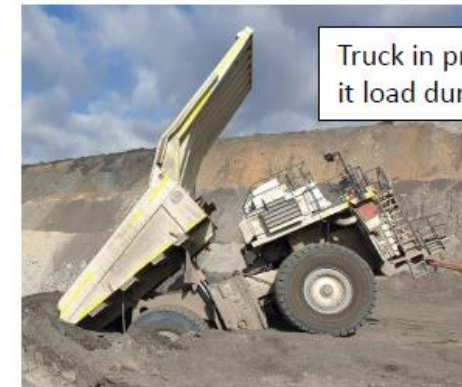
Due to the shallow material interface of the weak (Cat 1) material the point loading from the truck wheels has more significance for the initiation of this failure.

The calculation of the appropriate loading has been done using the static weight distribution as this is deemed more appropriate for this situation. The truck is estimated to be in the class of a Cat 793. (Komatsu 830E)

Truck in process of tipping its load during failure

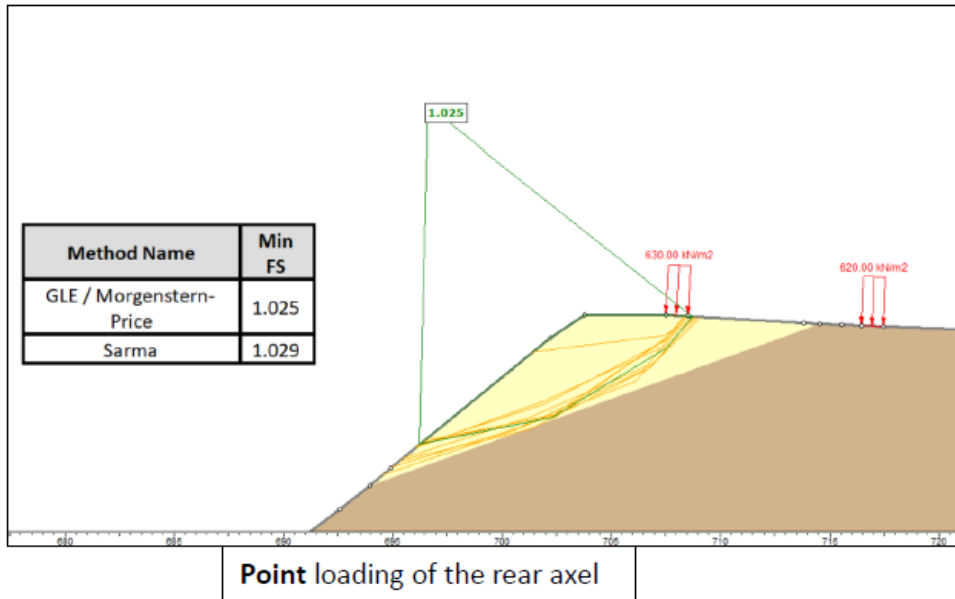
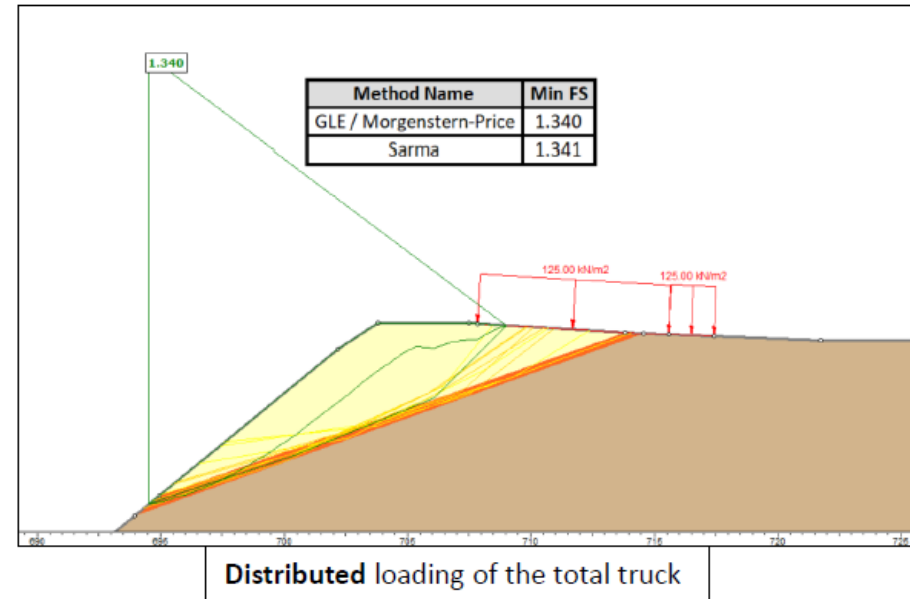
As discussed the shallow placement of the weak (Cat 1) material and the dozer push down interface just below the surface of the truck has influenced the stress impact generated by the truck. Normally for a dump of this height it is appropriate to use a distributed load for the truck as the force will be distributed progressively as it extends to the base of the dump. However, the shallow nature of this event and the near surface proximity of the weaker material suggests that the point loading method is more appropriate and more likely to represent the actual event.

Back analysis of the setting shows the point loading of the back wheels while using a static force is sufficient to destabilise the dump from a factor a safety calculation. FoS approaching 1 has been achieved in the model.
