Weekly incident summary

Week ending 10 March 2023

Incident type	Summary	Comments to industry
Dangerous incident IncNot0044271 Underground metal mine

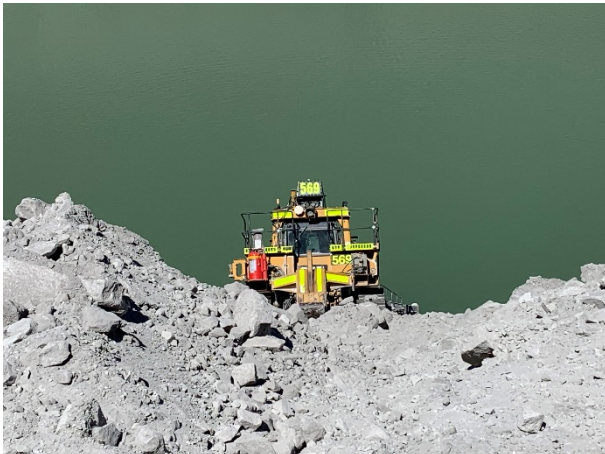
<p>A dozer was cutting down a dump at a coal mine. As there was a water body below the dump, the trigger action response plan (TARP) required a double windrow and stand-off from the edge. The operator started dump edge cutting (slot push). The operator cut down to a point where the dozer was unable to reverse back up the slope.</p> <p>The operator decided to continue down the slope towards the water body. The dozer stopped when the blade made contact with the ground in the water. The water was about one metre deep. The worker was uninjured. The Emergency Response Team assisted the worker back up the slope.</p>

<p>When stand-off distances are specified in procedures, workers must abide by them and protect themselves from further hazards.</p> <p>Supervisors must continually monitor worker compliance with procedures and the controls specified such as windrows and stand-off distances.</p>
