# Weekly incident summary

## Week ending 24 March 2023

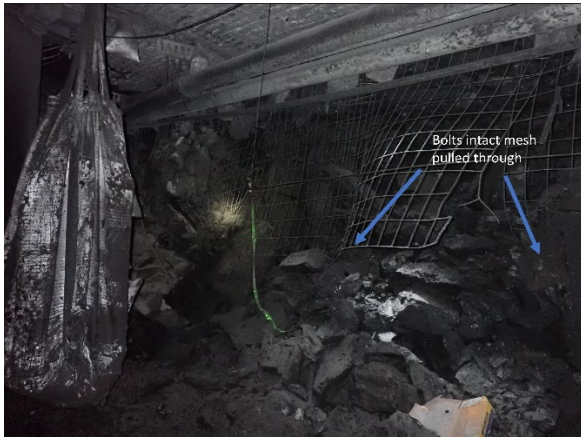
<p>A deputy was advancing the spear duster in the tailgate of a longwall. A pressure bump occurred causing material to push the mesh past the rib bolt and plate. Material slid out knocking the worker into a swilly, a large, deep puddle. Larger material then slid out hitting the worker. The worker took some time to free themselves from the coal and water.</p> <p>The worker was not injured, only suffering grazing on his arm.</p>

<p>The adequacy of installed strata support should be assessed before extraction commences. Additional support should be installed where required.</p>
