Weekly incident summary

Week ending 31 March 2023

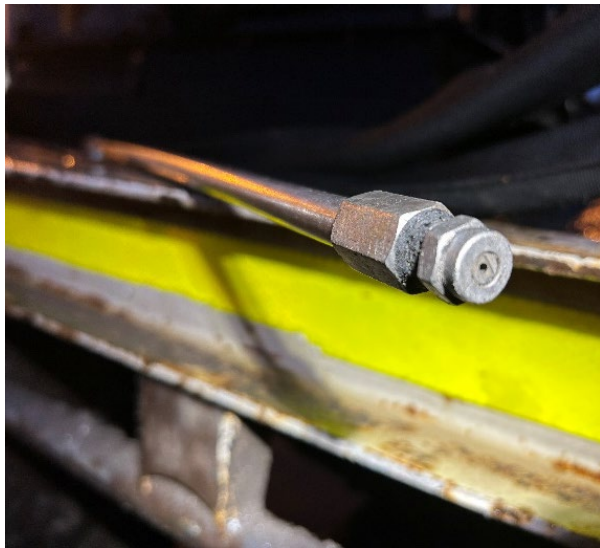
Incident type	Summary	Comments to industry
Dangerous incident IncNot0044382 Open cut coal mine	While using a pressure washer, the nozzle became blocked. The operator used their thumb to clean the tip. The operator was then hit by the stored water pressure in the lance. The operator was sent to hospital and cleared of any injury.

Workers must be trained and competent in the use of pressure washing equipment. Training and procedures must include awareness regarding fluid injection injuries.

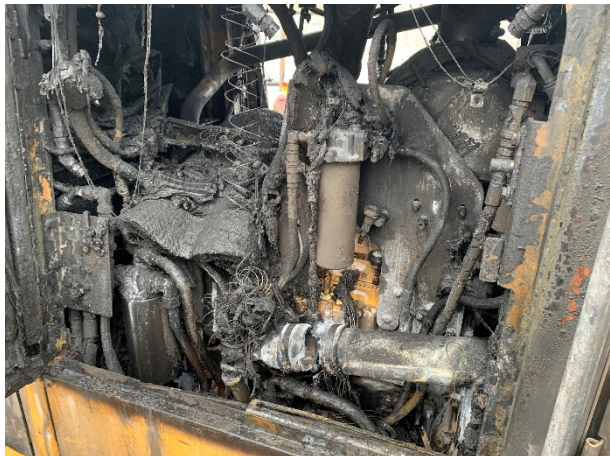
Incident type	Summary	Comments to industry
<p>Dangerous incident IncNot0044375 Open cut coal mine Fire or explosion</p>	<p>A Caterpillar 16M grader was parked-up for refuelling by a service cart. The service cart operator attached and activated the dry break fuel connector. The fuel gun immediately shut off. The operator activated the fuel dispense for a second time. Fuel was immediately sprayed out of the overflow area. The fuel ignited on the hot engine components.</p> <p>The fire suppression system on the machine was automatically activated. Two workers unsuccessfully tried to extinguish the fire with hand-held extinguishers. The fire was finally extinguished by water carts.</p>	<p>Refuelling systems must be engineered and matched with the fuel tank, breather, and delivery systems. Confirm that overflow piping and breathers direct fuel away from ignition points.</p> <p>Refer to:</p> <p>SB21-01 Fires occur while refuelling plant</p> <p>SB15-03 Fires ignite while refuelling mobile plant with quick-fill fuel systems</p>

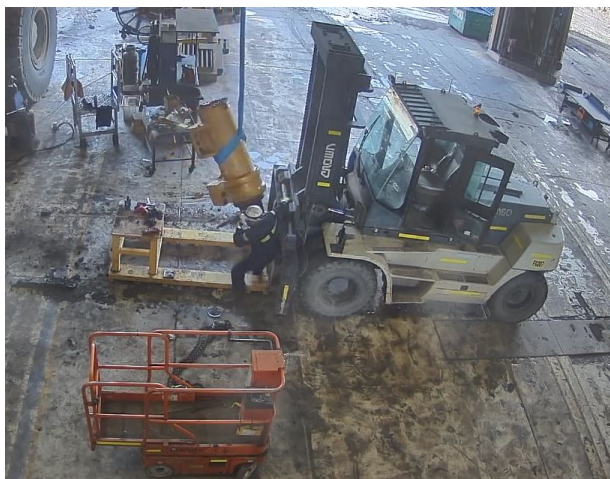
<p>Dangerous incident IncNot0044371 Open cut coal mine</p>	<p>A haul truck was in a workshop for maintenance. The position 1 strut was being replaced. The strut was removed using a custom forklift jib. A worker connected the overhead crane with a sling to the strut on the jib. The worker proceeded to undo the bolts holding the strut to the jib. While unbolting, the jib moved, so the worker applied more load with the overhead crane. When the last bolt was undone the strut started to swing and pushed the worker against the mast of the forklift as he tried to move away from the strut. He was not injured.</p>	<p>When lifting activities are carried out, workers must always consider the potential for loads to swing and for potential crush zones.</p> <p>During lifting activities, if something unexpected occurs, such as unanticipated load movement, work should stop, and the task should be reassessed before proceeding.</p>

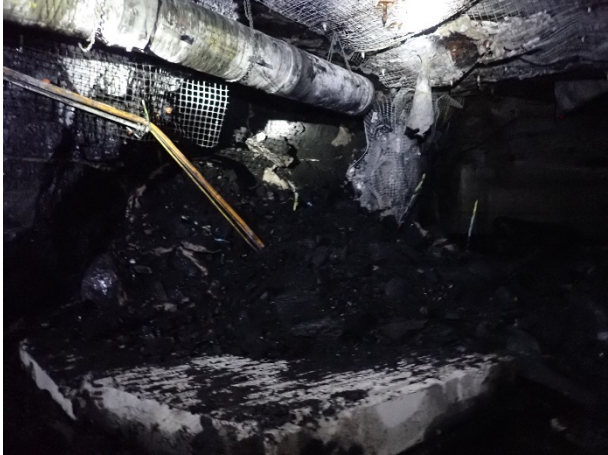
Incident type	Summary	Comments to industry
<p>Dangerous incident IncNot0044368</p> <p>Underground coal mine</p> <p>Ground or strata failure</p>

<p>A rib slump occurred in an underground coal mine. The slump was 4 metres long, floor to roof in height and 2.5 metres into the rib.</p> <p>At the time of the failure, the crew was preparing to use the miner to grade through a large reverse fault.</p> <p>Two workers in the heading were alerted to the failure when they heard coal being sucked along the ventilation tube. There were no indicators of outburst or seismic activity.</p>

<p>When mining towards predicted geological features, mine workers should take a proactive approach towards reviewing and enacting triggers on strata support trigger action response plans (TARPs).</p>
