Weekly incident summary

Week ending 28 April 2023

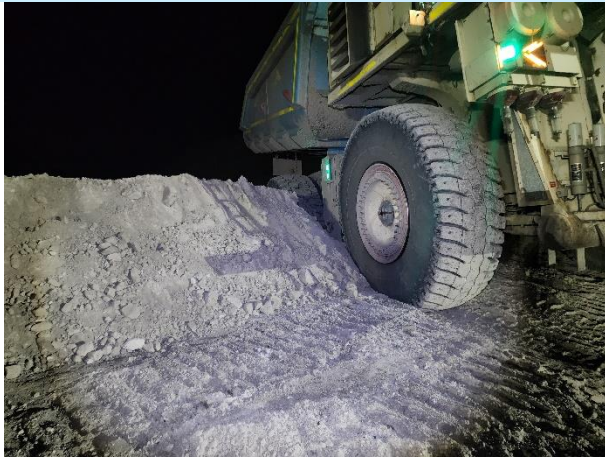
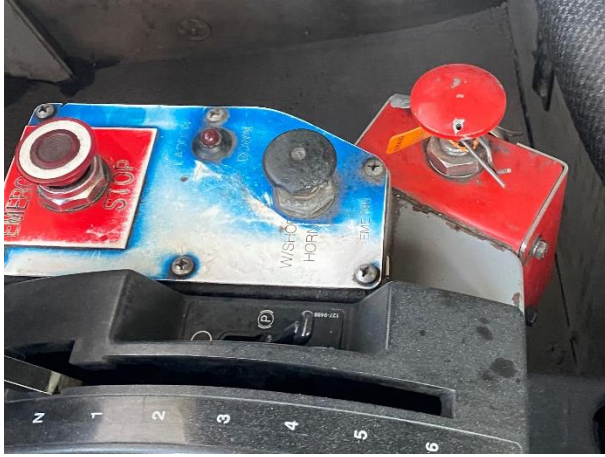
Incident type	Summary	Comments to industry
<p data-bbox="113 680 373 757">Dangerous incident IncNot0044568</p> <p data-bbox="113 775 373 808">Open cut coal mine</p> <p data-bbox="113 822 373 855">Fire or explosion</p>

<p data-bbox="395 680 1011 808">A haul truck was being operated on a ramp when the engine failed. The operator observed smoke and flames coming from the engine bay and immediately stopped the truck.</p> <p data-bbox="395 822 1011 913">The operator could not manually activate the fire suppression system as the operator couldn't remove the retaining pin.</p> <p data-bbox="395 931 1011 1059">The operator exited the truck. The fire suppression system then automatically activated. Water carts and the ERT attended the incident and extinguished the fire.</p>

<p data-bbox="1011 680 1479 875">Mines should include in their maintenance inspections of fire systems where clips and ties are installed (to prevent accidentally deploying the system) that they can be easily removed.</p> <p data-bbox="1011 893 1479 1021">Workers must be trained to activate the fire suppression system including the removal of any ties or clips.</p> <p data-bbox="1011 1039 1479 1167">Refer to Safety Alert SA22-06 Operator unable to activate fire suppression system during emergency</p>

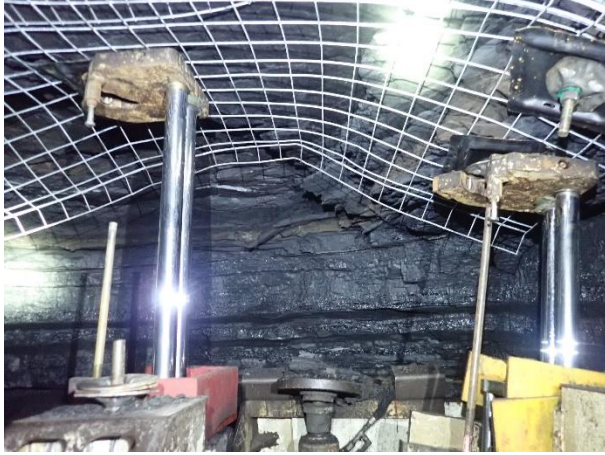
<p data-bbox="395 1606 1011 1823">Workers on a continuous miner were installing roof bolts. There was a small roof cavity across the face area. When a red-hot blocked drill steel was withdrawn from the hole, methane ignited and a flame spread across the face area to the opposite rib above the heads of the workers on the continuous miner.</p> <p data-bbox="395 1841 1011 2004">An inspector attended the mine and identified good ventilation, Venturi pumps in place and monitoring devices present. However, the bolt was being installed in a cavity about 0.4 metres deep.</p>	<p data-bbox="1011 1606 1479 1823">Ensure that gas measurements are conducted in roof cavities to ensure there is no accumulation of methane gas. Ensure the gas monitor/detector has time to accurately detect the gas in the cavity.</p> <p data-bbox="1011 1841 1479 1991">Workers must remain aware that in boggy strata, manual feed may be more appropriate to prevent drill steel blockages.</p>

Incident type	Summary	Comments to industry
	<p>The investigation identified that the drill steel was broken, which caused the drill tip to heat when using the auto feed function on the drill rig.</p>

<p>Mines should review their frictional ignition plans to include a similar scenario.</p>
