Weekly incident summary

Week ending 12 May 2023

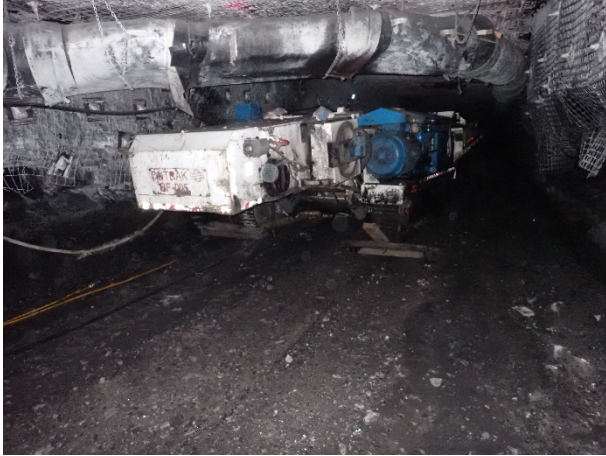
Incident type	Summary	Comments to industry
Dangerous Incident IncNot0044657 Underground coal mine	<p>A feeder breaker was being trammed up a grade in a development panel by a trainee operator and trainer. The feeder breaker rode up onto a rock on the ground that started to crack and break. The trainee operator stopped tramping. When the trainee started tramping again, the breaker feeder moved down the hill towards the workers. The feeder breaker rolled about 4 metres before it stopped. The trainee dropped the pendant. The cable was caught under the tracks and the power tripped.</p>

<p>The operating limits of machines such as grade and speed, and position of workers must be considered when planning tasks such as flits.</p> <p>Trainees must have a clear understanding about the operating parameters and characteristics such as braking performance.</p> <p>Pendants and remote controls must have functions and their operating direction clearly marked. Pre-use inspections should include checking that these markings are legible.</p>
