Weekly incident summary

Week ending 2 June 2023

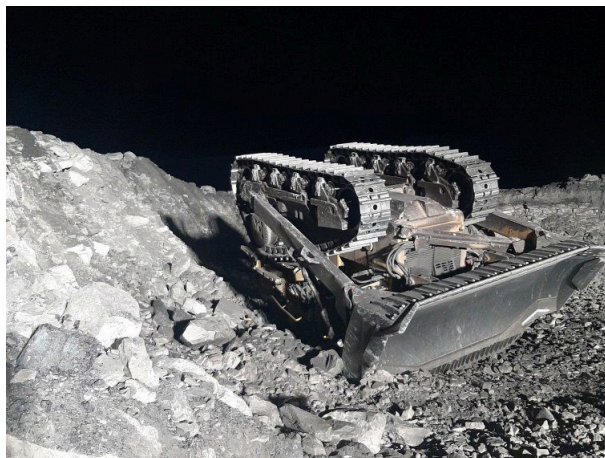
Incident type	Summary	Comments to industry
Dangerous Incident IncNot0044783 Open cut coal mine Roads or other vehicle operating areas	A dozer operator was preparing coal on a shared workbench. The operator was aware of the edge of the bench as the dozer trammed forward. The operator felt a track slump. The operator then tried to reverse but the whole side gave way, resulting in the dozer rolling onto its roof. The bench was about 4 metres high, and conditions were reported as dusty.	When dozers are working parallel to edges, the risk of the dozer inadvertently breaching the edge must be considered, and controls put in place such as windrows. When determining lighting requirements, secondary tasks in the area must be considered. The impact of lighting and shadowing on edges near work areas should be factored into work planning and lighting placement.

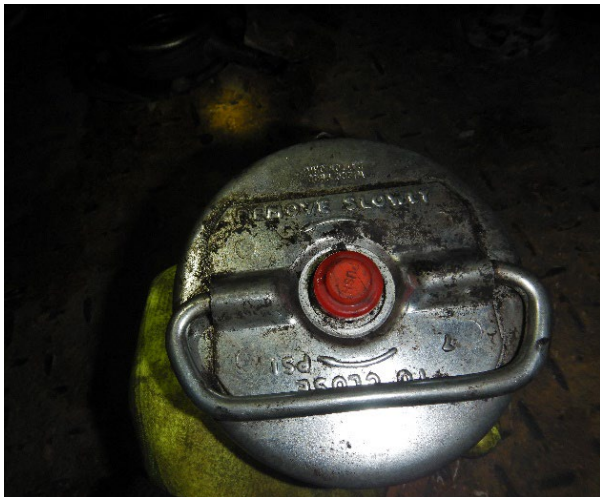
Incident type	Summary	Comments to industry
<p>Dangerous Incident IncNot0044771 Underground coal mine</p>	<p>A worker was driving a load haul dump (LHD) that overheated on the main travelling road. The operator removed the header tank cap and was sprayed with hot coolant. The worker was taken to the surface and then to hospital where he was transferred to a specialist burns unit. The worker was treated for superficial burns to the arm, chest and thigh.</p>

<p>Workers must not remove caps on coolant systems without first relieving the stored pressures. If there is any residual pressure at all in the cooling system, it may cause the coolant to vigorously boil when the system is open to atmospheric pressure.</p> <p>Mine operators should inspect all coolant systems to ensure warnings are in place and a means is available to dissipate the stored pressure to protect workers from exposure to hot coolant. Each radiator filler and radiator cap should be arranged or interlocked so that coolant pressure is safely released prior to the cap being able to be removed.</p>
