# Weekly incident summary

## Week ending 21 July 2023

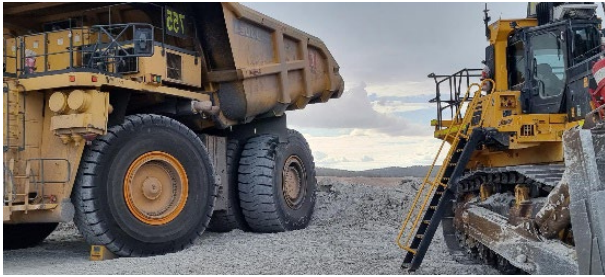
A dozer was pushing off the dump and directing trucks on where to unload. A breakdown in communication occurred, resulting in a truck reversing in behind the dozer as it was reversing across the dump. The ripper box on the dozer hit the tyre on the truck.

Vehicle collisions continue to be a source of concern. The Resources Regulator recently carried out a targeted awareness campaign focused on the risk of collisions involving heavy mining equipment. A <a href="#">Campaign video</a> is available.  Plant operators are reminded that they must establish positive communications before entering the work area of other mobile plant.  Workers must check the area behind their machine before reversing. Workers should use all aids such as mirrors, cameras and awareness systems that are fitted.

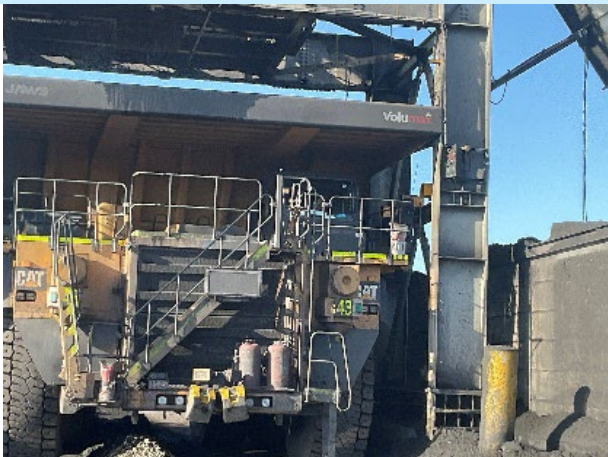
Dangerous incident IncNot0045072 Open cut coal Roads or other vehicle operating areas	A dump truck was approaching the reject bin to be loaded. As it passed under the bin, the tip of the tray above the operator cabin contacted the left side exit support leg, deforming the tray. This has occurred previously at this mine.	Haul trucks contacting the support legs of reject bins is a recognised hazard. The hierarchy of controls must be followed when determining controls.  When a notifiable incident occurs, <a href="#">Work Health and Safety (Mines</a>

<p>and Petroleum Sites) Regulation 2022 section 15 requires that mine operators review and revise control measures.</p> <p>Structures must be protected from impact with mobile plant. The extension of headboards and trays, and the accumulation of material under the bin, should be considered during the design of barriers and guides.</p>
<p>Dangerous incident IncNot0045077</p> <p>Open cut coal</p> <p>Roads or other vehicle operating areas</p>

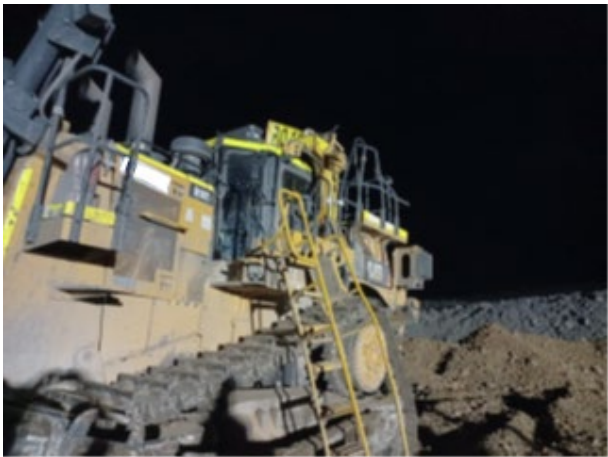
<p>A dump truck collided with a dozer while reversing to the tip head. The dozer was performing clean up along the face. The dozer operator was unaware of the truck on the dump.</p>

<p>When reviewing control measures, <u>Work Health and Safety Regulation 2017 clause 36</u> requires the hierarchy of controls must be followed. For dumps, controls such as segregation and engineered systems must be considered before resorting to administrative controls.</p> <p>Mine operators should routinely review available proximity detection and collision avoidance systems to determine if they are suitable for their operation.</p>

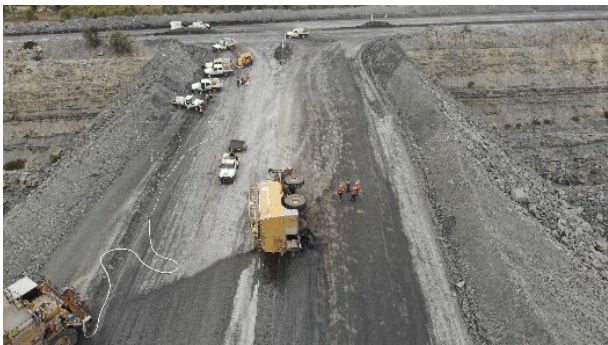
<p>A service truck was travelling along a haul road. After rounding a bend, the truck slid on a wet section of haul road onto a dry section which resulted in the truck rolling onto the driver's side. The operator was able to exit the truck and was uninjured.</p>

<p>When developing control measures to deal with the risks associated with service trucks, plant characteristics, including stopping distances, manoeuvrability, operating speeds and fluid movement must be considered.</p> <p>Operators of trucks need to remain situationally aware and drive to the conditions and manage their speed when negotiating turns.</p>
<p>Dangerous incident IncNot0045084</p> <p>Open cut coal</p>	<p>A haul truck was at the dump and had started to lift the tray. A nearby dozer operator noticed flames and called the truck operator instructing him to lower the tray. The dozer operator called emergency over the radio and told the truck</p>	<p>Workers must be regularly trained in how to respond in an emergency such as a fire on plant. Training should reflect the systems and lay out that workers</p>

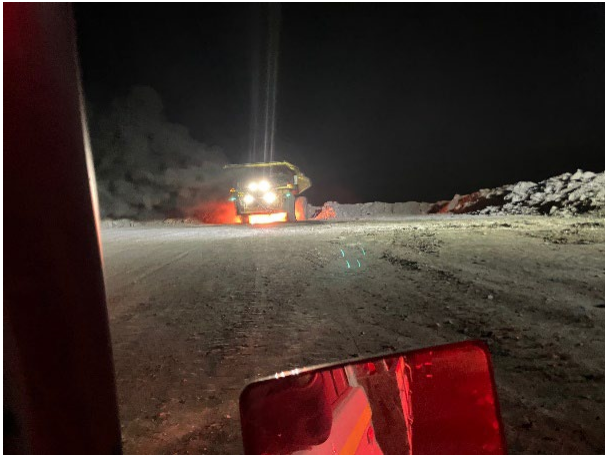
<p>operator to hit the fire suppression and exit the truck.</p> <p>The truck operator noticed flames outside the drivers' side door. The operator pulled the plastic tie on the fire suppression and attempted to activate it but was unsuccessful. The operator exited the cab through the passenger door, descended the primary egress, and waited with the dozer operator.</p> <p>The haul truck was engulfed in flames following the failure of the fire suppression system to operate.</p> <p>The operator was uninjured.</p>

<p>will be operating in, including activation of e-stop and fire suppression systems.</p> <p>The cause of the fire is being investigated. Further information may be published later.</p>
