# Weekly incident summary

## Week ending 23 June 2023

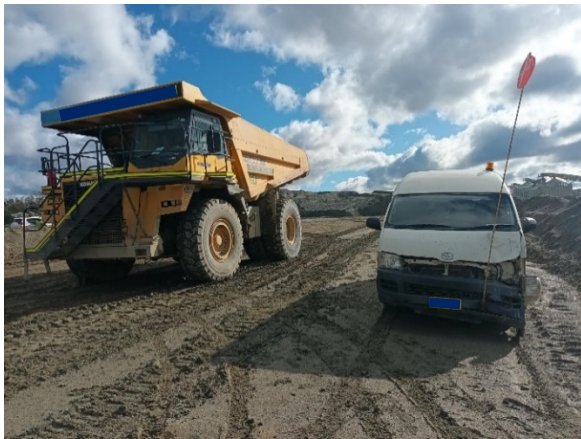
Incident type	Summary	Comments to industry
Dangerous Incident IncNot0044935 Open cut coal mine Roads or other vehicle operating areas	<p>An empty haul truck approached a stop sign at a railway crossing. On the other side of the crossing, there was a loaded haul truck approaching. The empty haul truck saw the loaded truck and reversed to give way to the loaded truck and allow more room to cross the railway line.</p> <p>As the empty haul truck reversed, it hit a van that had stopped behind it. The right rear wheel of the empty haul truck hit the front passenger's side of the van. The driver of the van was uninjured.</p>

<p>Mine operators should design sites to separate light and heavy vehicles where possible.</p> <p>Operators should review the separation distances in place at the mine. Supervisors should conduct audits to validate that workers are correctly implementing the controls in the roads or other vehicle operating areas control plans.</p> <p>When reversing, workers must use all available aids such as mirrors, cameras and proximity detection systems to confirm that it is safe.</p>

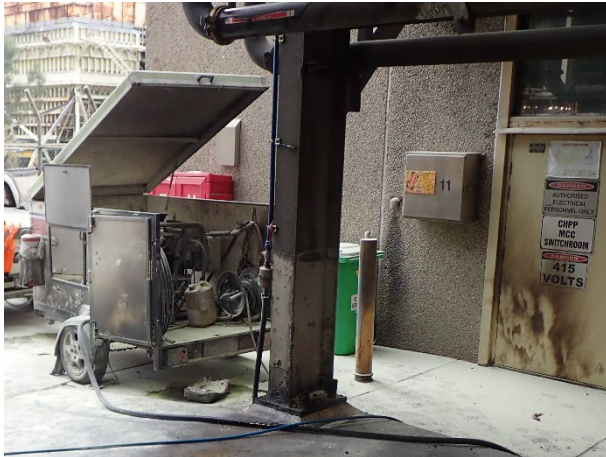
Incident type	Summary	Comments to industry
<p>Dangerous Incident IncNot0044923 Open cut coal mine Fire or explosion</p>

<p>A contractor was using a petrol-powered pressure cleaner in a coal handling preparation plant. Midway through the day, the worker attempted to refuel the unit. A fire erupted. The worker was seen rolling on the ground before getting up and removing their jacket. The worker was treated on site before being transferred to hospital.</p>

<p>Alternate power sources such as diesel or battery power must be considered before using petrol is considered.</p> <p>Where it is determined petrol powered equipment cannot be substituted, mine operators must assess the risk of using petrol on site. Controls must be implemented to manage the risk of refuelling. As a minimum, engines must be stopped and allowed to cool before petrol refuelling commences.</p>
<p>Dangerous Incident IncNot0044906 Underground metal mine</p>	<p>An operator and offsider (nipper) were completing bolting and meshing work using a Jumbo. While attempting to attach a drill steel to the coupling, the nipper's arm became entangled resulting in a serious injury.</p>	<p>An investigation has commenced and further information may be published in future.</p>
