# Weekly incident summary

## Week ending 22 September 2023

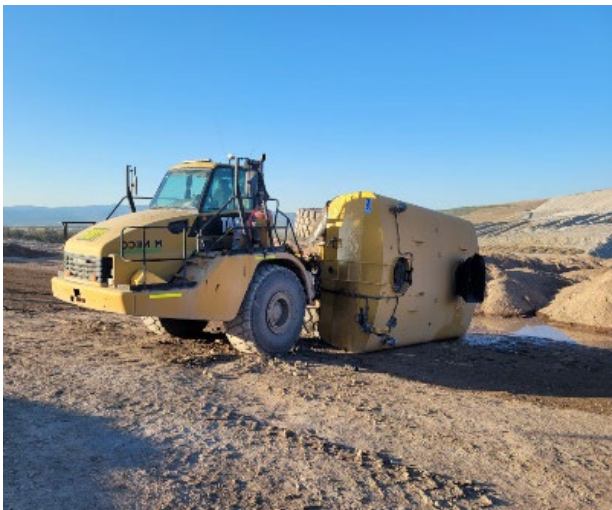
Incident type	Summary	Comments to industry
Dangerous incident IncNot0045430 Open cut coal mine Roads or other vehicle operating areas

The body of an articulated water cart truck overturned while negotiating a corner after it was filled up.

The stability of articulated vehicles is a known risk that needs to be managed at mine sites.  When developing control measures to deal with the risks associated with articulated trucks, plant characteristics, including stopping distances, manoeuvrability and operating speeds of both the loaded and unloaded vehicle and the mine’s road design must be considered.  Movement of fluid in tanks mounted on mobile plant can significantly influence the centre of gravity and overall stability of the vehicle. Consideration should be given to tank shape, baffling and compartmentalisation to control fluid surge.  Operators of articulated trucks need to remain situationally aware and drive to the conditions.

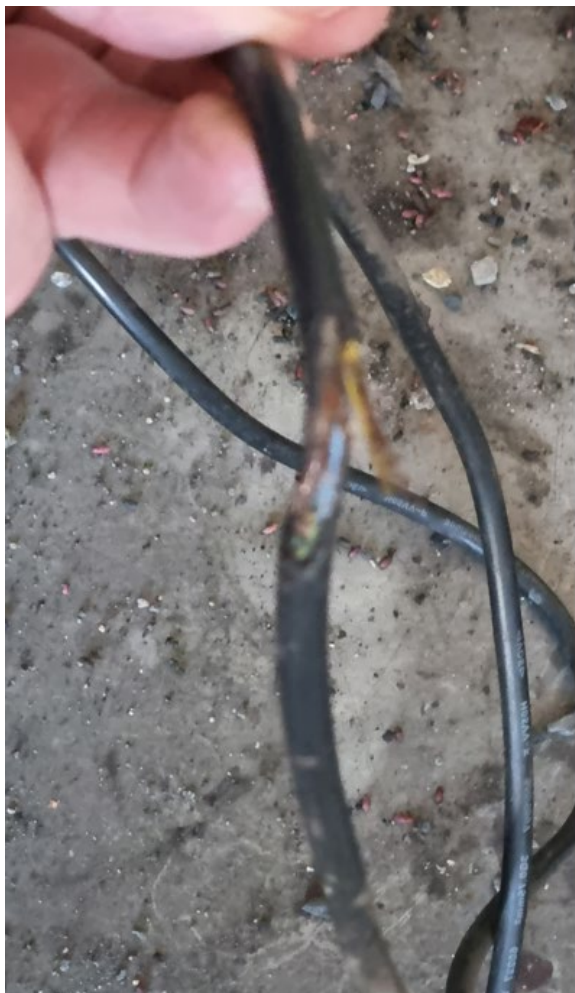
Dangerous incident  
IncNot0045465  
Coal processing  
plant

A worker investigating an electrical fault on a fridge in a crib room contacted a damaged cable and suffered an electric shock.

The residual current device (RCD) to the fridge circuit did not trip in the incident but was reportedly tested and worked effectively.

Mine operators must ensure that fit-for-purpose electrical installations are maintained in a state without risk to workers.

Refer to Safety Bulletin

[SB20-03 Electric shocks in the mining industry](#)
