Safety Bulletin

Date: October 2023

Haul truck front strut removal poses risks to workers

Safety Bulletin SB23-08

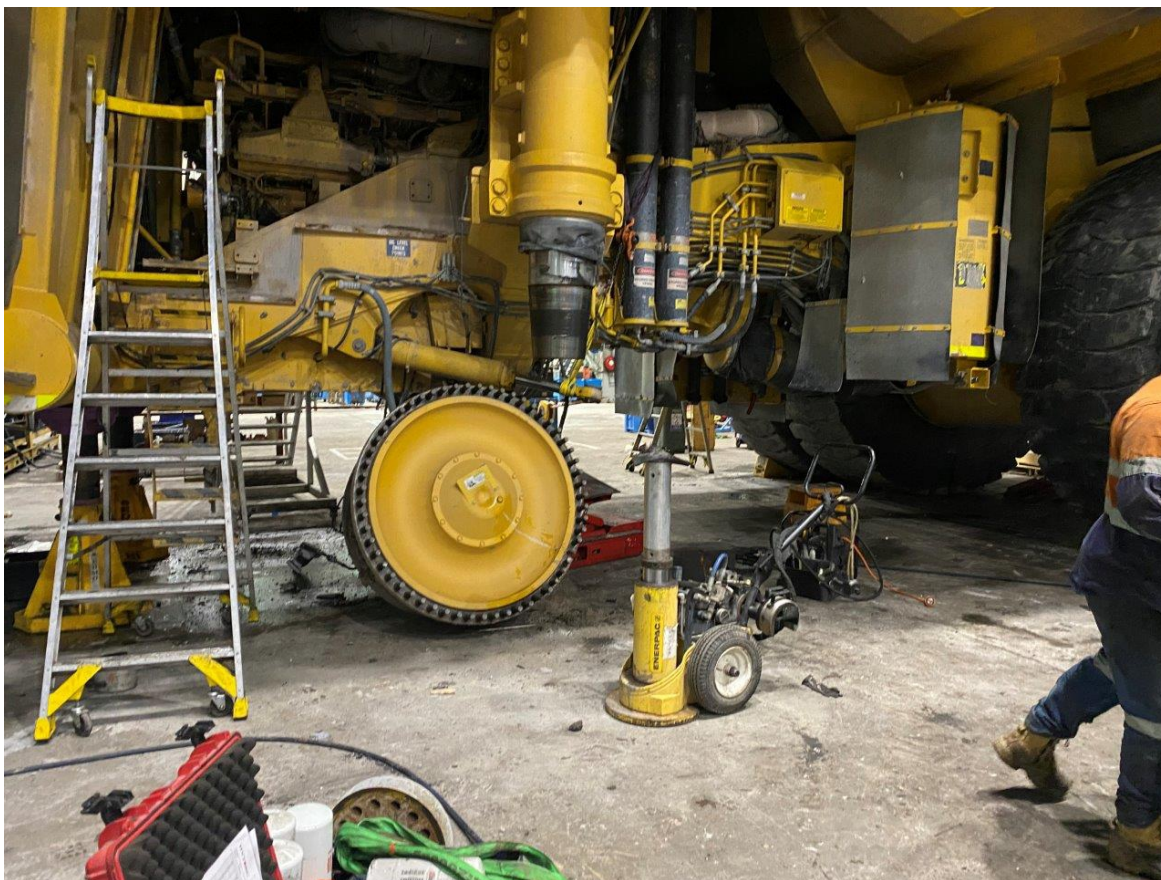
Figure 1: The 4.8 tonne front wheel hub of the Komatsu 930E haul truck after falling off a jack stand

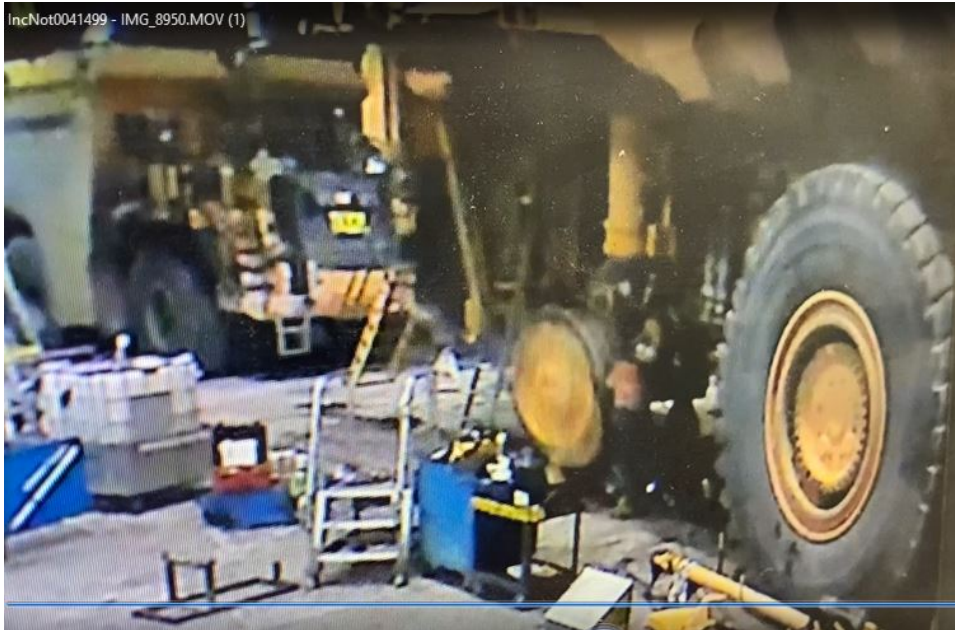
Incident 1 – 21 January 2022

Three workers were removing the front wheel hub from a Komatsu 930E dump truck. The wheel hub fell to the ground after the tapered connection between the wheel hub and spindle was released. The hub, weighing about 4.8 tonnes, fell from the single jack that was set up to support it. The workers narrowly avoided injury from the falling hub.

Figure 2: Komatsu 930E haul truck front wheel hub falling off jack stand glances worker

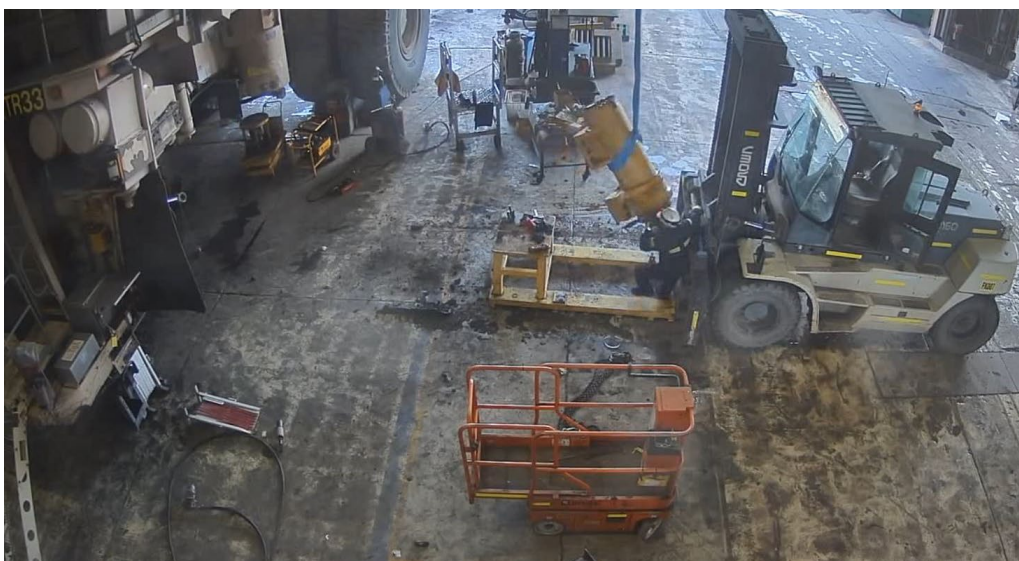
Incident 2 – 26 March 2023

A haul truck was in a workshop for maintenance and the position 1 suspension strut was being replaced. The strut was removed using a custom forklift jig. A worker connected the strut on the jig to the overhead crane with a sling.

The worker began undoing the bolts holding the strut to the jig, however the strut moved, so the worker applied more load with the overhead crane. When the last bolt was undone, the strut started to swing and pushed the worker against the mast of the forklift as he tried to move away from the strut. The worker was not injured.

Figure 3: Front strut suspended from overhead crane hits worker

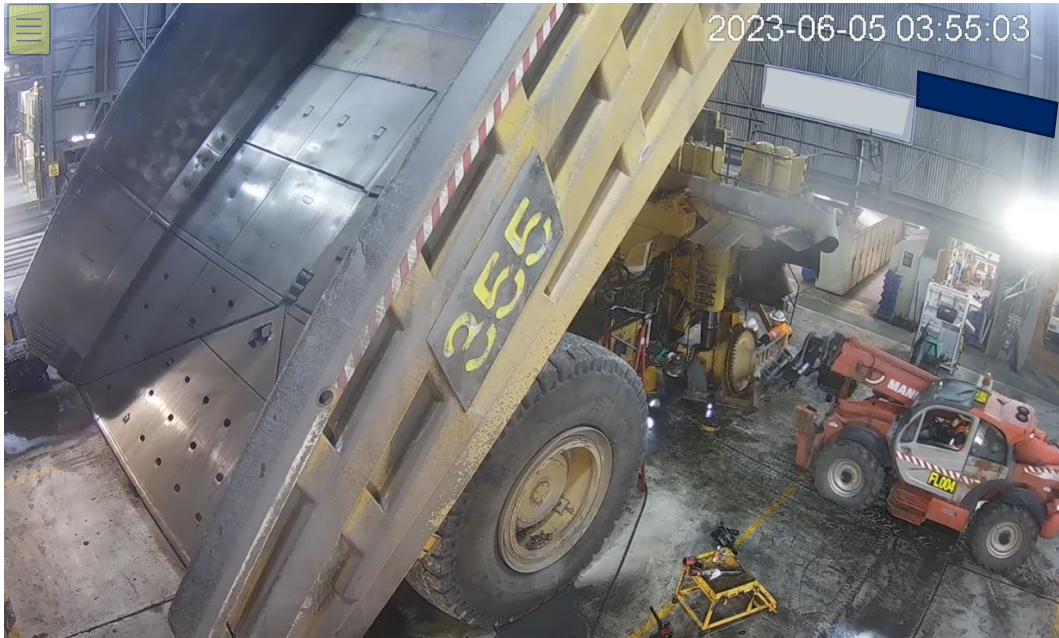
Incident 3 – 5 June 2023

Workers were changing out a front wheel hub assembly on a Caterpillar 789 haul truck in a workshop. While removing the wheel hub from the taper, the assembly unexpectedly moved. The assembly was fixed to a frame that was sitting on the tynes of a telehandler. The tynes dropped when the load moved. A worker in close proximity was hit in the face. The worker suffered minor grazing.

Figure 4: Front strut supported by telehandler hits worker

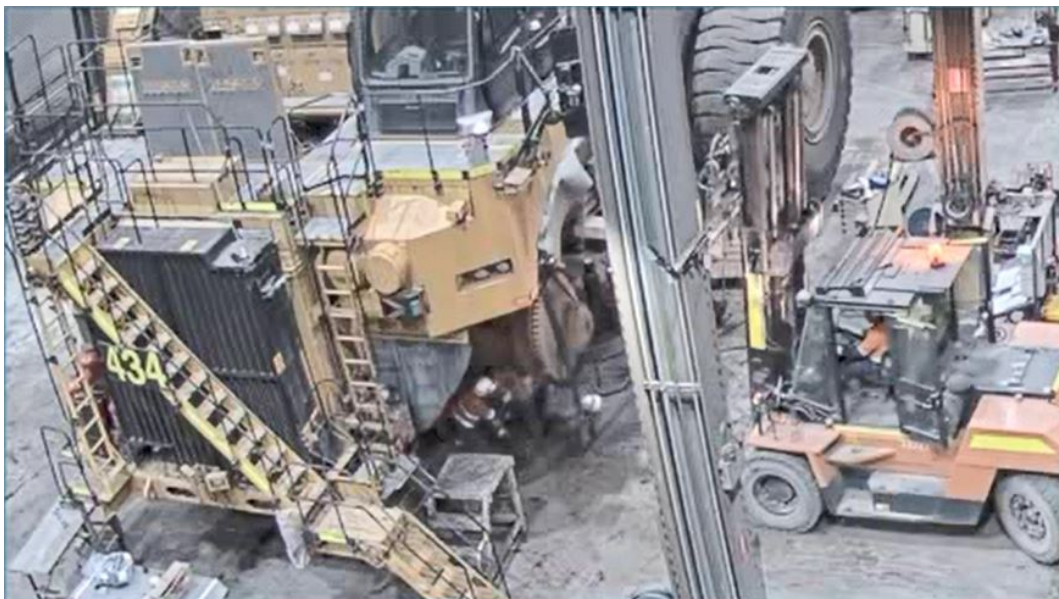
Incident 4 – 18 September 2023

Workers were disassembling a Caterpillar 795F haul truck front strut in situ using a forklift to support the wheel hub assembly. A worker was below the wheel hub was removing strut bolts with a rattle gun. The wheel hub released from the strut taper, making contact with the worker, knocking them to the ground. The worker was not injured.

Figure 5: Caterpillar 795F front wheel hub assembly supported by forklift during dismantling hits worker
