# Weekly incident summary

## Week ending 27 October 2023

Document control	
CM9 reference	DOC23/361835
Mine safety reference	ISR23-xx
Date published	3 November 2023
Authorised by	Director of Regulatory Operations Office of the Chief Inspector

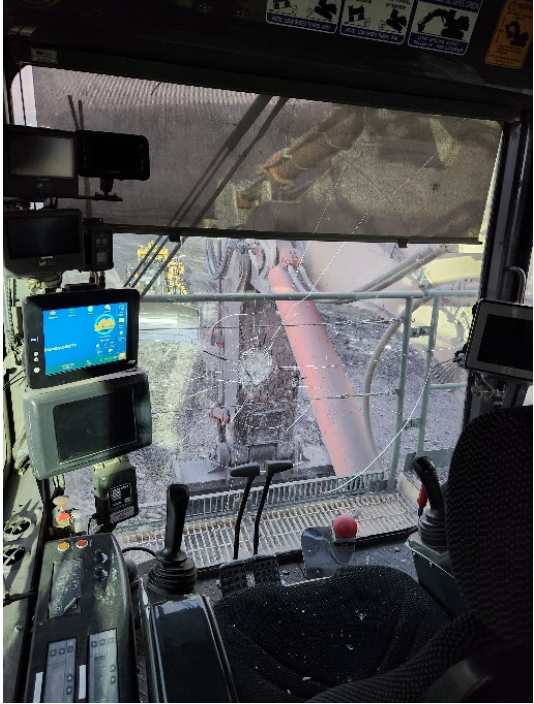
<p data-bbox="124 1720 368 1895">           Dangerous incident            IncNot0045666            Open cut coal mine            Fire or explosion         </p>	<p data-bbox="416 1720 887 1816">           An excavator caused an unintended initiation of explosives while filling an excavator bucket with overburden.         </p> <p data-bbox="416 1832 919 1957">           Fly rock from the explosion hit the windscreen of the excavator resulting in laminated glass inside the operator's cabin. No rock penetrated the glass.         </p> <p data-bbox="416 1973 935 2036">           An adjacent haul truck sustained damage to the side mirror and some debris on the         </p>	<p data-bbox="975 1720 1461 2036">           Sites must maintain effective explosives management systems. These systems should include safe work procedures and signed off checklists that minimise the potential for misfires and/or unaccounted explosives devices. There must be a process in place to ensure any misfires are identified, logged and communicated to workers.         </p>

<p>walkway. A nearby dozer also had fly rock material impact the machine. The haul truck and dozer were about 5-10 metres from the bucket when the incident occurred. There were no injuries suffered by any of the operators.</p>
