## **Compliance audit program**

EL8547 Boona Exploration Project

**Haverford Holdings Pty Ltd**

*December 2023*

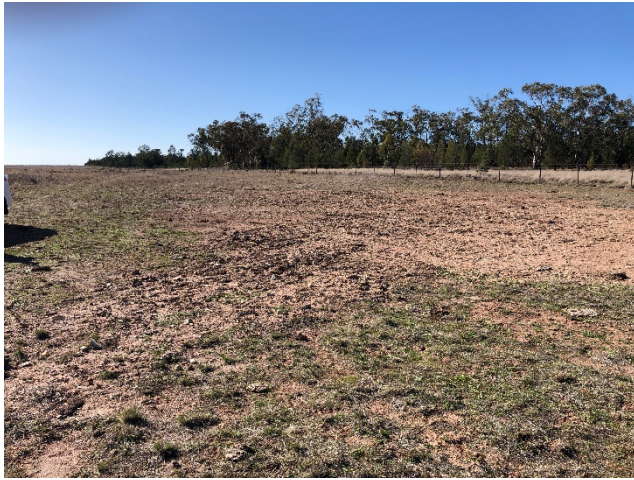
Four RC holes drilled in March 2023 were inspected during the audit. No issues of concern were identified at any of the sites. It was noted that rehabilitation sign-off had not been sought for these holes and Talisman staff said further rain and regrowth would be needed to confirm successful rehabilitation before seeking sign-off.

Figure 1 Drill hole ACRC001, drilled March 2023

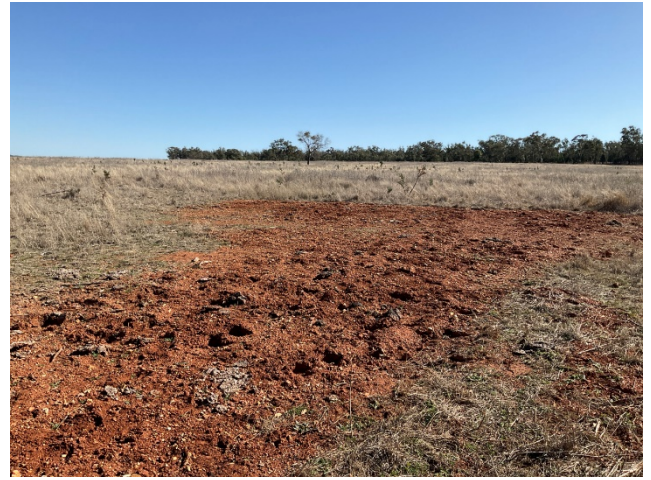
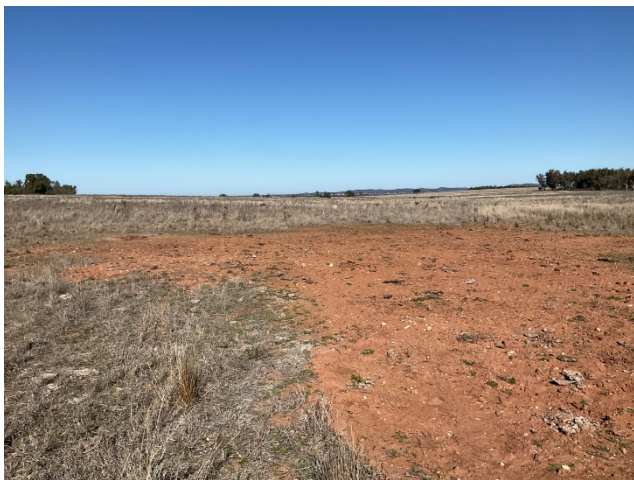
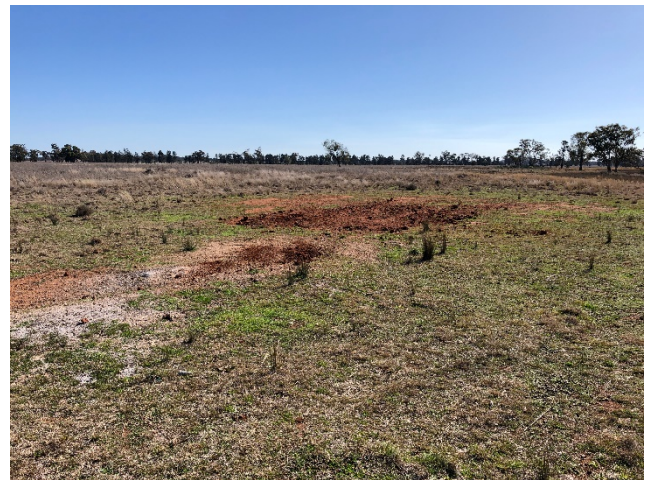
Figure 1, Figure 2, Figure 3, and Figure 4 show rehabilitation of the 4 holes inspected.

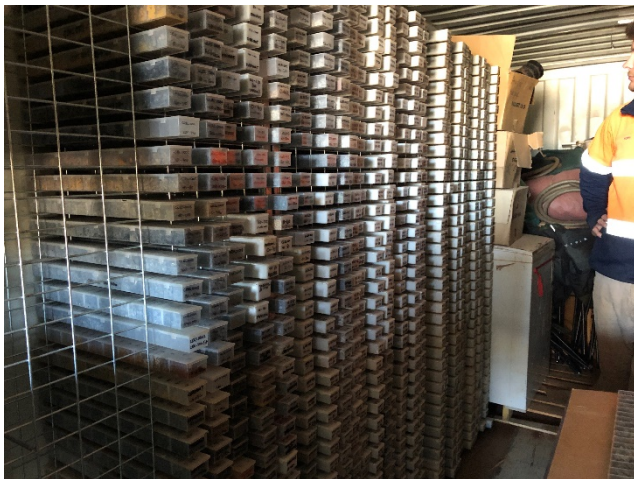
The chip samples were observed to be stored in a locked shipping container in a storage yard in Condobolin. Chip trays were stored in racks by hole number (see Figure 5) and were observed to be adequately labelled with hole number and depth (see Figure 6).

Figure 5 Chip sample storage on racks in shipping container

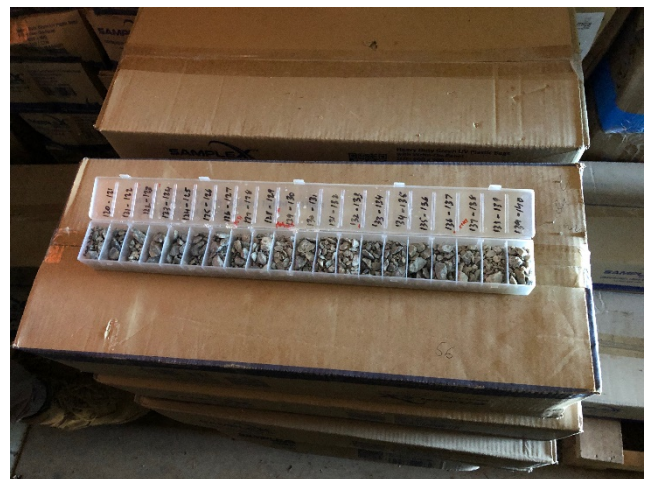
Figure 6 Example of chip tray labelling
