Safety Alert

Date: December 2023

Haul truck engine module narrowly misses workers

Safety Alert SA23-07

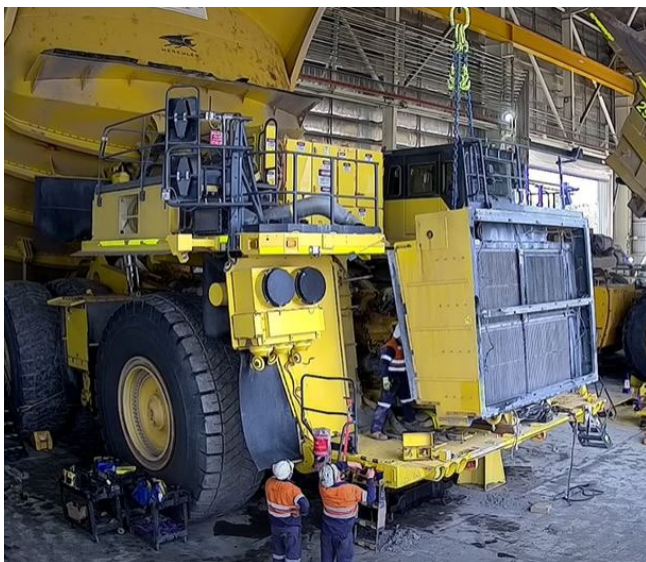
Two workers were in the engine bay of a Komatsu 930E haul truck adjusting lever hoists (cumalongs) and lifting chains while installing an engine module on 15 November 2023. As the overhead gantry crane operator was taking the weight of the module on the crane, the module slid back on the supporting tracks about 1.5 m. Both workers took evasive action to avoid being hit or crushed by the moving module, but were uninjured.

Figure 1: Worker manoeuvring engine module

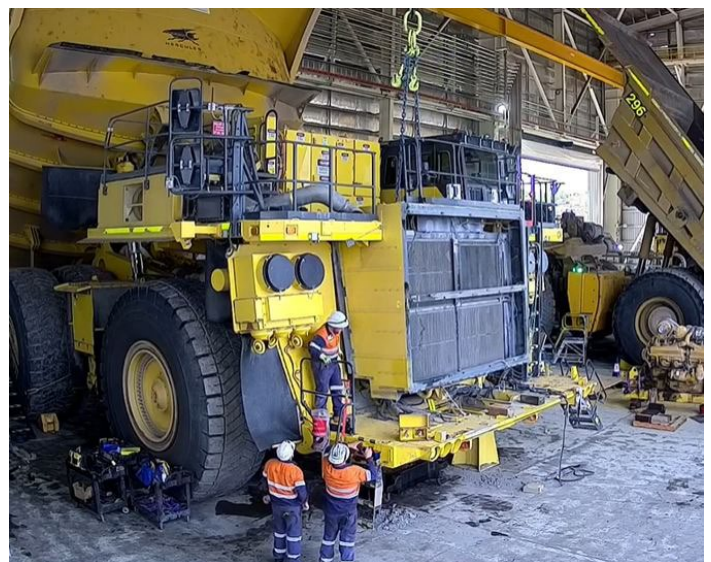
Figure 2: Worker moves clear of moving module

During this process the crane operator took the weight up on the front of the engine module and it began to slide backwards into the engine bay.

One of the workers leaped to the side of the front platform, whilst the other followed the engine module into the engine bay.

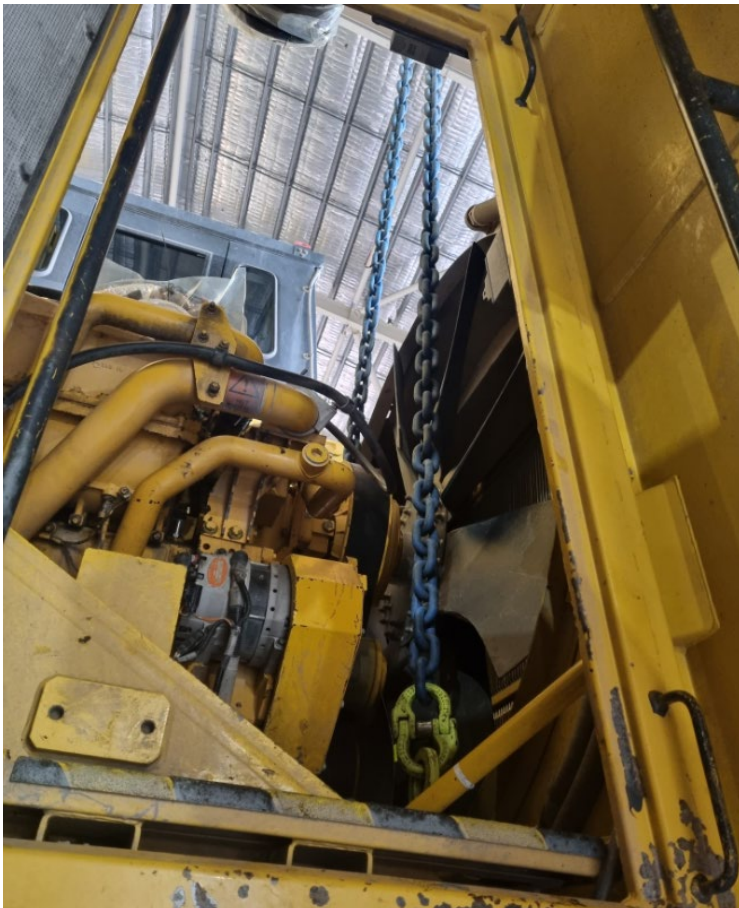
The lifting jig was changed out for a 2 leg chain set to allow the rear end of the engine module to be lifted, while 2 lever hoists fitted horizontally pulled the module in on slide rails.

Figure 3: Chains supporting the engine module during installation

- The engine module was not secured from moving backwards towards the engine whilst installing. This hazard is not identified in OEM documentation. Typically, the engine module is difficult to install and has to be pulled into position with chain blocks and/or lever hoists.

- review risk assessments and procedures to ensure the hazard of unplanned movement during lifting an engine or radiator modules into or out of a haul truck is considered
- update existing procedures with photos for the site-specific removal or installation of engine or radiator modules
- ensure effective controls are in place
- ensure the procedures and controls are clearly communicated to workers
