Weekly incident summary

Week ending 5 January 2024 (16 December 2023 – 5 January 2024)

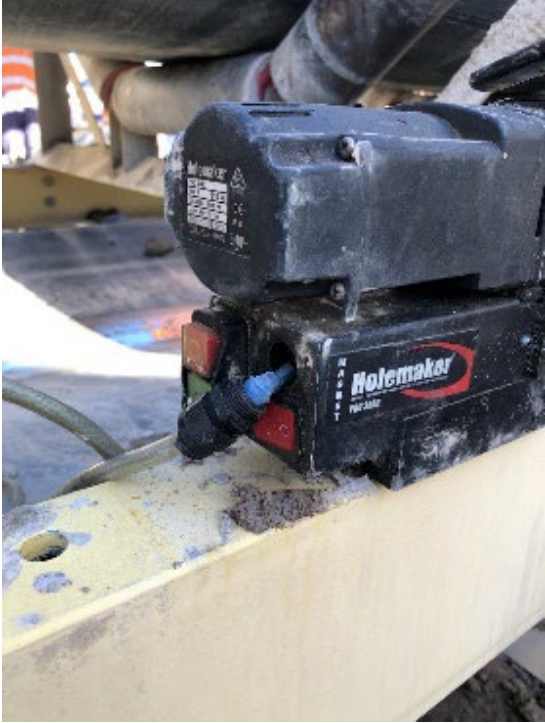
Incident type	Summary	Comments to industry
Dangerous incident IncNot0046027 Underground metals mine	<p>A worker suffered an electric shock while installing a new skirting system to a conveyor using an electric rotor broach to drill holes.</p> <p>A gland on the portable drill was pulled out and allowed ingress of moisture to internal electrical components.</p>	<p>Mine operators should seek every opportunity to apply the hierarchy of controls when managing electrical equipment in harsh environments.</p> <p>Using extra low voltage electrical equipment and field devices considerably reduces the risks associated with electric shock.</p> <p>Where this control cannot be applied, the maintenance of the ingress protection (IP) rating for the electrical equipment should be paramount.</p>

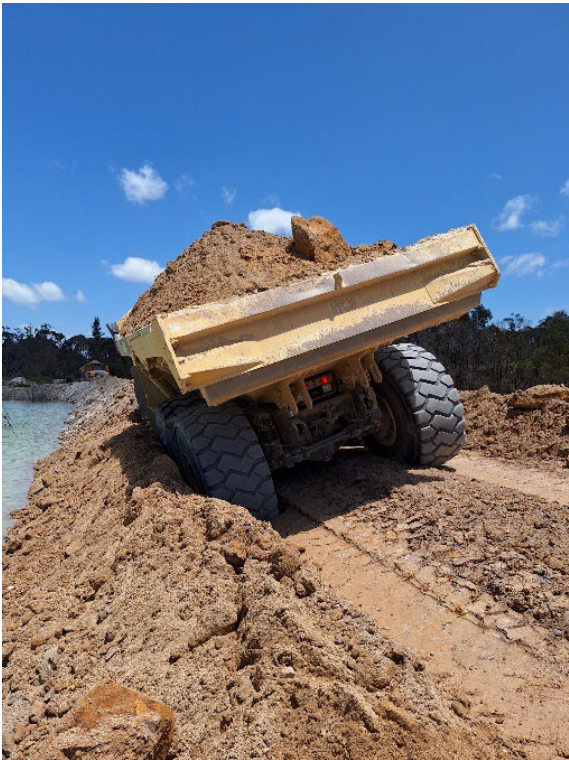
<p data-bbox="124 972 371 1055">Dangerous incident IncNot0046032</p> <p data-bbox="124 1077 288 1144">Construction materials</p> <p data-bbox="124 1167 323 1263">Roads or other vehicle operating areas</p>

<p data-bbox="405 972 986 1227">A loaded articulated dump became bogged while tipping overburden along a dam wall. The driver failed to hear positive communication from the dozer operator and continued to reverse with the left-hand side of the truck sinking. The truck was not able to be removed under its own tractive effort.</p>

<p data-bbox="1027 972 1465 1413">Mine operators should ensure that dam wall design, construction methodologies, and procedures are established that consider the strength, size distribution and consistency of the materials to be used when constructing dam walls. This should include geotechnical consideration of the potential for slumping and subsidence areas to form, particularly following significant rainfall events.</p>

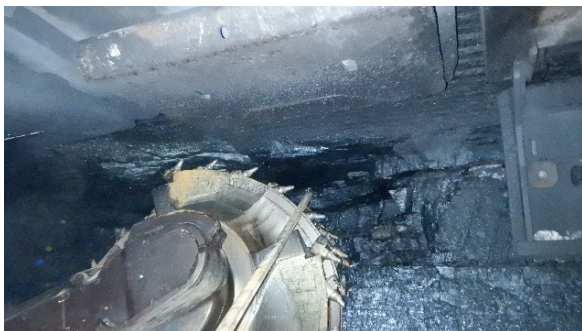
Incident type	Summary	Comments to industry
Dangerous incident IncNot0046099 Underground coal mine Fire or explosion

<p>A fictional ignition event occurred during production on a long wall when workers were heading back to the main gate cutting the roof.</p> <p>There were frictional ignition checks and 16 picks were changed. The event lasted about 60 seconds and was extinguished with 2 frictional ignition hoses.</p>

<p>Appropriate procedures and trigger action response plans (TARPs) must be in place for when the risk changes including changes in geology and the seam section being cut. Implementing and monitoring the ventilation standards required to manage methane levels must be to a standard to minimise the risk. Ensure ventilation is installed and maintained to maximise ventilation quantities at the working face.</p>
