Weekly incident summary

Week ending 9 February 2024

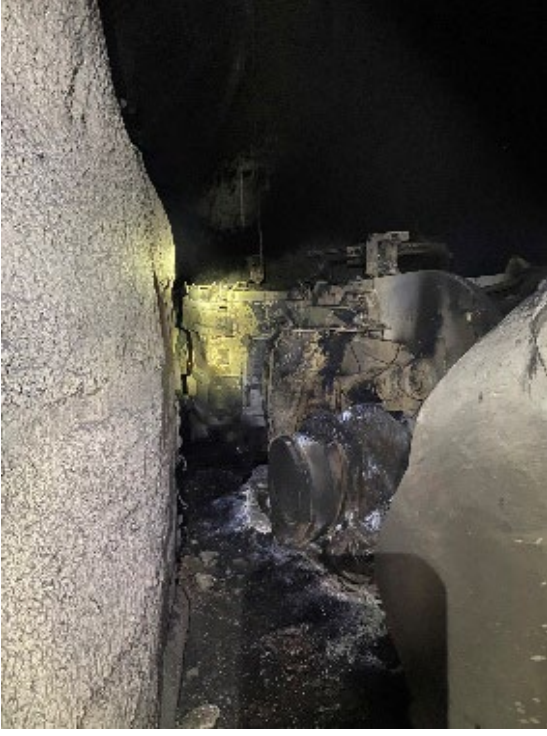
<p>A remote-control automated loader caught fire underground. The mine's fire suppression system initiated but did not fully extinguish the fire. The loader continued to burn, and the mine's emergency response was activated.</p> <p>All people were accounted for in refuge chambers and the loader was allowed to burn until the fire went out.</p>	<p>This incident is under investigation and further information may be published later.</p> <p>Mine operators should ensure that risk control measures to prevent the occurrence of fires, and response to underground fires, are implemented and remain effective.</p> <p>Emergency response procedures should be routinely examined to ensure minimum standards are met or exceeded.</p>

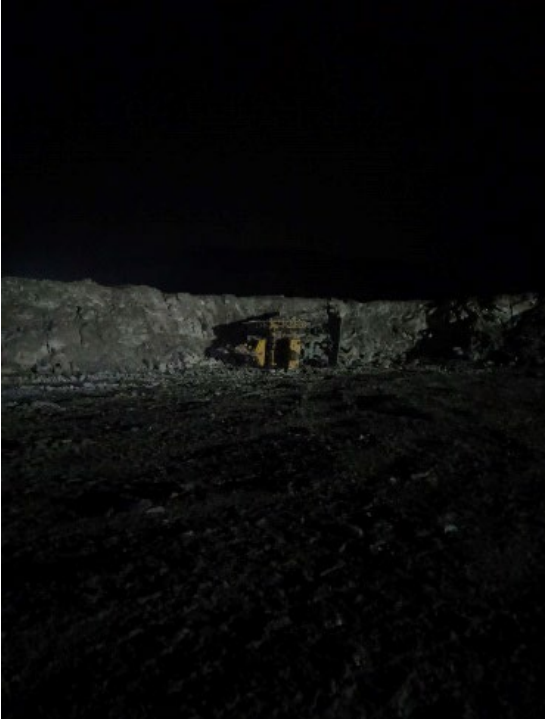
<p data-bbox="124 981 264 1048">Dangerous incident</p> <p data-bbox="124 1070 325 1102">IncNot0046292</p> <p data-bbox="124 1124 300 1191">Open cut coal mine</p> <p data-bbox="124 1214 322 1303">Roads or other vehicle operating areas</p>

<p data-bbox="395 981 963 1124">While capping a shot, a dozer operator reversed over the edge of a bench and came to rest on a ripper box. The dozer pivoted onto its right-hand side.</p> <p data-bbox="395 1146 951 1290">The dozer operator was a trainee under instruction at the time of the incident. The operator was wearing a seatbelt and was not injured.</p>

<p data-bbox="1015 981 1414 1384">Situational awareness is a key control when operating mobile equipment. Workers should be trained in the importance of this control and include it in their pre-task risk assessment. Ancillary systems such as GPS guidance, dispatch systems and two-way communication should be used only when it is safe to do so.</p> <p data-bbox="1015 1406 1311 1438">Refer to safety bulletin:</p> <p data-bbox="1015 1460 1401 1527"><u>SB19-01 Rise in dozer incidents putting operators at risk.</u></p>

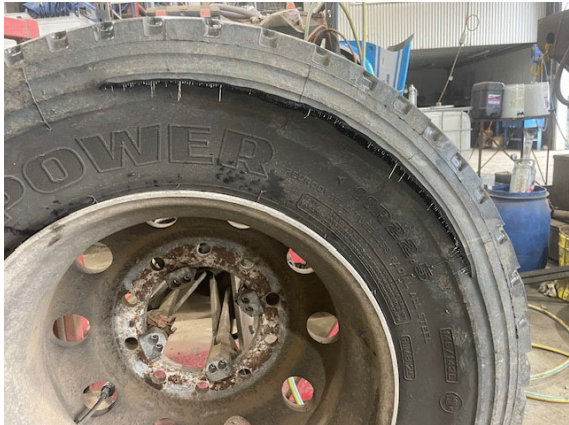
Incident type	Summary	Comments to industry
Dangerous incident IncNot0046294 Construction materials	<p>While inspecting and reinflating a truck tyre that had been run flat, the tyre exploded while a worker was standing in front of it. The worker was knocked over by the force. He was transported to hospital. A second worker suffered a cut over their left eye.</p>

<p>Mine operators should review their safety management systems for assessment, inflation and management of tyres that may have been run underinflated or been subject to damage in service including consideration of reduced inflation pressures for leak testing and inspection.</p> <p>Consider the hierarchy of controls when conducting this process and what training and authorisation is required to conduct this type of work.</p> <p>Procedures should stipulate that maximum rated inflation pressures are not exceeded during inflation.</p> <p>Ensure that workers who have been appropriately trained and appointed are the only ones to conduct tyre fitting and inflation activities.</p>
