Safety Bulletin

Date: March 2024

Bulldozer incident increase

Safety Bulletin SB24-01

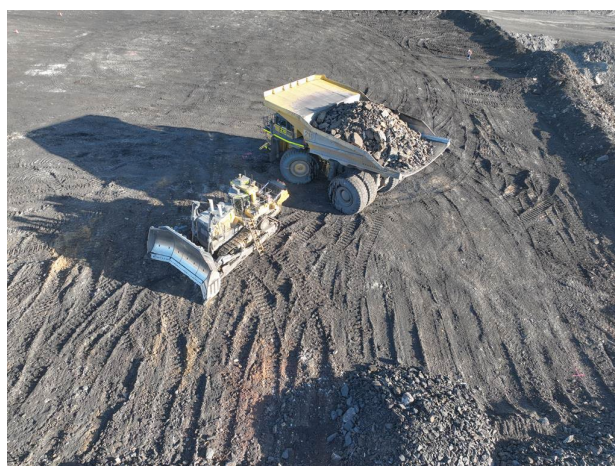
Example 1 - IncNot0045257

While approaching a dump tip head, a haul truck proceeded behind a dozer that was maintaining the tip head without making positive communication. The dozer operator did not see the truck and reversed back making contact with the left side of the stationary truck.

The following causes were identified:

1. The dozer reversed a long way in an unusual manoeuvre and failed to look behind
2. No positive communication by the truck operator
3. The dozer operator was in-training, operating under minimal supervision arrangements

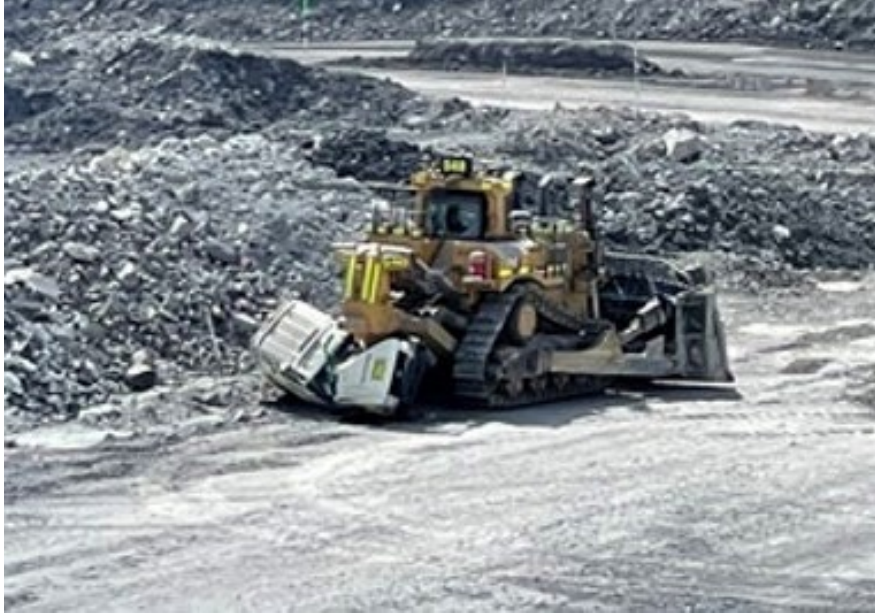
Example 2 - IncNot0043760

Incorrect parking location of light vehicle (LV) in relation to the active work area.

The operator of the LV parked within the 30 metre exclusion zone of a dozer and then proceeded to operate the dozer, leading to the event.

The operator of the D11 dozer had reversed into their unoccupied light vehicle.

Contributing factors included:

- a lack of adherence to the 50/30 rule
- not following safe park up procedures
- poor change management process.

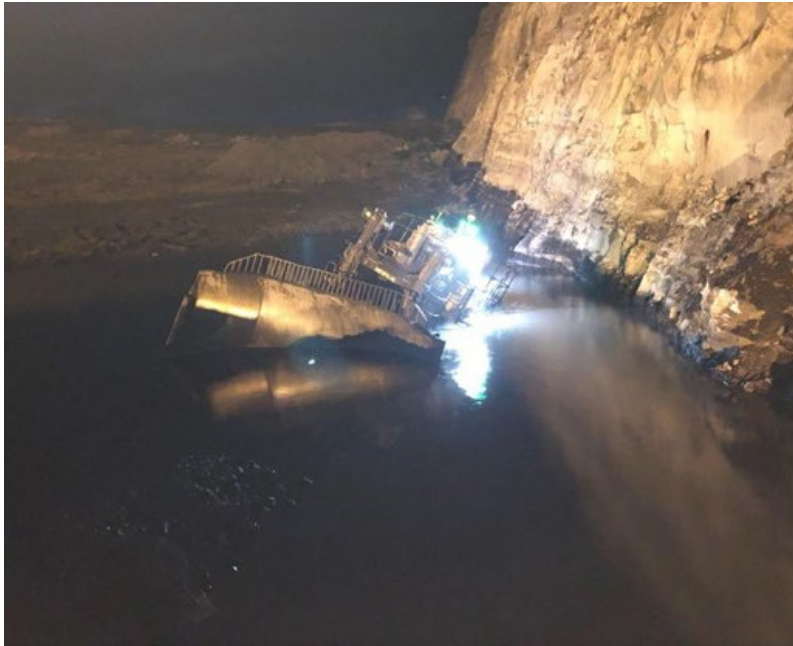
Example 3 - IncNot0042903

A dozer was cleaning up around an excavator when it slid off the coal floor into a body of water, dropping a track into a deeper section, with water rising over the tracks. The operator was unharmed. Police were informed of a rescue in progress by the Open Cut Examiner. Material was placed into the water to form a "bridge" which the operator walked out on.

A contributing factor was the dozer operator failing to follow procedure and reversing while in a body of water of unknown depth.

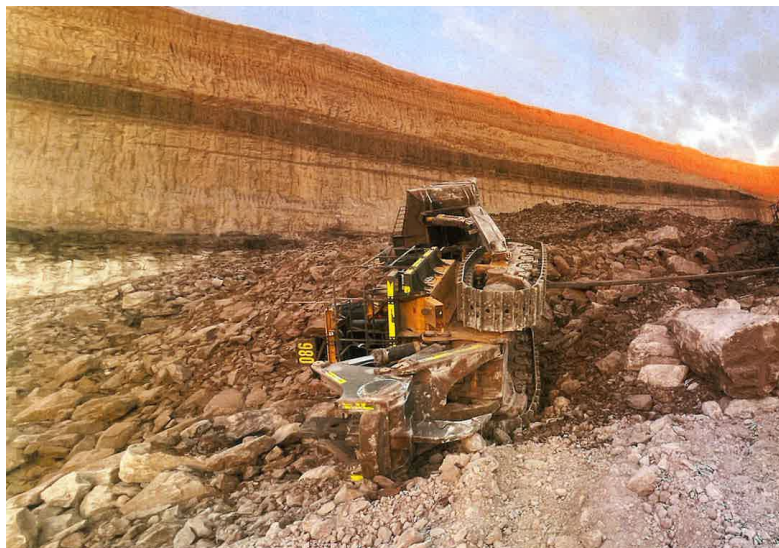
Example 4 - IncNot0045178

A Komatsu 475 Super Dozer was pushing down over height material on the top of a blast heave adjacent to a CAT 6060 Excavator's work area. The operator was using an access track to travel back into the work area and noticed a large rock had fallen onto the track. The operator attempted to move the rock off the track with the dozer blade.

The operator believed they had removed the rock and cleared the track. The operator tracked back to change direction and move forward to continue up the track. Upon moving forward, the operator

felt the right-hand side track climb upward, incorrectly believing it was a smaller rock they continued forward.

As the right hand track climbed onto the rock, the dozer tilted to the left causing the left hand side track to slide off the left hand side of the access ramp resulting in the dozer rolling onto its side.
