Compliance audit program

EL8268 Bowdens Silver exploration project

Bowdens Silver Pty Ltd

April 2024

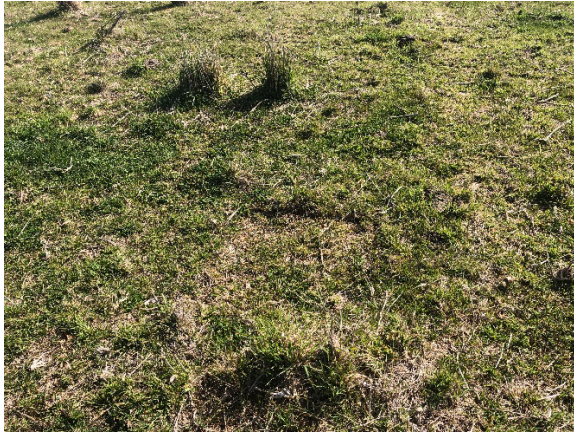
The seismic lines inspected were found to have minimal disturbance, in some areas flattened grass was evident from the steel plate, occasional small holes from the receiver nodes, and vehicle tracks.

Figure 1 Seismic line 20, small square shaped area of flattened grass from steel plate

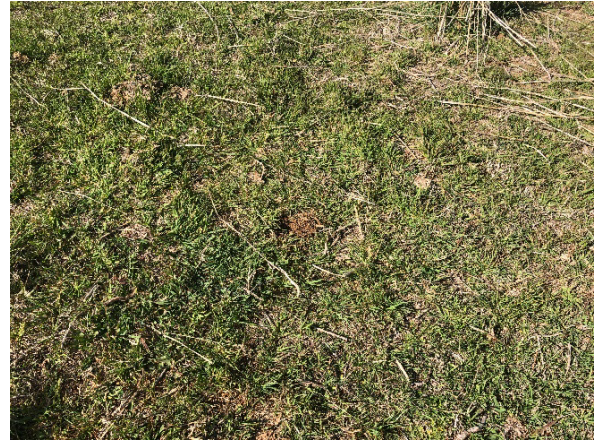
Figure 2 Seismic line 20, pasture with small peg hole from a node

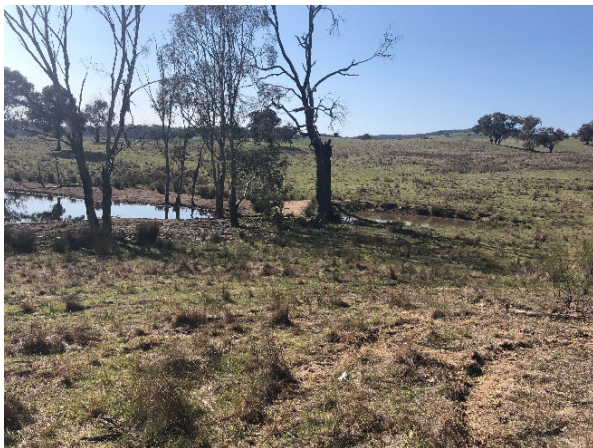
Figure 3 Seismic line 20, vehicle tracks in foreground and exclusion zone due to waterway in background

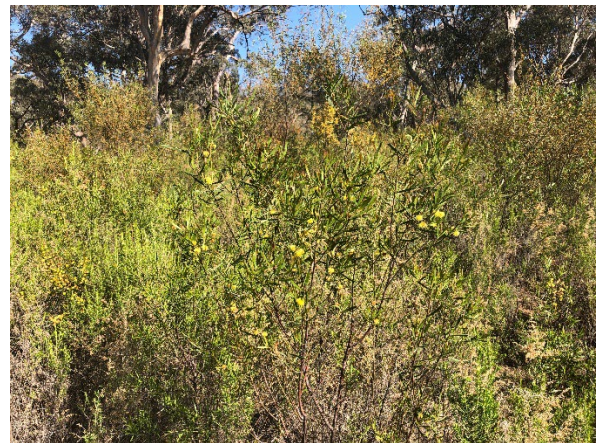
Figure 2 Seismic line 20 exclusion zone (no vehicles), due to threatened species (*acacia ausfeldii*)

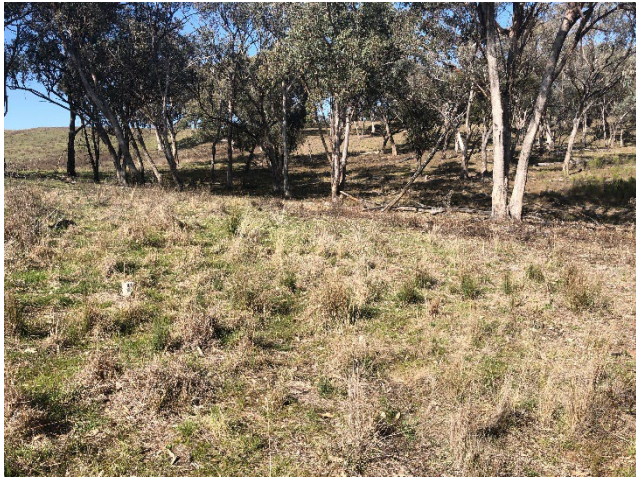
Figure 5 Drilling location of drill hole BAR19001

The 2019 drilling associated with the Barabolar Project Part 2 was within native woodland and moderately sloping landscape. Selected drill sites were inspected and found to be substantially rehabilitated. The rehabilitated pads broadly reflected the surrounding native woodland understory, being rocky with limited ground cover.

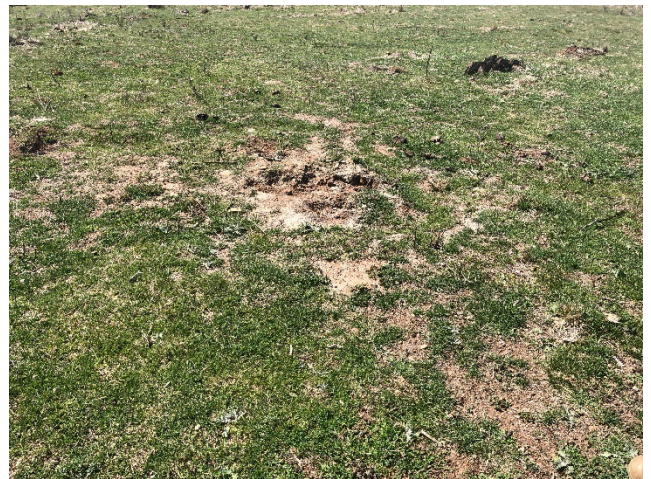
Figure 8 Drilling location drill hole BAR22006

The 2022 drilling associated with the Barabolar Project Part 3 was within cleared paddocks and observed to be substantially rehabilitated with no erosion or sedimentation issues. The 2022 drilling activities used low-impact methods such as above ground sumps and no pad excavation or vegetation removal. It was understood the 2022 drilling was conducted during a wet period. At the time of inspection there was evidence of bare ground where vegetation has not yet re-established.
