Safety Bulletin

Date: April 2024

LHD crowd cylinder failures - potential worker injuries

Safety Bulletin SB24-02

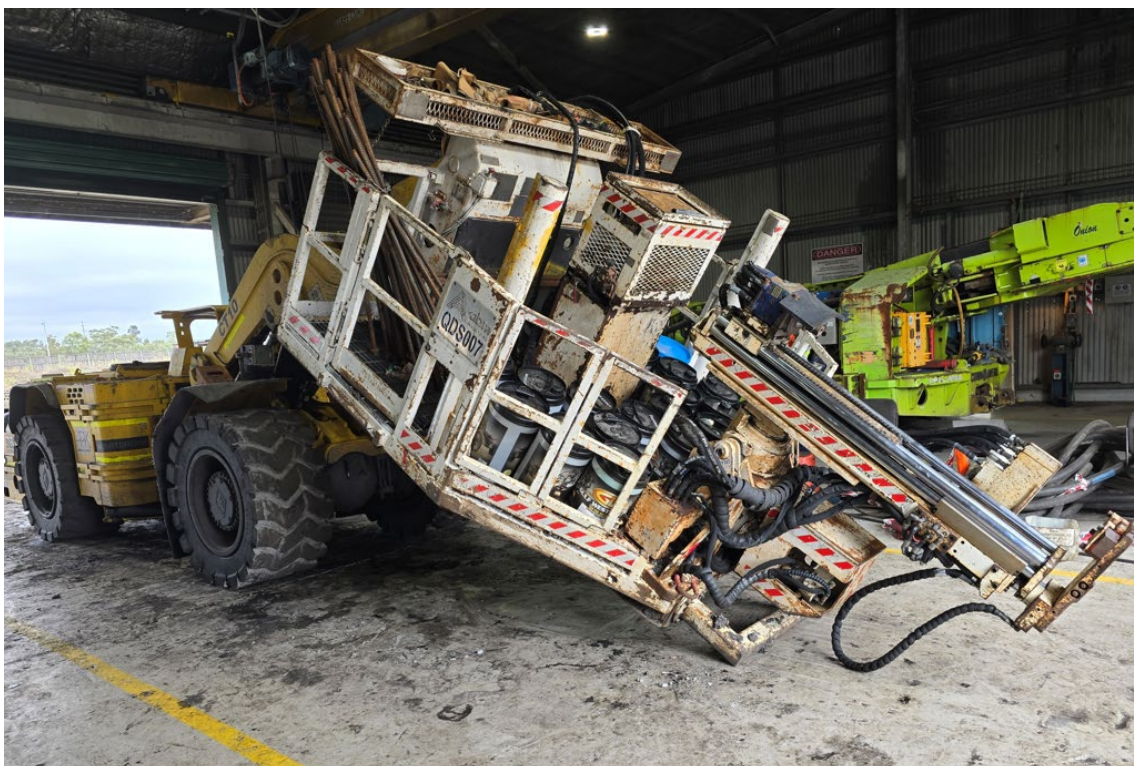
The crowd cylinder forms the top mount supporting the attachment plate. LHDs in the underground coal industry are widely used as utility vehicles, coupling to a variety of implements including some where people are elevated (such as work baskets and drill rigs). Overloading or failure of the crowd cylinder can cause the implement to drop and rotate about the lower load arm pivot joint. Any people in the machine, or in close proximity on the ground, are placed at immediate risk of serious injury or worse.

Figure 1: LHD with drill rig attachment during simulation testing after crowd cylinder failure

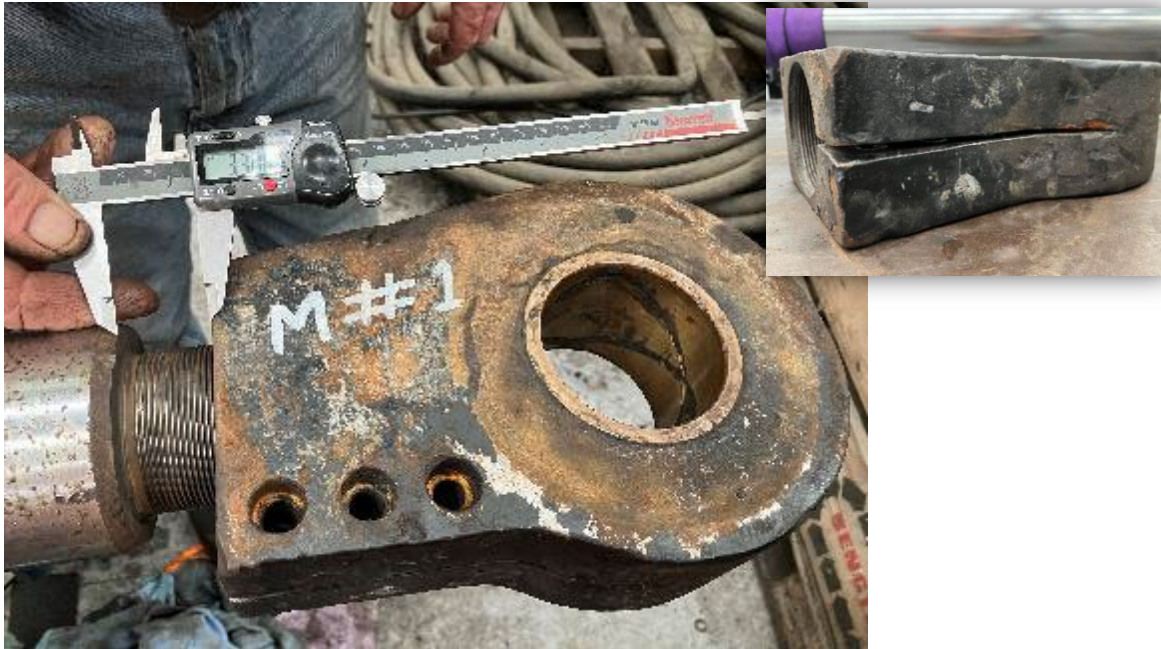
A Coaltram CT08 LHD had a Roberts jib attachment to raise a bolting supplies cassette. As the operator raised the bolting cassette from the ground, there was a loud bang, and the cassette, jib, and LHD attachment plate dropped about 300 mm to the ground. No one was in the immediate vicinity of the pod at the time of incident. On closer inspection, it was found that the front crowd cylinder clevis had separated from the cylinder rod end.

Figure 2: Coaltram CT08 crowd cylinder clevis failure

The LHD was removed from service and the crowd cylinder sent to the original equipment manufacturer (OEM) to be stripped, measured and investigated. The OEM determined the clevis:

- threaded bore was out of round (oval) by 0.58 mm.
- was damaged, causing the clamp gap to spread
- had worked its way off the rod over time until it separated suddenly under load.

- The attachment design was reviewed to prevent reoccurrence:
 - The clamp procedure was developed to reduce potential for the clamp joint fasteners from becoming loose.
 - The clamp bolt length is to be checked on assembly to ensure that the bolts do not bottom out on the bolt shank.
 - Consideration was given to shimming clevis clamp so bolts can pull up tight on closed joints.
- A routine inspection service sheet was developed.
 - Workers should inspect that clamp bolts are in place and secure.
 - Workers should inspect for any gaps between the rod and clevis.

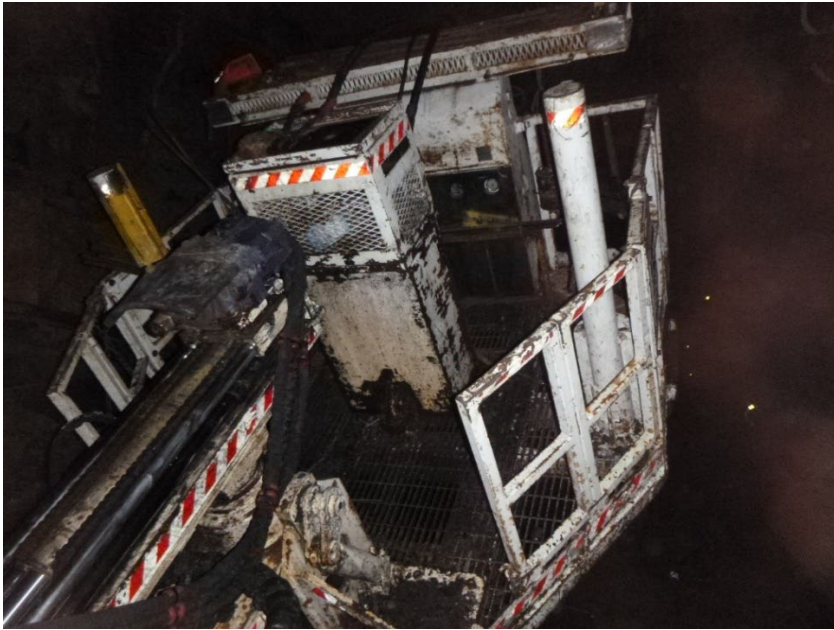
A worker was hanging mesh from a hydraulic strata support bolting rig basket attachment for the majority of the shift. The worker asked the LHD operator to tilt the basket up to gain better access for meshing. The LHD operator activated the tilt up lever, but the bolter basket tilted forward towards the ground from a height of about 1.5 m.

Figure 3: The bolter basket rotated forward with a worker onboard when controls were activated

- The hire CT10LP LHD was brought to the surface and hydraulic pressures tested with the OEM.
- The crowd cylinder was removed, stripped and inspected. It was determined the piston had been machined for an alternative seal. On disassembly, the seal back-up rings were found to have markings of damage that may have affected the seal.
- The crowd cylinder was replaced, retested and the LHD was returned to service.
- A maintenance program work order was created to replace crowd cylinders annually.

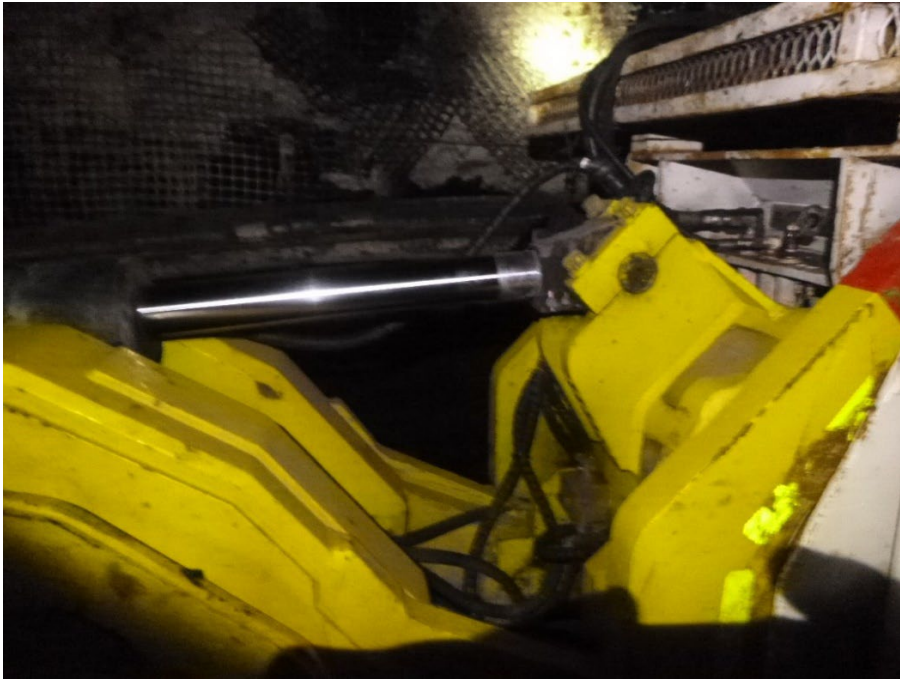
A worker was in the bolting rig basket fitted to the same Coaltram CT10LP LHD in incident 2, installing poly pipe over structure bolts. The basket was fully raised when the basket rolled forward unexpectedly. The worker was thrown against the basket control panel but was not injured. The operator lowered the basket to the floor to check on the worker, and the scene was preserved. A prohibition notice was placed on use of the CT10LP for lifting workers.

- The bolting rig basket was about 400 kg heavier than the nameplate requirement and the centre of the mass was unknown.
- The hydraulic pressure relief (rapid yield valve) setting was unable to hold the basket level across the full range of movement of the implement.

Figure 4: The bolter basket fitted to the CT10 rotated forward unexpectedly. The worker in the basket was not injured

Even if the rapid yield valve was set correctly, the additional mass of the bolting rig basket along with its unknown centre of gravity were outside the operating capabilities of the Coaltram CT10LP and it would not have held the basket level over the full range of movement.

Note: The CT10 (not CT10LP) had a low flow hydraulic function that should be used to provide fine control of the crowd function when using work platforms.

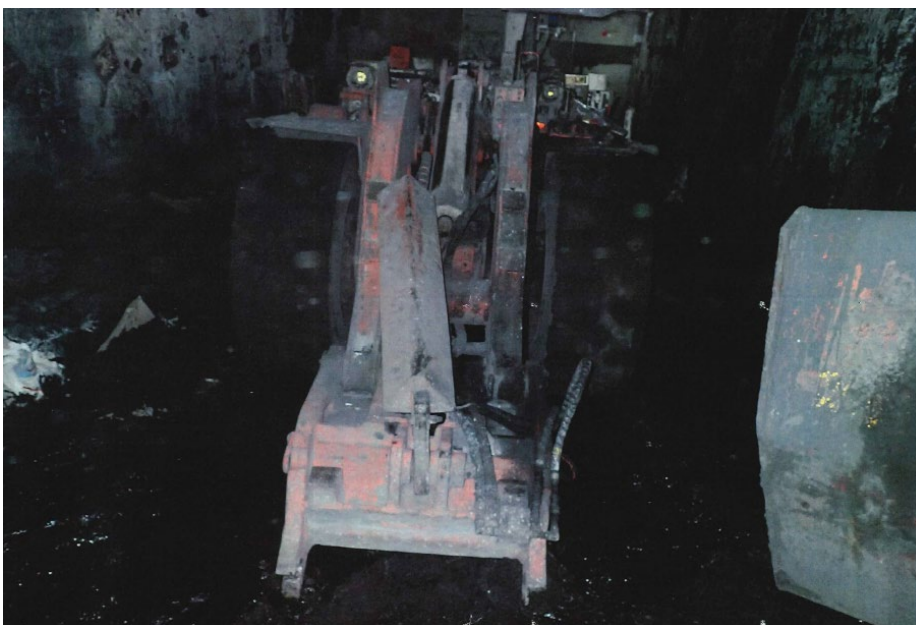
A Sandvik ED10 LHD fitted with a bucket attachment had unloaded stowage material in a cut through when the crowd cylinder failed at the connection between the clevis and cylinder rod. The bucket fell to the ground as the operator was lowering the bucket.

Figure 5: The ED10 with bucket attachment suffered failed welds on rod end clevis

The welds between the crowd cylinder clevis at the attachment plate and the rod end of the crowd cylinder failed. The mine prohibited the use of work baskets and jibs and conducted NDT inspections on the remaining LHD fleet crowd cylinders.

The OEM was notified of the incident and requested to participate in a root cause analysis (RCA), and the crowd cylinder was replaced.

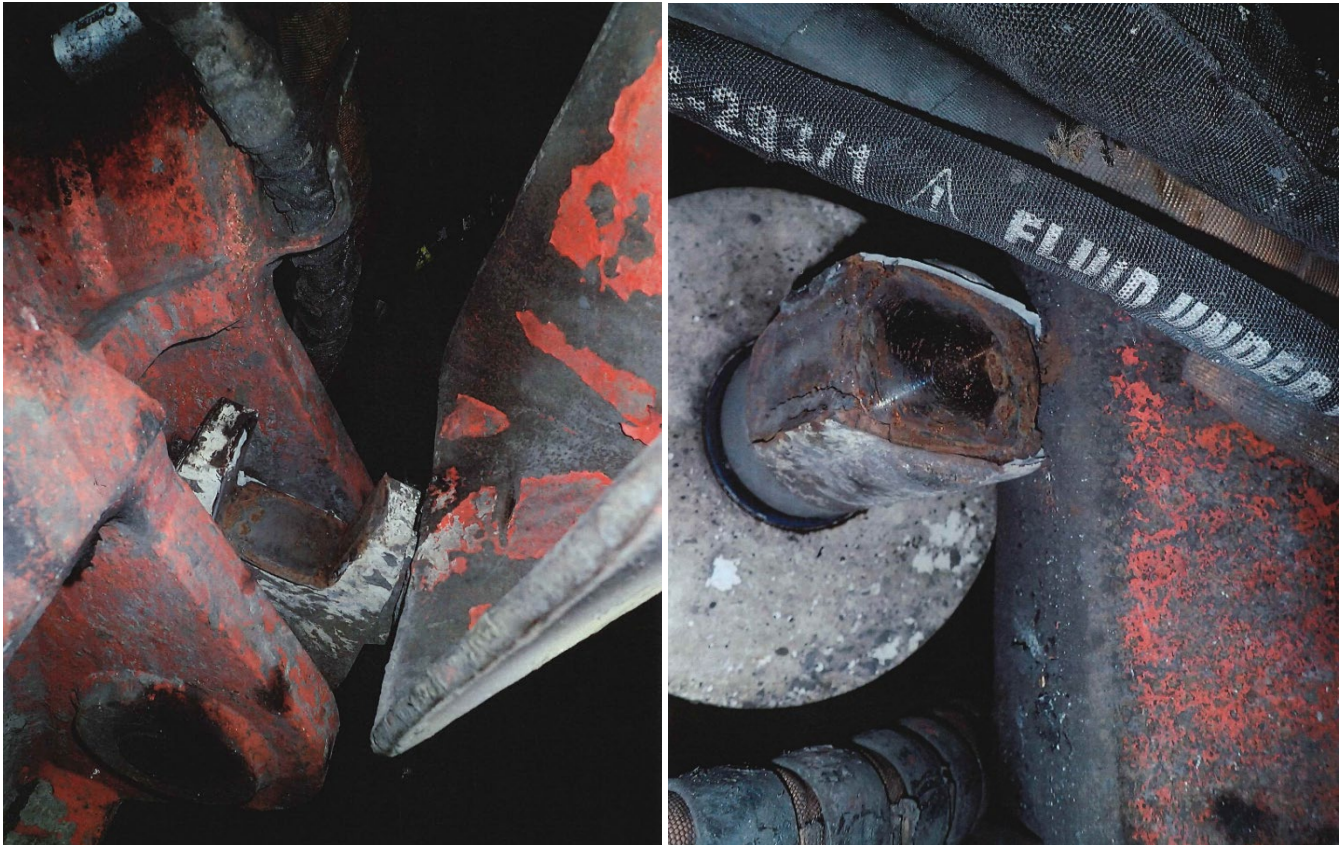
Figures 6 and 7: The ED10 attachment plate crowd cylinder clevis and crowd cylinder rod failed welds

The welds between the clevis and the rod end appeared to lack fusion. Fatigue and corrosion contributed to the failure.

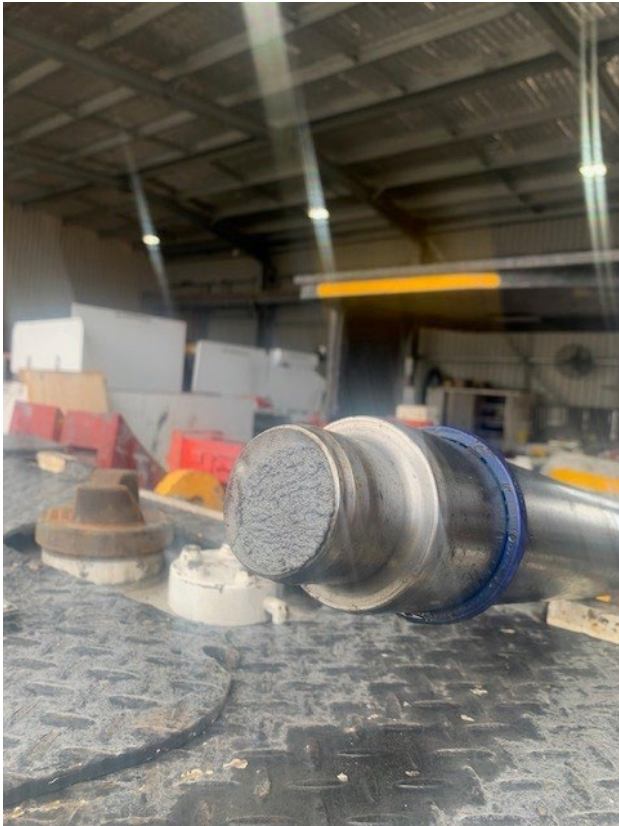
An ED7 LHD with a duck-bill attachment was carrying 2 bundles of link n lock timber and stopping material. The crowd cylinder piston rod broke at the piston-end inside cylinder. All crowd cylinders on these LHDs were overhauled or replaced within the previous 3 years. A leaking crowd cylinder was reported at the mine on an ED7 in recent reports.

Cyclic fatigue initiated from the rod-end machining transition to the threaded section used to secure the piston to the rod.

Figure 8: ED7 with duck-bill attachment suffered piston rod end fatigue failure

The mine operator contacted the equipment owner and advised its workforce that neither work baskets nor bolting rig baskets were to be used on the ED7 fleet until crowd cylinders were verified as replaced.
