# Weekly incident summary

## Week ending 5 April 2024

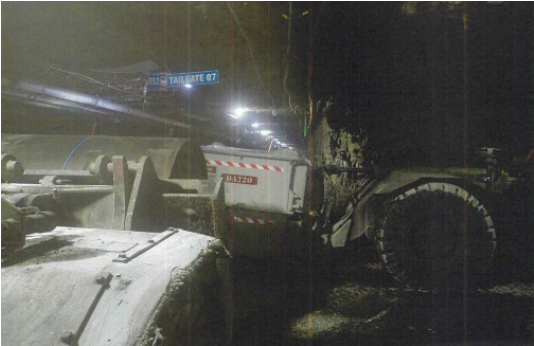
<p>Two load haul dumps (LHDs) collided at an underground intersection. Both LHDs had slowed before entering the intersection and both sounded their horns.</p> <p>One LHD had a roll of conveyor belt on its forks and was travelling outbye when it collided with the other LHD, which had a flinger stone duster on its forks. The forks on the first LHD collided with the duster.</p>

<p>Mine operators must develop and implement systems and procedures around vehicle interaction.</p> <p>Underground site road rules must explicitly require machines entering the main travel road in outbye areas to stop before entering.</p> <p>Soft controls such as signs and mirrors should be periodically audited to ensure they are effective.</p> <p>Roadways and intersections should be designed, constructed, and maintained to safely manage interactions between mobile plant.</p>

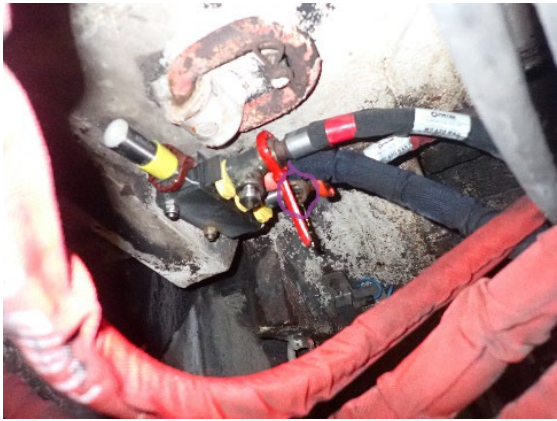
Incident type	Summary	Comments to industry
<p data-bbox="113 232 264 300">Dangerous incident</p> <p data-bbox="113 322 328 356">IncNot0046665</p> <p data-bbox="113 378 352 445">Underground coal mine</p>	<p data-bbox="389 232 970 490">A fitter was testing a hydraulic cylinder on a maingate roof support after it was changed. He extended the cylinder successfully but on retraction there was a sudden release of fluid. He was about half a metre from the release point and was sprayed by a significant amount of oil.</p> <p data-bbox="389 512 948 658">A preliminary examination revealed the hose retainer staple was not installed and had migrated out of the bleed screw in the hydraulic cylinder valve assembly.</p>

<p data-bbox="1011 232 1469 344">Hose retainers and staples are key controls in preventing the escape of high-pressure fluids.</p> <p data-bbox="1011 367 1485 624">Staple life and replacement intervals must be considered in all fluid power circuits on longwall systems including low-use circuits. Staple retention should be considered for all staple connections in fluid power systems.</p> <p data-bbox="1011 647 1485 792">Mine operators must develop and adhere to strict inspection and maintenance standards and practices to prevent fluid loss.</p>
