Weekly incident summary

Week ending 8 June 2024

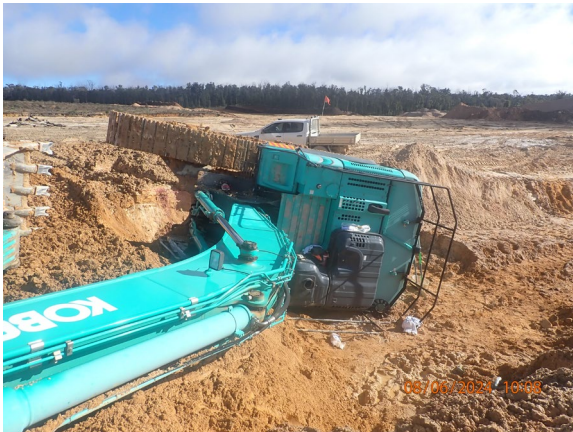
Incident type	Summary	Comments to industry
Dangerous incident IncNot0047057 Quarries Roads or other vehicle operating areas	An excavator operator began work at 6.15am, clearing clay from a bench he had formed the previous evening. The intent was to begin loading a waiting truck once they had removed the clay from the area. The operator did not conduct a pre-shift inspection of the area and the area did not have supplementary lighting. While tramping backwards, the operator lost situational awareness of the trench and backed into it, rolling on its cab side. The quarry's emergency plan was activated, and emergency services successfully freed the operator from the cab. The operator suffered minor injuries.	Mine operators have a duty to manage risks to health and safety associated with the movement of mobile plant at their mine. The operator must have regard to all relevant matters including the design, layout, construction and maintenance of all roads and other areas at the mine site used by mobile plant. Mine operators must ensure adequate lighting is provided to active work areas to ensure that workers do not lose situational awareness to hazards within their working area. Workers should identify hazards within their workplace before starting work and should implement controls where possible to eliminate or

<p>minimise the risk. Where a worker identifies a hazard, the worker should follow the mine's safety management system to control the risk and notify the supervisor where appropriate.</p>
<p data-bbox="124 680 352 943"> Dangerous incident IncNot0047056 Underground coal mine Fire or explosion </p>

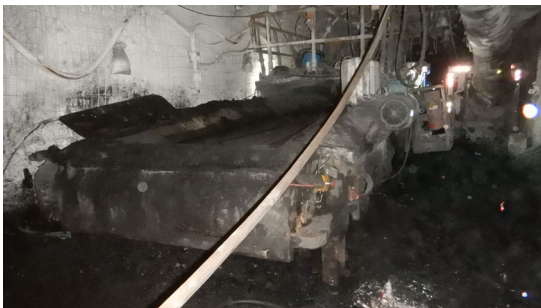
<p data-bbox="392 680 967 1099"> A shuttle car driver noticed smoke when unloading coal onto a belt in a development panel. On investigation, the worker discovered hot embers under a mobile boot end. Water was applied to the area to remove heat. </p> <p data-bbox="392 887 967 1099"> A preliminary investigation identified the design of the mobile boot end allowed for a 200 mm gap from a steel panel to the floor at the loading point and during roadway cleaning on the previous shift fines were pushed under the boot end. </p> <p data-bbox="392 1122 967 1196"> The preliminary investigation recommended the following preventative actions: </p> <ul data-bbox="392 1218 967 1451" style="list-style-type: none"> • Incident learning to be communicated to panel deputies and fitters. • Shift notes to be updated and communicated to deputies to include boot end to be lifted and cleaned following roadway cleaning.

<p data-bbox="1011 680 1474 1048"> Mine operators must ensure that housekeeping activities in and around plant or structures in underground mines does not create additional risks of fire and explosion. It is suggested that mine operators review their fire and explosion risk assessments and update any hazard management plans or subordinate documents where appropriate. </p>

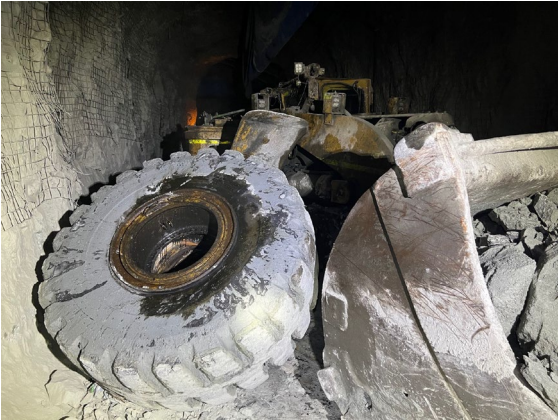
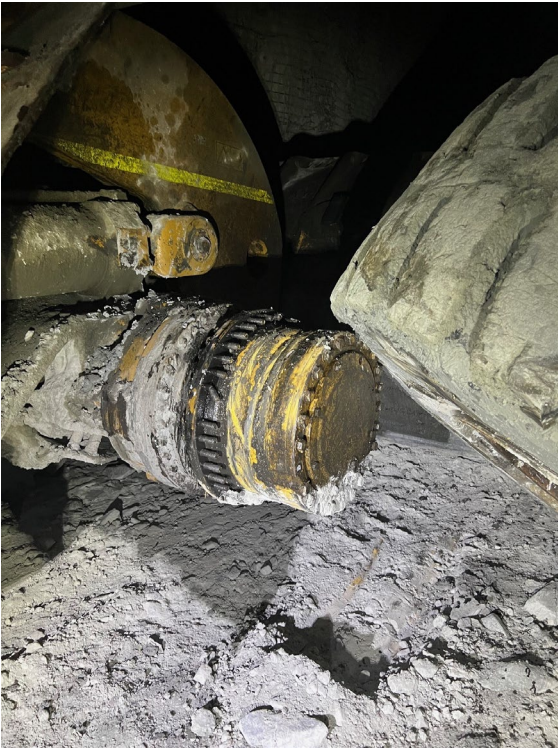
<p data-bbox="124 1805 320 2018"> Dangerous incident IncNot0047018 Underground metals mine </p>	<p data-bbox="392 1805 967 2018"> An underground load haul dump was bogging waste from an incline in an underground metalliferous mine. The operator was tramping in first gear, at a low speed uphill, when he thought a rock hit the heel of the bucket. He stopped and reversed a metre to </p>	<p data-bbox="995 1805 1474 2018"> Mine operators must ensure that equipment is maintained as per the original equipment manufacturer's instructions, fit for purpose and that workers are trained and competent to undertake required tasks. </p>

Incident type	Summary	Comments to industry
	<p>assess. The position 2 wheel came off the loader. The operator immediately stopped the machine and notified the shift boss. The wheel was lodged between the wall and the position 2 guard.</p> <p>Preliminary findings showed all but 2 wheel studs were undamaged, which would suggest the wheel nuts vibrated loose. The preliminary cause for the loss of wheel nuts was incorrect torque setting on workshop rattle guns. It was worth noting that loss of wheel integrity was not flagged by any operators in previous prestart inspections.</p>

<p>Mine workers must follow any reasonable requirement set by the mine operator to ensure the health and safety of themselves and their colleagues. This may include undertaking a diligent pre-start inspection of any plant that they will be operating.</p>
