Safety Bulletin

Date: July 2024

Overtaking or passing equipment in mining areas

Safety Bulletin SB24-03

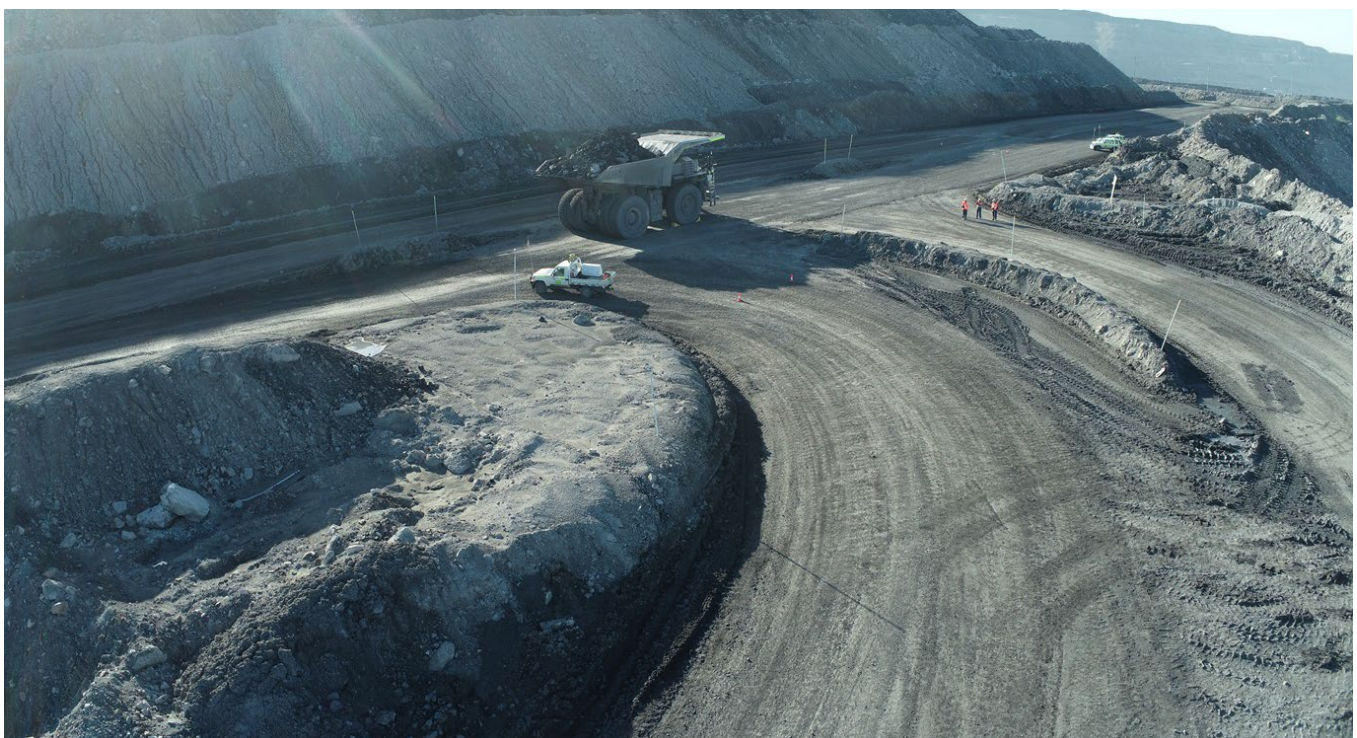
When approaching a T-intersection, a haul truck crossed onto the right-hand lane to pass a grader. At the same time, a light vehicle approached the intersection up a ramp to turn left.

The haul truck proceeded through the intersection on the wrong side of the road as the vehicle attempted to turn left. Before turning left, the vehicle driver looked to the right for oncoming traffic. The driver began the left hand turn but had to quickly apply the brakes to avoid a collision with the oncoming haul truck.

Figure 1: The vehicles at the NSW mine site

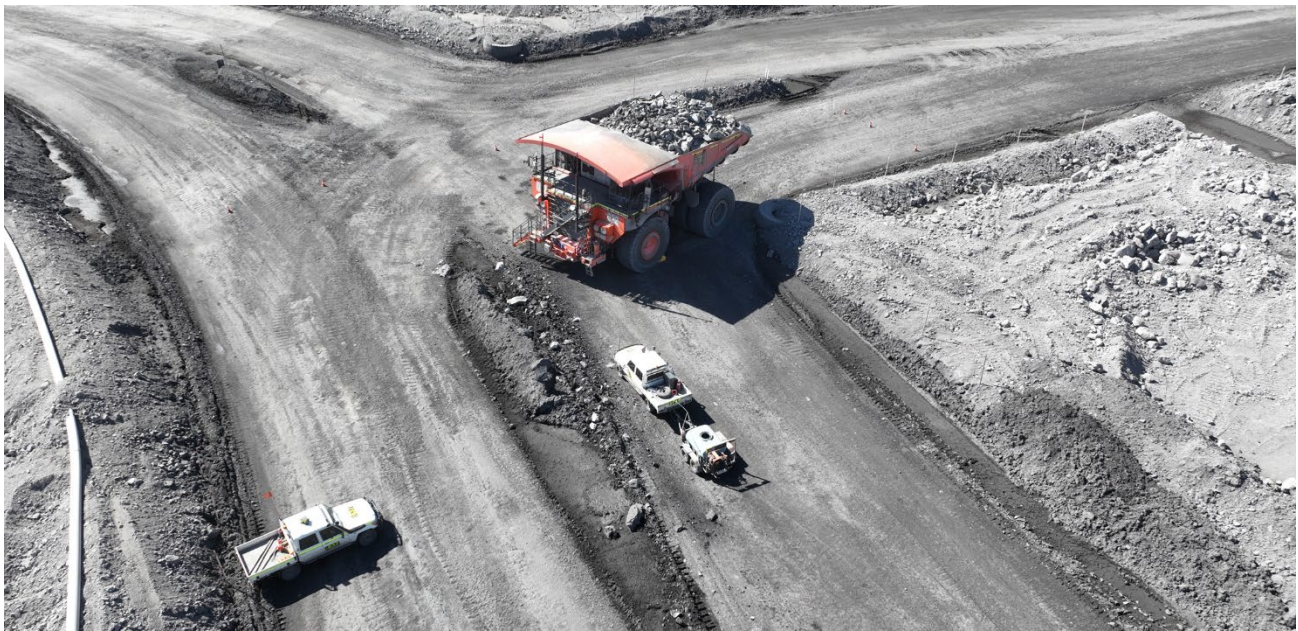
A near miss occurred between a haul truck and a light vehicle towing a tandem-axle trailer with a water tank/pump set up for cleaning. The incident occurred at a haul road intersection on a NSW mine site. The loaded truck was travelling northbound and started to make a left turn at the T-intersection. It had to stop about 7 metres from the light vehicle, which was positioned on the wrong side of the road intersection, with 2 people in the vehicle, travelling towards the intersection.

The passenger was using a pressure washer gun held out the passenger window as the vehicle was driven along the wrong side of the road to allow the passenger to wash the 'Keep left' left sign on the centre island.

Figure 2: A haul truck and light vehicle near miss incident during road maintenance on a NSW mine site recently.

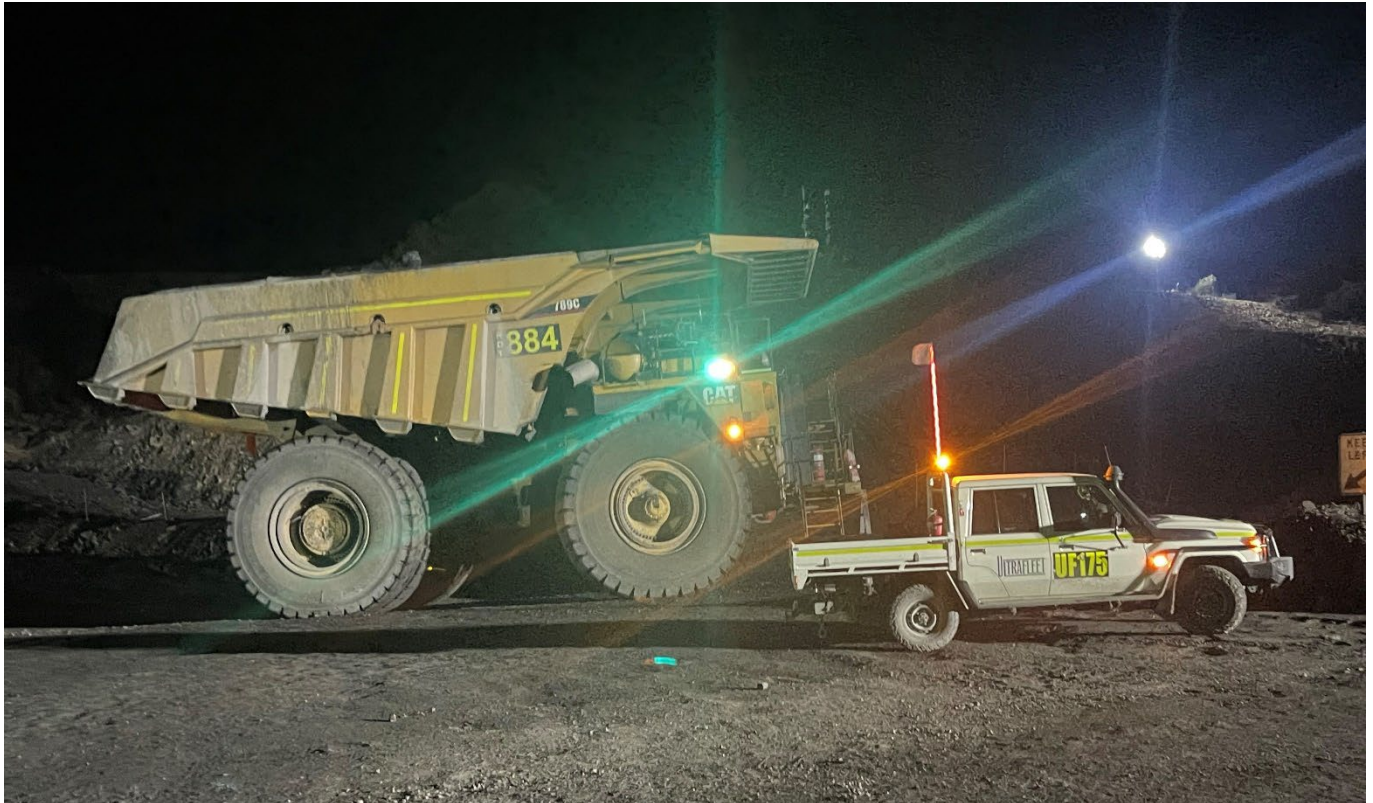
A light vehicle with 2 people inside was in the process of passing trucks that were stopped for a potential hierarchy traffic rule non-compliance at a T-intersection on a NSW mine site recently.

The driver obtained positive communications with the truck operator to pass on its off side.

While the light vehicle was passing the stationary truck, a supervisor communicated that the hierarchy scene preservation requirement was no longer required and the truck operator was advised to resume normal operations.

The truck operator checked their mirrors, released the park brake and rolled forward about 5 metres at up to 4 km/h while the light vehicle was in the process of passing on its off side.

After noticing that the truck had started to move, the light vehicle driver called the truck operator to stop, which it did immediately.

The light vehicle remained outside the line of fire of the truck and was travelling parallel with the truck when it started to move. The vehicles stopped about 7 metres apart.

Figure 3: Haul truck and light vehicle near miss incident (vehicle passing haul truck)
