# Weekly incident summary

## Week ending 5 July 2024

This incident summary provides information on reportable incidents and safety advice for the NSW mining industry. To report an incident to the NSW Resources Regulator: phone 1300 814 609 24 hours a day, 7 days a week.

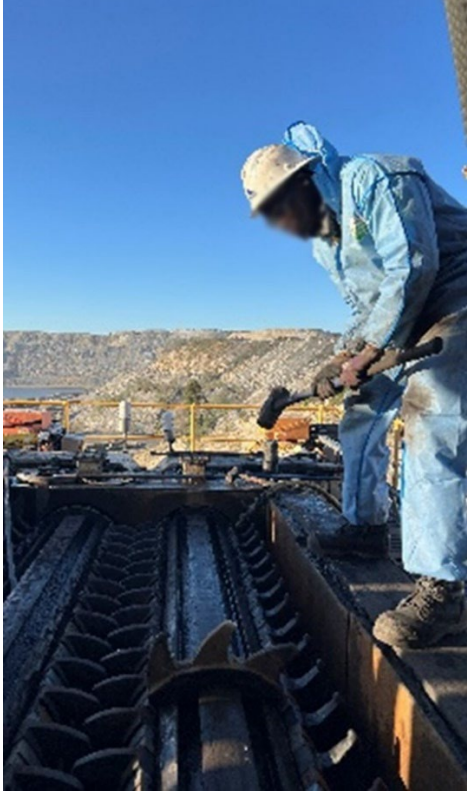
Incident type	Summary	Comments to industry
Serious injury IncNot0047205 Coal processing plant	<p>While removing a tooth segment from a secondary crusher, a worker struck the segment with a hammer and felt an injury to his chest.</p> <p>The injured worker was assessed by paramedics and flown to hospital. While waiting for further assessment, the worker's condition deteriorated, and he described increasing pain and shortness of breath. X-rays identified a small metal fragment in his lung.</p> <p>An initial investigation indicated the use of incorrect tooling for removing the teeth.</p>	<p>All mine workers should be reminded of the dangers associated with the use of hard metal tools, including contact with other hard metal surfaces.</p> <p>Fit-for-purpose tools and equipment, work procedures and training should be provided to workers to prevent injury from metal fragments becoming projectiles.</p> <p>Soft faced hammers should be considered where force is being manually applied to hardened steel.</p>

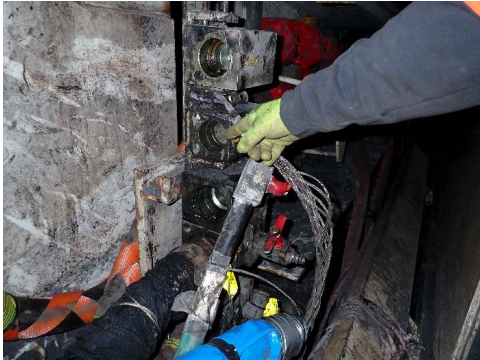
<p>Dangerous incident IncNot0047192 Underground coal mine</p>	<p>While rolling out air and water hoses across an AFC installation, a fitter was asked to connect a 50 mm air hose to a manifold before the hose was rolled out. The fitter removed a retaining staple to connect into a 50 mm airline supply. The end cap ejected, hitting the fitter in the leg just below the kneecap.</p> <p>The fitter was unaware that the line was pressurised.</p>

<p>Mine operators should have procedures in place to prevent exposing workers to the hazards of stored energy. Mine operators should ensure workers are trained on these procedures, and that all workers are aware of the status of stored energy sources.</p>
<p>Serious injury IncNot0047169 Open cut coal mine</p>	<p>A worker suffered a fractured tibia and fibula when joining the flanges (pipe ends) of 2 polyethylene pumping pipes of ~Ø355 mm in a pit.</p>	<p>Mine operators should ensure that pulling and/or joining poly pipe is being carried out in accordance with a safe work procedure (SWP) and that all workers conducting the activity have been trained</p>

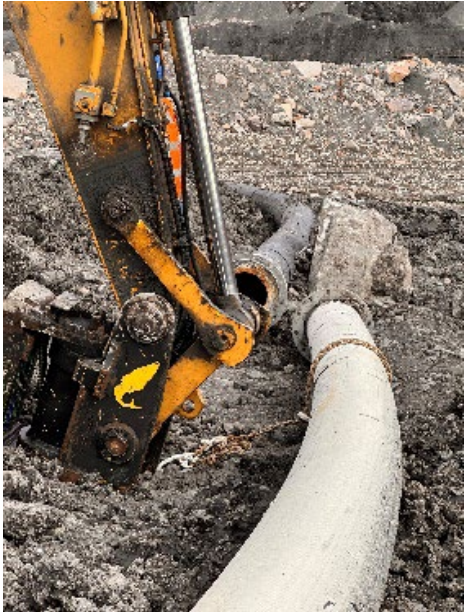
Incident type	Summary	Comments to industry
	<p>One of those poly pipes was resting on the ground, being supported by a large rock. The other pipe was secured via a single wrap chain attached to an excavator hitch. There was a slight overlap and misalignment of the 2 pipe flanges. As the 2 poly pipe flanges were being joined, it appears the poly pipe attached to the excavator hitch moved (slipped) within its restraining chain allowing the poly pipe to hit the left leg of the worker. The internal stored energy within the poly pipe released when the chain slipped along the pipe.</p>

<p>and assessed as being competent in that SWP. The SWP should:</p> <ul style="list-style-type: none"> <li>• be developed from a risk assessment that sets out and assesses all foreseeable risks to workers during in-pit pulling and/or joining activities. This should include risks associated with mobile plant, potential stored energy within the poly pipe and possible in-pit environmental conditions.</li> <li>• set out fit-for-purpose equipment to be used and how it is to be used.</li> <li>• provide a fit-for-purpose means to secure the poly pipe to the pulling equipment.</li> <li>• provide safe standing zones for workers so they are, so far as is reasonably practicable outside possible recoil zones.</li> <li>• provide processes to pull in-pit poly pipes together</li> <li>• provide processes to join 2 poly pipe flanges together.</li> </ul> <p>Refer to Safety bulletin:  <a href="#">SB09-03 Broken pull chain results in fatality</a></p>
