Investigation information release

Dangerous incident involving an explosion in a reclaim tunnel after use of an electrofusion welder

Incident date: 22 July 2024

Investigation information release IIR24-07

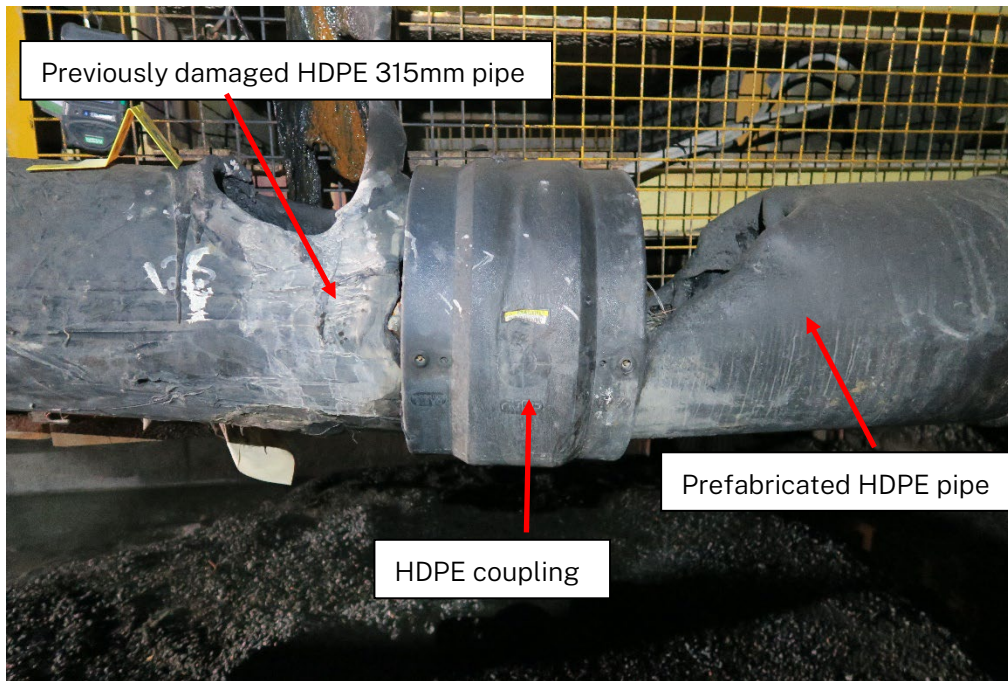
Two workers attended the Concentrator No 2 scats reclaim tunnel to extend the existing HDPE piping that connected to the underpans of a conveyor feeder and ran towards the back of the tunnel. Part of the task involved fitting a HDPE coupling to an existing length of HDPE pipe and another prefabricated length of HDPE pipe. The end of the existing length of HDPE pipe had been damaged by mobile plant.

To prepare the pipe surfaces before the electrofusion welding process started, the ends of the 2 pieces of pipe were cleaned using an abrasive sanding pad affixed to a handheld grinder and the ends were wiped with paper towel product (WypallX80).

The workers also placed this paper towel product into the existing pipe to help stop a slow leak of water coming from further up the pipe towards the welding area.

Figure 1 - Heat damaged HDPE coupling and connecting pipes

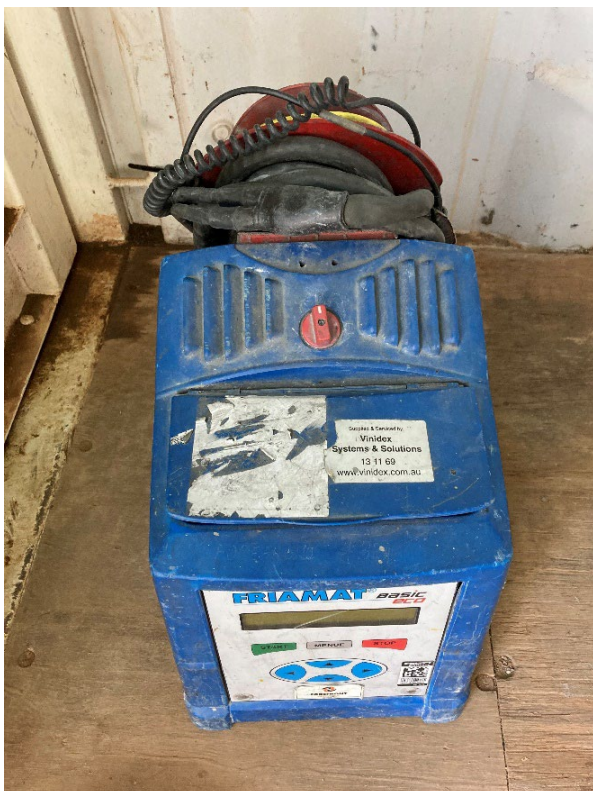
Once the coupling and 2 pipe pieces were fitted together, the workers set up the electrofusion welding unit by connecting the electrodes to the coupling. The workers then scanned the supplied barcode that was affixed to the coupling. The barcode provided the product information the welding unit required to automatically adjust the welding settings. In this instance, the welding unit determined the applicable welding time to be 1040 seconds.

Figure 2 - The electrofusion welder used in the work task

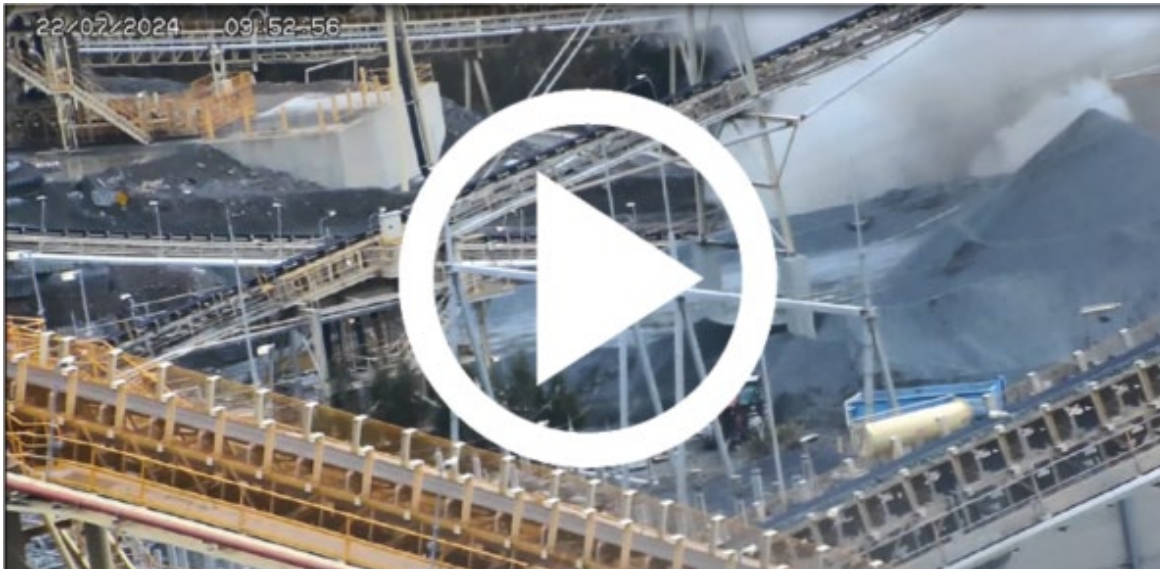
While the emergency response was being mobilised, an explosion was seen and heard coming from the end of the tunnel. The explosion caused some damage to equipment and infrastructure immediately in front of the tunnel and scattered debris over a distance of 60 metres. The explosion was captured on CCTV.

Figure 3 - CCTV footage of the tunnel explosion (top right of photo)
