Weekly incident summary

Week ending 4 August 2024

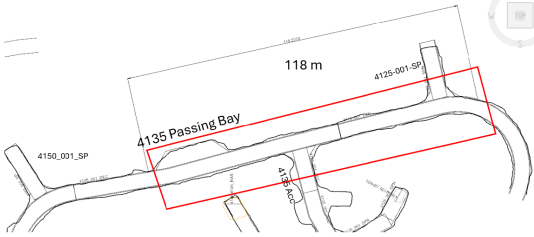
Incident type	Summary	Comments to industry
Dangerous incident IncNot0047366 Underground metalliferous mine	<p>A mine worker was driving a light vehicle with 3 other occupants down a decline when the service brake became unresponsive. The driver shifted to first gear and applied the park brake and stopped the vehicle. It took 118 metres to bring the vehicle under control and stop.</p> <p>The wheel nut indicators appear to have melted off due to high heat from the brakes. Low range was not engaged.</p>

<p>Brake fade (or vehicle braking system fade) is the reduction in stopping power that can occur after repeated or sustained application of the brakes of a vehicle, especially in high load or high-speed conditions. Brake fade is caused by a build-up of heat in the braking surfaces and the changes and reactions in the brake system can be experienced with both drum brakes and disc brakes.</p> <p>Mine workers are reminded that before commencing a decent they should choose an appropriate gear with the appropriate speed range to allow the engine braking to maintain speed.</p> <p>Mine operators must ensure that their workforce is trained and</p>

<p>competent to operate vehicles in underground conditions.</p>
<p>Dangerous incident IncNot 0047351 Underground coal mine Roads or other vehicle operating areas</p>	<p>A mine was undertaking work on its main travel roads as part of recommencing mining operations. The mine was scheduled to transport some heavy mining equipment underground. Due to wet conditions, the mine operator decided to do a trial run with the mine dozer and attachments on wet concrete on a 1 in 5 drift. During the trial the dozer lost traction and the jib attachment hit a disused 8 inch poly pipe on the right-hand rib line, damaging the pipe. Before the incident, it was ensured no personnel or vehicles were in the drift except for the dozer and operator.</p>

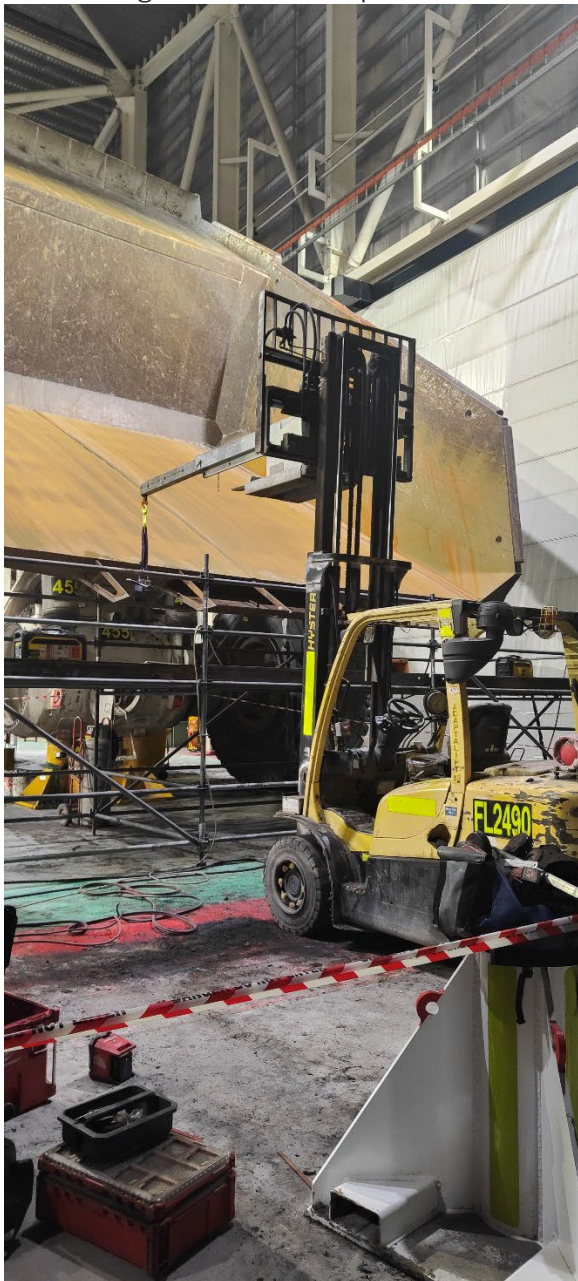
Incident type	Summary	Comments to industry
Dangerous incident IncNot0047350 Open cut coal mine	<p>Two workers were standing on a 1.5 metre scaffold to position an extension plate on top of the dovetail on a haul truck. The plate was secured with a lift jib and magnet. During the lifting process, the plate dislodged and hit one worker on his left knee. The worker suffered a soft tissue injury and was later released back to the site following an assessment. The plate dimensions were 8 mm thick 132 cm 98 cm and about 80 kg. The scene was preserved.</p>	<p>Workers must ensure that they do not work under suspended loads and that they choose the appropriate lifting apparatus for the job. In this instance, the worker suggested that they should have welded lifting points onto the plate, which would have had a higher factor of safety.</p>
