# Weekly incident summary

## Week ending 28 July 2024

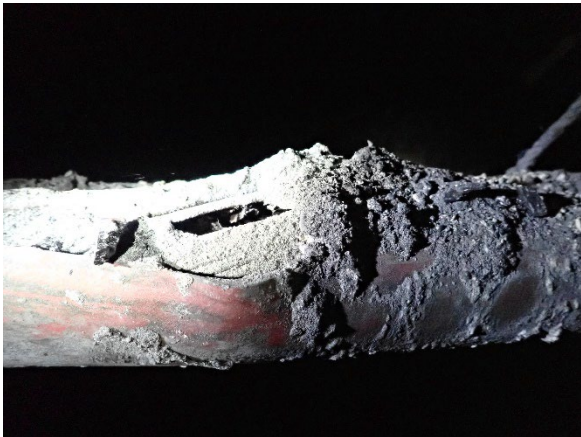
Incident type	Summary	Comments to industry
	<p>cable were incorrect and were lowered to more than half the original setting.</p> <p>On inspection of the cable, it was suspected that the heat generated from the arc fault ignited the internal tar or insulation of the cable.</p> <p>The flame was described as being like a 'candle'.</p> <p>There was no excessive buildup of material on top of the cable that otherwise could have combusted.</p>

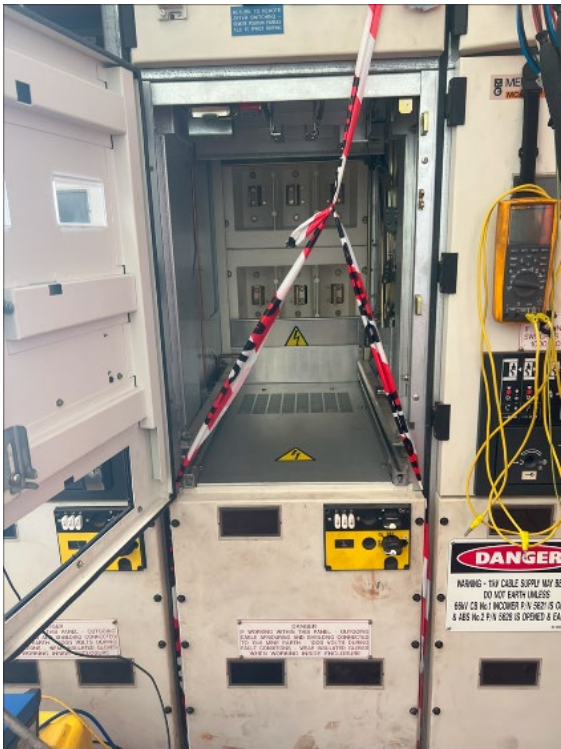
<p>Dangerous Incident IncNot 0047306 Underground coal mine</p>	<p>The mine was conducting annual high voltage maintenance on one of the 66-11 kV switchyards with 2 contract companies assisting. The switch yard contained dual 10 MVA 66/11 kV transformers and the switch room contained an 11 kV Merlin Gerin MC set. One of the jobs required was to inspect, test and maintain the 11 kV MC set.</p> <p>As part of the inspection of outlet number 2 cell and circuit breaker, one of the contractors was inspecting and cleaning the line side and load side spouts in the cell. When he touched the load side spout, he received an electric shock.</p> <p>The contract electrician was treated at the incident scene and the electric shock procedure was followed. The contract electrician was transported to the first aid facility and held under observation until the ambulance arrived. A 12 point ECG was completed onsite and the contract electrician was transported to the local hospital for further monitoring and blood tests. He was later discharged as medically fit and transported back to site.</p> <p>The apparent cause was the capacitive build-up in the 300 mm<sup>2</sup> XLPE cable (UG Feeder approx</p>	<p>Mine operators must develop and implement a robust isolation procedure that considers isolation and dissipation of capacitive build-up.</p> <p>Electricians must always ensure that they are trained and competent to undertake the electrical task and are able to dissipate and test all electrical components in an electrical system that are to be worked on.</p>

Incident type	Summary	Comments to industry
	<p>2.5 km long) connected to the load side of outlet number 2, which was discharged by the electrical contractor when he touched the load side spout to earth.</p>
