Safety Alert

Date: September 2024

Fire occurs on longwall face in underground coal mine

Safety Alert SA24-03

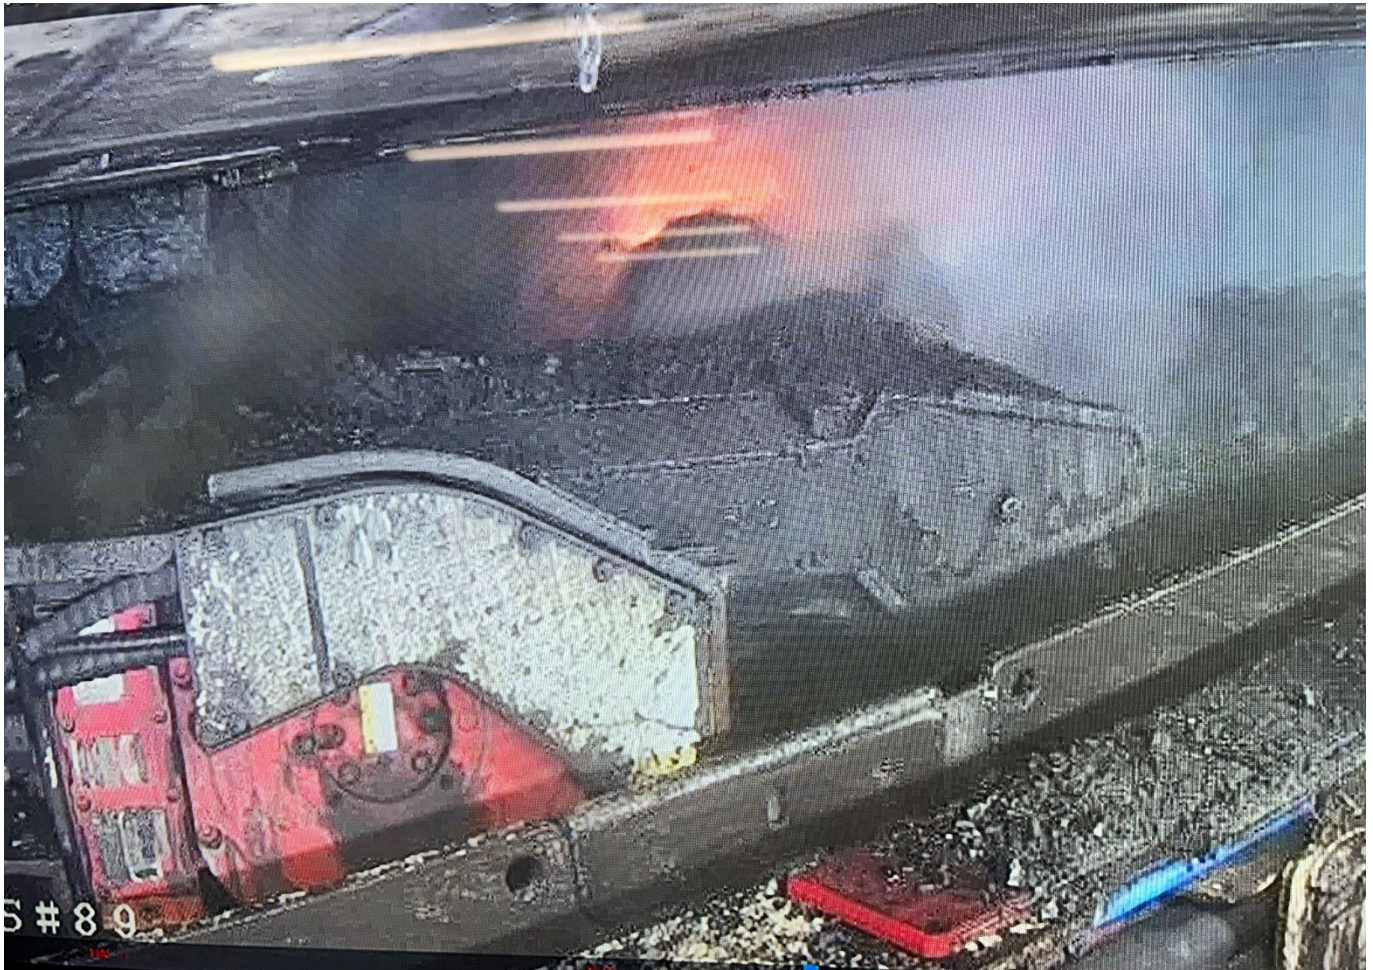
Figure 1: The tailgate drum

A fire occurred in front of the face side of the tailgate cutter drum of an operational shearer in a NSW underground coal mine on 26 August 2024.

The shearer failed to clear the tailgate snake area completely when haulage stopped after the anti-collision haulage function tripped. At the same time, the Armoured Face Conveyor (AFC) panline advanced on the bank push, which forced the tailgate drum into the face. The drum continued to rotate, which generated frictional heat. The cutting horizon consisted of a metre of sandstone/siltstone from the floor with a metre of coal above that.

After several minutes, flames erupted in the area immediately in front of the tailgate drum. This was captured on the system's continuous video display and the surface operator stopped the drum rotation. The flames were extinguished by the shearer drum sprays before the worker on the face, who was about 40 metres away, had time to intervene. Having been alerted to the fire by the surface operating centre, the worker on the face proceeded to the shearer and made the area safe by dousing it with water.

The mine has determined there were deficiencies in the programming of the automation process that allowed the AFC panline to advance while the shearer was not clear of the advancing panline. This forced the face side of the tailgate drum into the coal face, which consequently generated sufficient frictional heat to ignite the coal that was immediately in front of the drum.

All frictional ignition controls were found to be compliant after the incident, with the shearer drum cutter picks and sprays in excellent condition. Air quantity across the longwall face was 40 cubic metres/second and the tailgate was liberally stone dusted.

- review their automated cutting processes with specific emphasis on the suitability of controls within the software to prevent automated commands that may result in creating unsafe conditions
- communicate this alert to workers who are engaged in overseeing remote mining operations to highlight the challenges that exist with regard to identifying unsatisfactory operating conditions in a timely manner before a dangerous incident occurs underground.
