Weekly incident summary

Week ending 6 September 2024

This incident summary provides information on reportable incidents and safety advice for the NSW mining industry. To report an incident to the Resources Regulator: phone 1300 814 609 24 hours a day, 7 days a week.

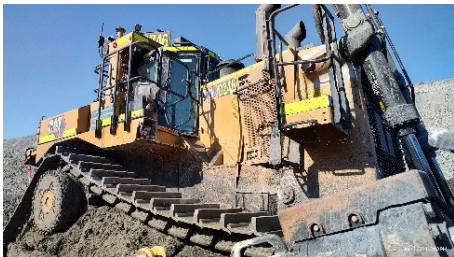
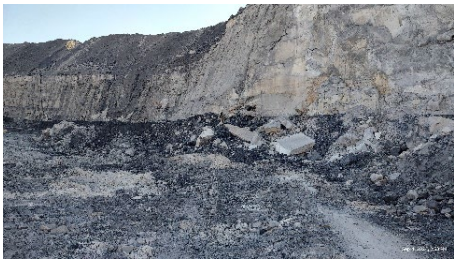
Incident type	Summary	Comments to industry
Dangerous incident IncNot0047596 Open cut coal mine Ground or strata failure

A large rock fell from a high wall and impacted a D11 dozer that was nearby. The operator drove about 50 metres to safety and was not injured.

When geotechnical reports identify hazards on highwalls, mine operators should ensure that controls to manage the risks are implemented and communicated to workers. In areas where previous geotechnical failures have occurred, the frequency of inspections and reporting on hazards should be increased and the outcomes communicated to workers.

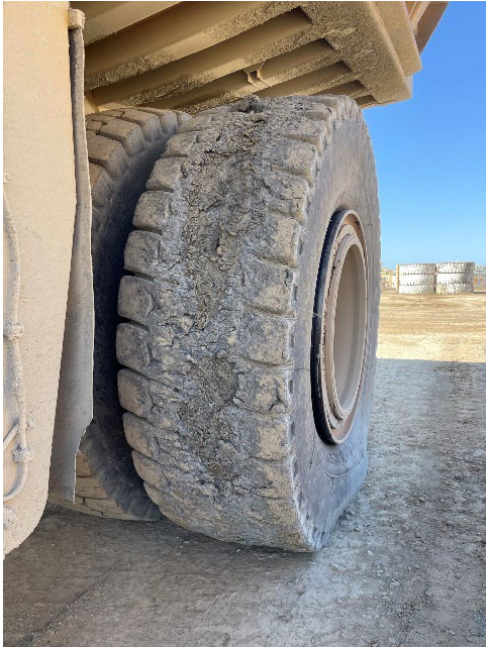
Incident type	Summary	Comments to industry
<p data-bbox="113 203 411 371">Dangerous incident IncNot0047586 Underground metals mine</p>	<p data-bbox="411 203 911 371">The outer tyre (position 3) of a haul truck failed, and the released pressure scattered rocky material over a range of about 75 metres.</p> <p data-bbox="411 371 911 495">Material from the event hit an adjacent drill rig and landed in a work area where workers were servicing a digger.</p> <p data-bbox="411 495 911 618">No workers were impacted or injured by the material, but some equipment was damaged.</p> <p data-bbox="411 618 911 741">The haul truck was loaded, and the tyre failed on the running surface (within the tread).</p>

<p data-bbox="911 203 1479 327">The integrity of tyres is a critical control in preventing the uncontrolled blast of compressed gas from within the tyre.</p> <p data-bbox="911 327 1479 495">Tyres should be inspected closely as part of pre-use inspections and operators should receive training to assist them in identifying tyre defects.</p> <p data-bbox="911 495 1479 618">The suitability of tyres for the duty cycle must be considered prior to being declared fit-for-purpose.</p>

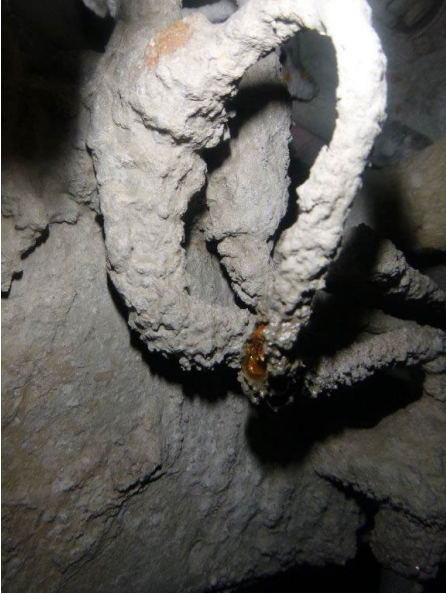
<p data-bbox="113 1429 411 1597">Dangerous incident IncNot0047583 Underground metals mine</p>	<p data-bbox="411 1429 911 1731">An operator was driving a light vehicle, (LV troop carrier) up a decline when a loader was coming down the decline. The LV drove into a cut away to give way to the loader. While reversing out of the cut away the operator felt the loss of brakes in the LV and reversed into the wall.</p> <p data-bbox="411 1731 911 1908">Initial assessment identified a pinhole in one of the brake circuits allowing a slow leak of fluid and reduced braking efficiency.</p>	<p data-bbox="911 1429 1479 1697">Vehicles need to be fit-for-purpose with regular maintenance and inspection systems in place. This must include critical systems such as brakes. Operational testing of service and park brakes should be included in pre-use inspections.</p> <p data-bbox="911 1697 1479 1908">Engine bays should be kept clean to prevent build-up of material on hoses that can prevent the identification of leaks.</p>
