Safety Bulletin

Date: October 2024

Recent increase in vehicle interactions

Safety Bulletin SB24-08

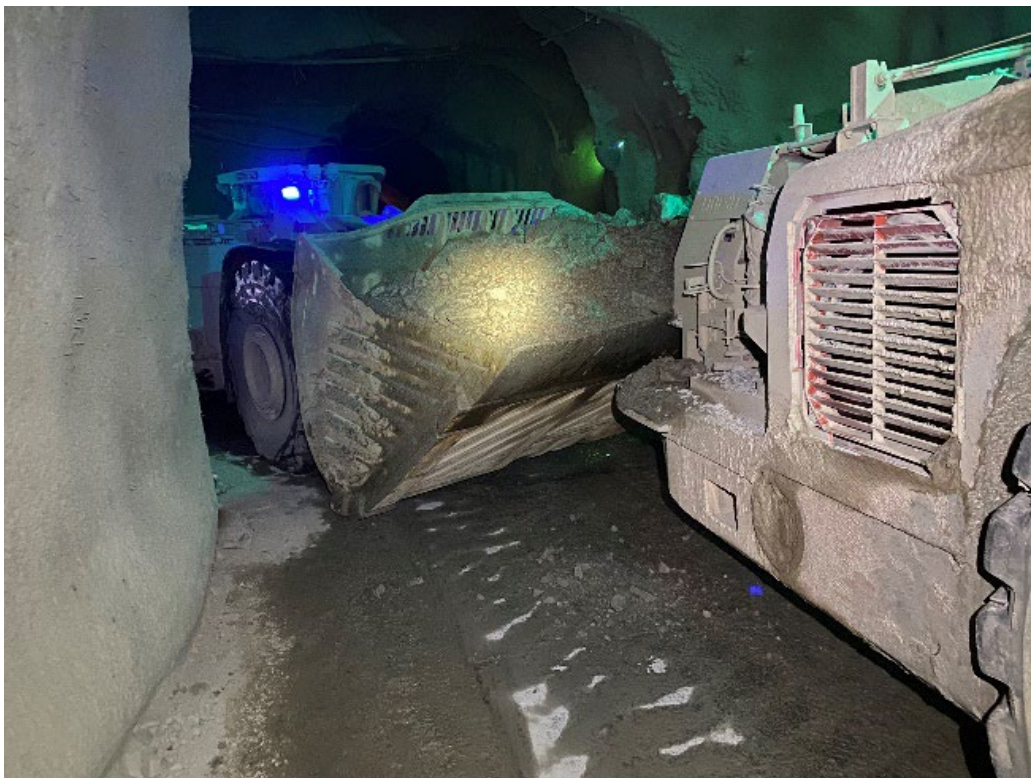
Figure 1: Vehicle collision in an underground metalliferous operation

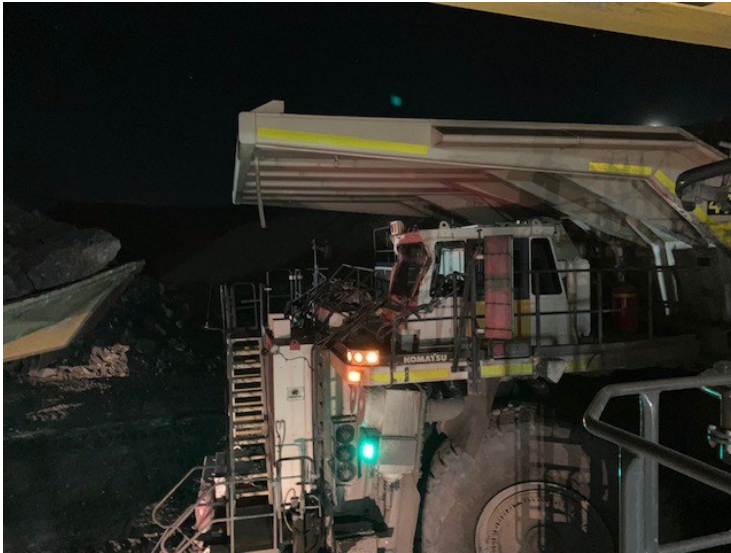
Figure 2: Interaction with the cab from reversing truck tray

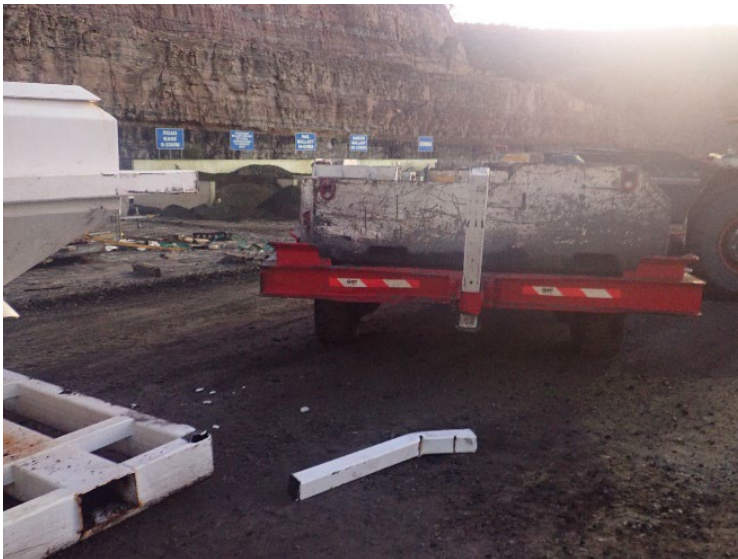
Figure 3: On the surface of an underground coal mine
