Weekly incident summary

Week ending 04 October 2024

This incident summary provides information on reportable incidents and safety advice for the NSW mining industry. To report an incident to the NSW Resources Regulator: phone 1300 814 609 24 hours a day, 7 days a week.

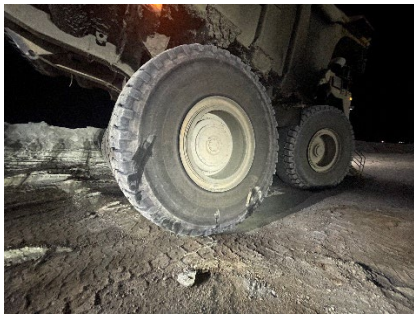
Incident type	Summary	Comments to industry
Dangerous Incident IncNot0047782 Open cut coal Roads or other vehicle operating areas	<p>A dozer was cleaning up around a dig face when a haul truck reversed into place. The truck contacted the dozer on the drivers offside.</p> <p>The truck driver breached the mine's procedure by positioning the rear of the truck towards the loading unit prior to the bucket being presented.</p>

<p>Workers have a duty to take reasonable care for themselves and others while in the workplace. This includes staying alert, being aware of their surroundings, and maintaining control of the plant and machinery they operate.</p> <p>Workers are also reminded that as part of their duty, they must comply with reasonable instructions and procedures of the workplace. Following procedures for loading trucks is considered reasonable.</p>

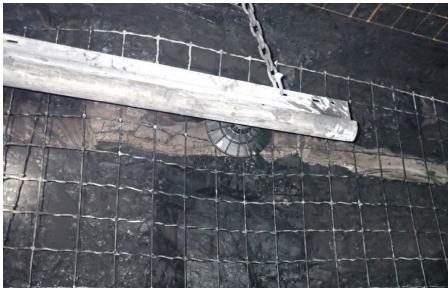
Incident type	Summary	Comments to industry
<p>Dangerous Incident IncNot0047779 Underground coal Leave blank</p>	<p>A continuous miner operator was struck on the head by a monorail trolley when it fell from the end of the rail in a development production area.</p> <p>There was no mechanical stop on the end of the monorail to prevent the trolley from falling.</p>

<p>The omission of a simple but necessary control can have serious consequences for workers.</p> <p>When extending monorails, it is essential that the monorail brake is secured at the end of the line to prevent the trolley from falling off.</p> <p>Operators should do a visual check to ensure the brake is in place before proceeding forward and engaging the trolley.</p>
<p>Dangerous Incident IncNot0047769 Construction materials Roads or other vehicle operating areas</p>	<p>A supervisor pulled up near a stationary haul truck to pick up the operator. The operator, unaware of the nearby light vehicle, moved the truck forward several metres to realign it, contacting the light vehicle with the ladder, which was in the lowered position.</p> <p>The supervisor assumed the truck was parked up when he stopped in front of it.</p>

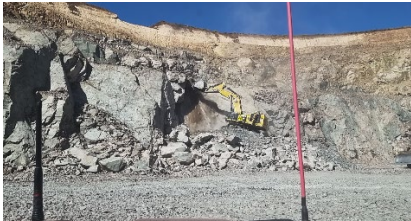
<p>Dangerous Incident IncNot0047767 Underground metals Leave blank</p>	<p>While scaling loose material from a batter a large volume of hung-up material was brought down resulting in a rock deflecting off another rock on the rilled material and shattering the</p>	<p>Work methods for scaling must consider the risk of falling material and locations of people and equipment operators.</p> <p>Consideration should be given to the height of the excavator operating</p>

Incident type	Summary	Comments to industry
	<p>side window of an excavator. Some rock also flowed onto the excavator tracks.</p> <p>The catch-bund had previously caught scaled material, leading to overflow when a large volume of scaled material came in at once.</p>

<p>platform so that scaled rock will fall down and away from the excavator.</p> <p>Ensure that the catch-bund is large enough to safely hold the quantity of scaled rock.</p>
