Safety Bulletin

Date: November 2024

Safety-critical system failures - steering

Safety Bulletin SB24-09

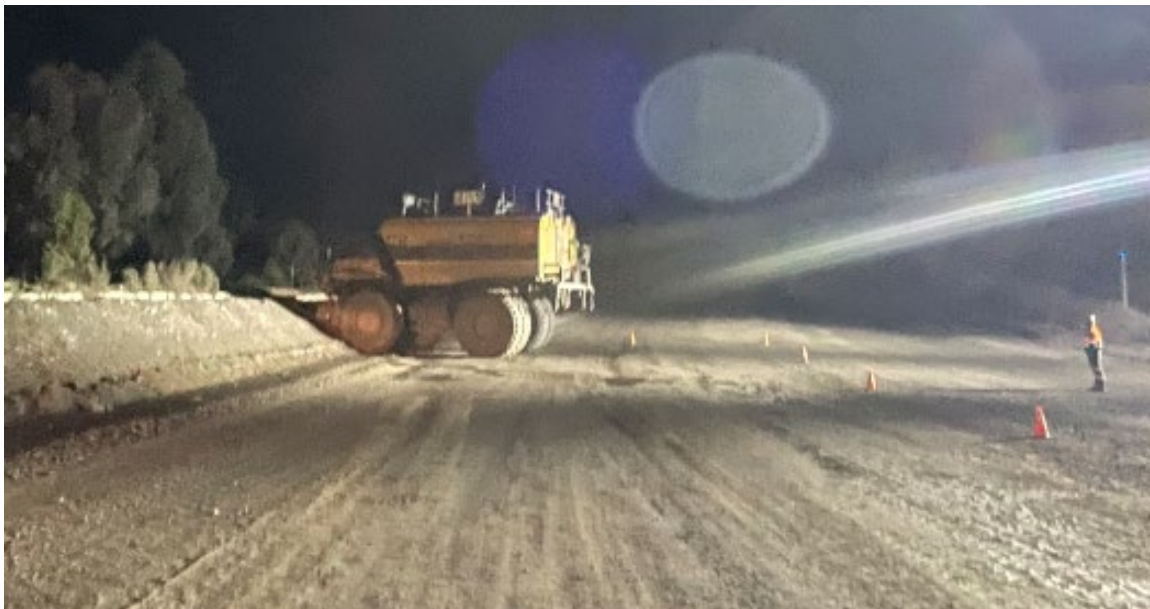
About 11pm, the steering on a Komatsu HD785-7 water cart appeared to lock up while negotiating a bend in a haul road. The operator applied the brakes and the water cart slid, front first, into a windrow, causing the rear of the water cart to swing out perpendicular to the windrow. The operator was uninjured.

Figure 1: The water cart collided with a bund after steering became difficult

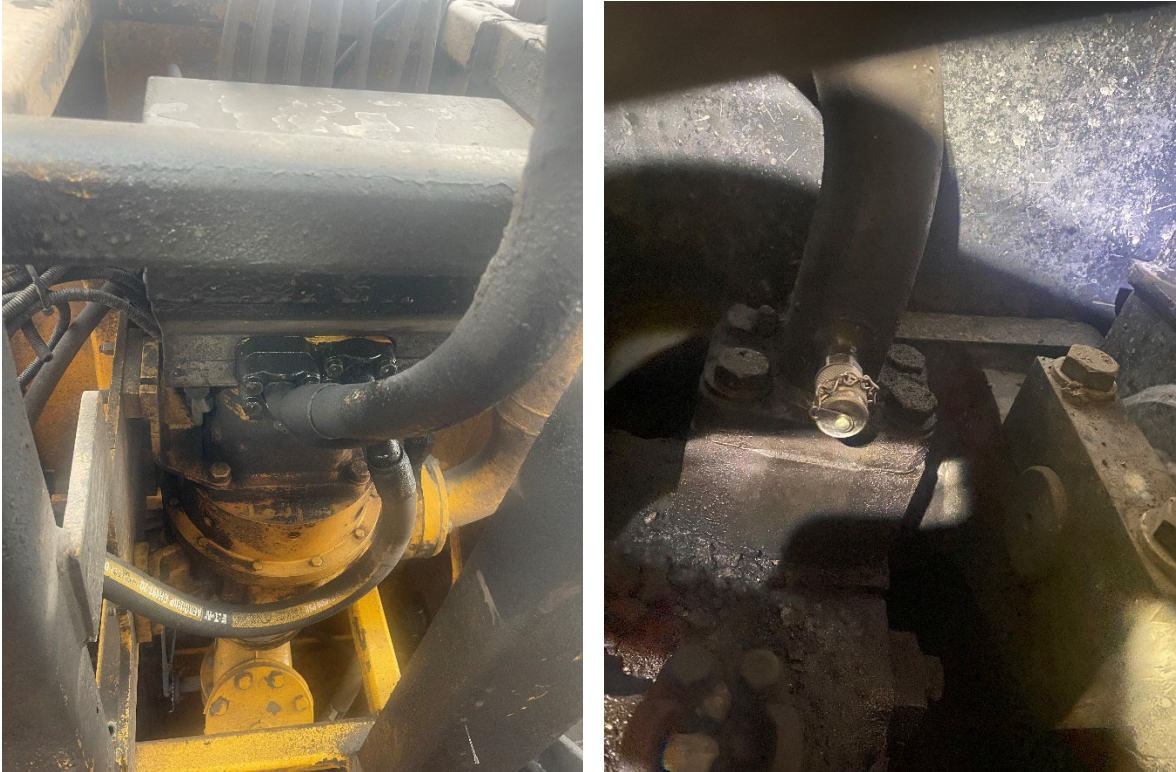
The mine's investigation identified low hydraulic oil as the cause of the steering failure. The truck design did not include a low hydraulic oil reservoir level light/alarm, so the hydraulic oil leaks went undetected. The hydraulic-powered water pump module for the water cart spray system was plumbed into the truck's hydraulic system, which also controlled the steering. A total of 6 hydraulic leaks were identified with water pump module.

Figures 2 and 3: Hydraulic oil leaks on the water pump drive supply hose fitting, and staff test fitting

- develop and install a low level hydraulic warning visual and audible alarm and interlock to shut down auxiliary systems that may impair steering or braking function
- update the introduction-to-site process to include conformance with AS5364:2021, specifically addressing add-on features and auxiliary systems that modify OEM steering circuit design
- update maintenance and prestart inspections to include looking for oil leaks and checking oil levels.

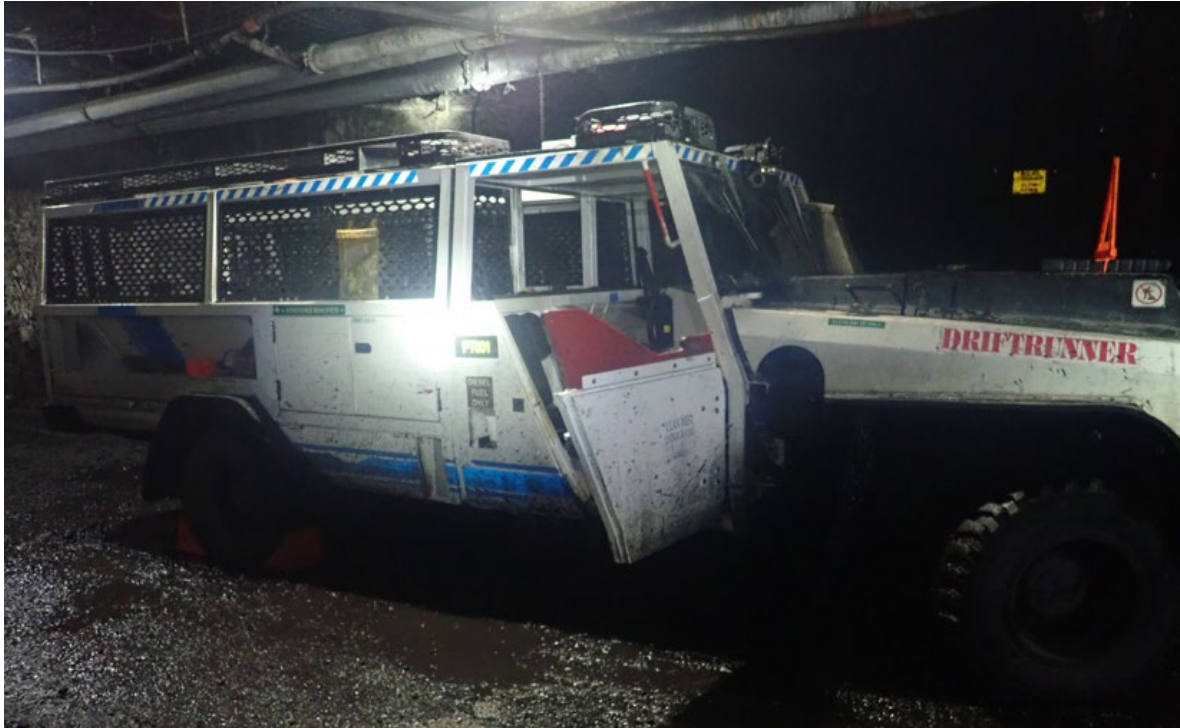
About 7:55am, 2 workers were in an underground coal mine personnel transport, travelling outbye in the main travel road when they lost steering control. The vehicle swerved and clipped a rib (side wall), with the brakes pulling the vehicle up just short of the rib on the far side of an intersection. Although the occupants were uninjured, the vehicle's front suspension trailing arm and bracket was damaged.

Figure 4: A drift runner lost steering and collided with the rib in a main travel road

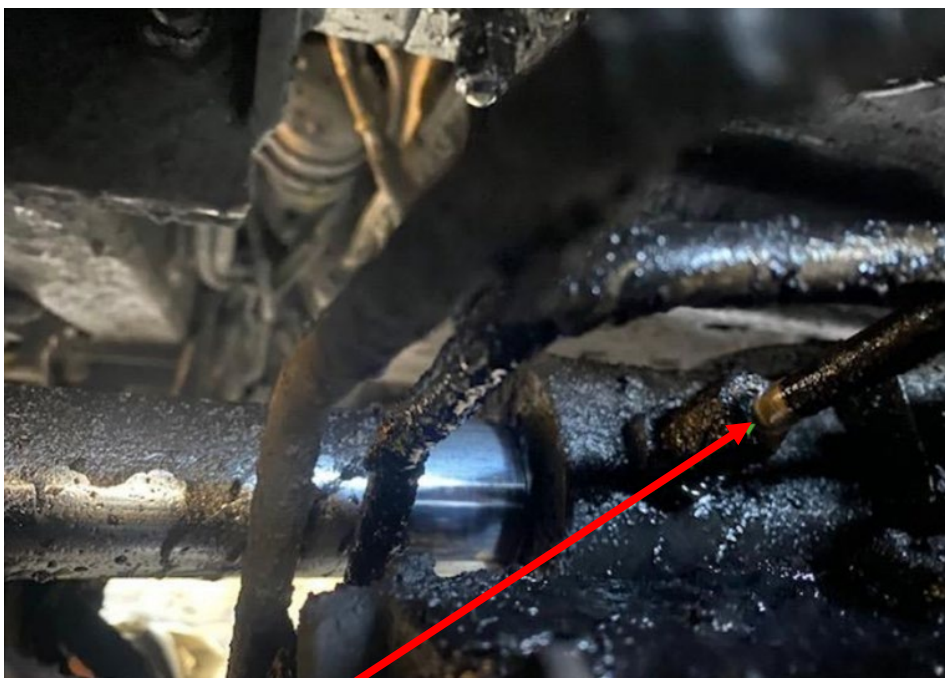
An inspection of the vehicle identified the hard pipe had come out of the steer cylinder fitting,, dumping the hydraulic oil, and causing the machine to lose power steering.

Figure 5: Failed fitting on steer cylinder

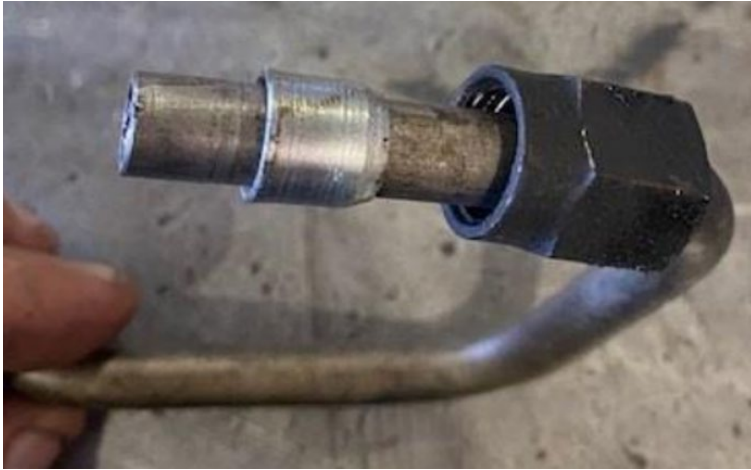
The investigation identified the vehicle had recently returned from overhaul. Although the fitting was tightened, it was believed it was not given the additional one-and-a-quarter turns required to cause the olive to deform and 'bite' into the hard pipe, as specified in the supplier's assembly process. In addition, the supplier of the steering components had upgraded the hard pipe to stainless steel with thicker walls, so strict adherence to the process was more critical to achieve a satisfactory joint.

Figure 6: Failed fitting showing no engagement marking on pipe from crush olive

- test thinner-walled, stainless steel piping that will meet the pressure requirements, and still prevent corrosion
- supply preformed and assembled hard piping as a kit ready to install.
