Weekly incident summary

Week ending 15 November 2024

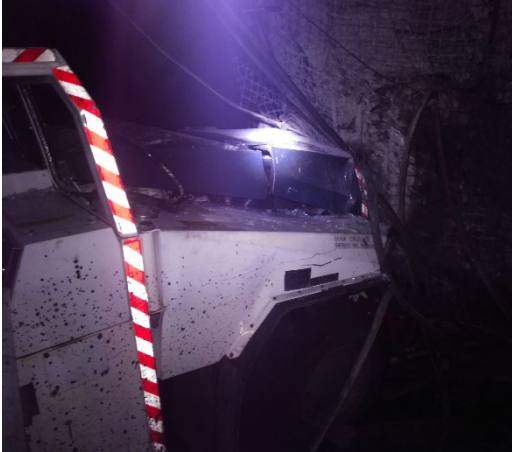
Incident type	Summary	Comments to industry
Dangerous incident IncNot0047993 Underground coal mine Roads or other vehicle operating areas	A worker was driving inbye in an underground mine vehicle when he had a micro sleep. He woke up just before there was a collision, but when he went to brake, his foot missed the brake pedal. The vehicle collided with the corner of an intersection he was approaching. It was the worker's second night shift in 3 months.	Workers should ensure that they turn up fit to work long hours and for several days and or nights in a row. Other reasonable controls are: <ul style="list-style-type: none"> • roster patterns that allow for adequate sleep and life activities (eating, washing and family) • shift durations that consider workers' commuting times to allow for adequate sleep and life activities • allowing a 48-hour break after a block of night shifts and an adequate break between blocks of shifts for recovery • allowing an adequate break between shifts to enable 7 – 8 hours' sleep

<ul style="list-style-type: none"> • increasing supervision during periods of low alertness (e.g. 3am to 5am) • providing training and information on the risks of shift work and ensure supervisors and management can recognise problems • ensuring breaks are taken within shifts to mitigate fatigue. <p>Further information can be found at our health control plan resources guide.</p>
<p>Critical incident IncNot0047989 Small mine - quarry</p>	<p>A worker died from natural causes while undertaking work at a mining operation. Workers tried unsuccessfully to revive the worker.</p>	<p>The NSW code of practice into managing psychosocial risks has identified exposure to traumatic events such as experiencing, witnessing, a serious near miss, injury or workplace fatality as a psychosocial hazard.</p> <p>Mine operators should ensure that psychosocial risk assessments that are undertaken to comply with clauses 55A-D of the Work Health and Safety Regulation 2017. Consider this hazard and ensure appropriate controls are implemented.</p> <p>The code of practice should be used to assist practitioners with assessing and controlling psychosocial risk within the workplace.</p> <p>The code can be found at www.safework.nsw.gov.au/resource-library/list-of-all-codes-of-practice/codes-of-practice/managing-psychosocial-hazards-at-work</p>

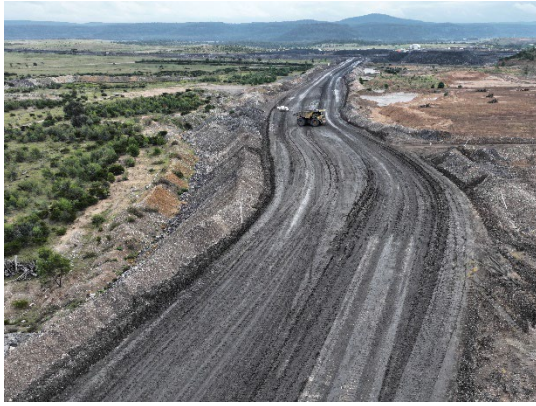
<p>High potential incident IncNot0048016 Surface coal mine</p>	<p>An empty rear dump truck slid 90 degrees clockwise while descending a ramp following wet weather.</p>	<p>Mine operators must undertake appropriate examinations of haul roads following wet weather periods. Where appropriate you must stop</p>

<p>Rainfall on the previous night had resulted in a wet haul road surface. The wet weather trigger action response plan (TARP) was implemented limiting speed to a maximum of 30kph. After hauling laden onto the dump, the operator commenced the return run. On descent of a short section on the access road, the truck lost traction. It slid at low speed for about 50 metres before rotating clockwise and stopping in the middle of the road. The truck crossed the centre line of the road at this point.</p>

<p>production until a dry line can be graded in or there is appropriate traction available to trucks even at low speeds.</p>
