# Weekly incident summary

## Week ending 25 October 2024

This incident summary provides information on reportable incidents and safety advice for the NSW mining industry. To report an incident to the Resources Regulator: phone 1300 814 609 24 hours a day, 7 days a week.

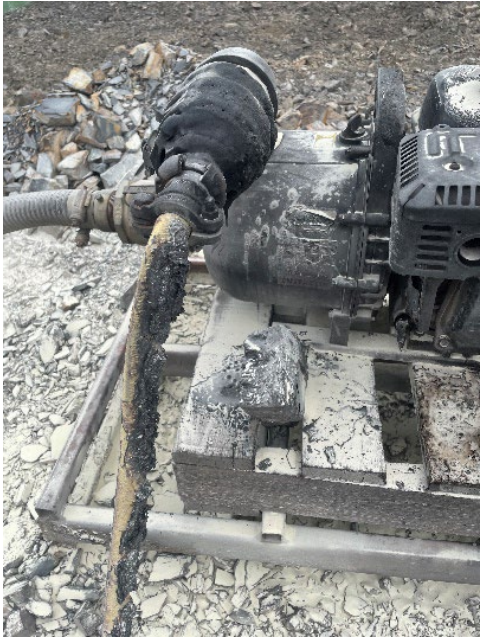
| Incident type | Summary | Comments to industry |
|--|--|---|
| Serious injury<br>IncNot0047878<br>Construction materials<br>Fire or explosion | <p>A worker suffered serious burns when the fuel being used to refill a petrol-powered pump ignited.</p> | <p>Hot engine exhausts are a well-known ignition source.</p> <p>As a minimum petrol-powered pumps shall be turned off and allowed to cool down prior to any refuelling activities.</p> <p>Mine operators should have documented safe work procedures for refuelling petrol engines and workers trained in those procedures.</p> <p>Consideration should be given to using diesel engines in place of petrol engines.</p> |
