Quarterly safety report

July to September 2024

Title: Quarterly safety report – July to September 2024

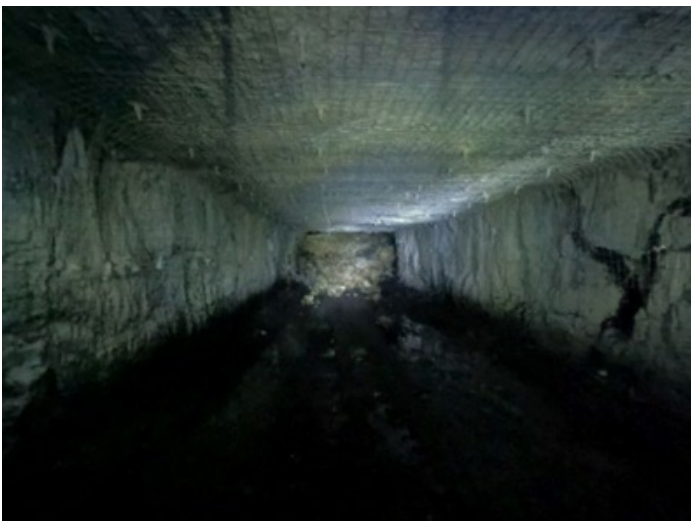
Dangerous incident | IncNot0047223 – Fall of ground through intersection

Summary: A fall of ground occurred affecting an entire intersection at a heading where mining had been occurring inbye of the area during night shift. The crew had withdrawn equipment for planned maintenance on day shift before the fall occurred. The area design was a run out on the left-hand side of the bord and pillar panel with herringbone and floor stripping. There was an unbolted section and a bolted section through the run out. At 11am, it was observed there was a roof and skin failure in the open lift (unbolted area). At 3pm, it was reported that the fall of ground had progressed through the entire intersection (bolted and unbolted).

Picture 1.
Debris after roof failure

Comments to industry: Mine operators are reminded of the need for workers who are required to install and maintain tell-tale strata monitoring devices to be trained on the correct installation and defect management requirements for the lifecycle of the devices.

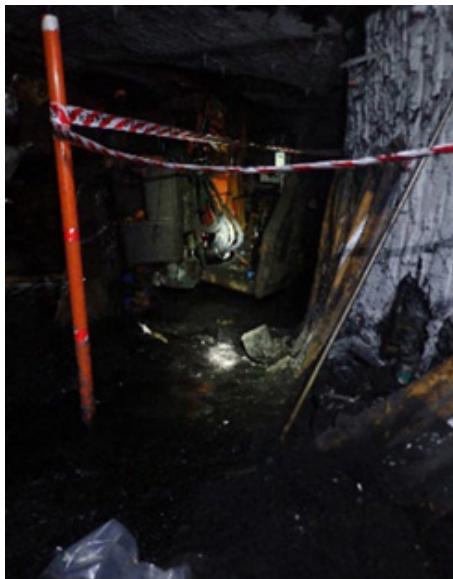
Dangerous incident | IncNot0047488 – Worker hit by coal after cornice failure

Summary: Two workers were standing beside a bolting rig, with their backs to the rib, at the corner of a cut-through intersection when a large piece of coal fell from the roof/rib interface and hit one of the workers on the shoulder. The worker suffered a fracture. The mechanism of the cornice failure was the formation of a block of coal that had 2 weak/free faces.

Picture 2.
Area after fall of coal.

Comments to industry: Mine operators should have a procedure for supporting exposed cornices, or the installation of mechanical protection from exposed cornices. Refer to the [Code of practice: Inundation and inrush hazard management](#).

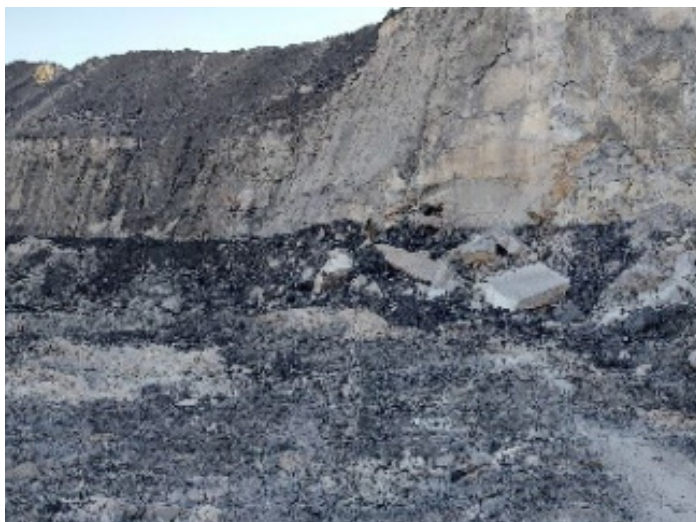
Summary: A large rock fell from a high wall and impacted a D11 dozer that was nearby. The operator drove about 50 metres to safety and was not injured.

Picture 3.
Highwall rockfall which contacted dozer.

Comments to industry: When geotechnical reports identify hazards on highwalls, mine operators should ensure that controls to manage the risks are implemented and communicated to workers. In areas where previous geotechnical failures have occurred, the frequency of inspections and reporting on hazards should be increased and the outcomes communicated to workers.

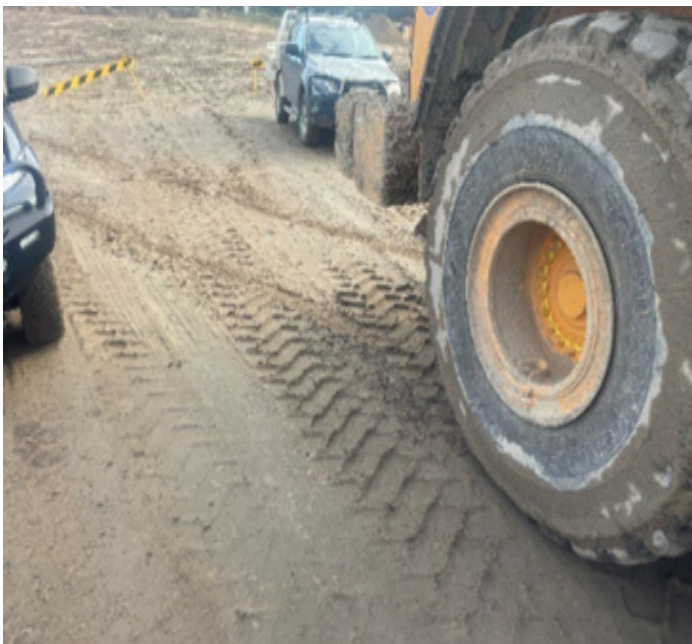
Dangerous incident | IncNot0047225 – Dozer reversed into light vehicle

Summary: A loader reversed into one of 2 light vehicles that had stopped about 10 metres behind it. The first vehicle failed to make positive communications with the loader because of a flat radio battery. When the loader began to reverse, the first vehicle moved out of the way and the loader continued until it hit the second vehicle. The second vehicle operator assumed the first vehicle operator made positive communications but didn't hear anything. He had his flashing light on and sounded the horn to stop the loader.

Picture 4.
Dozer and light vehicle interaction.

Comments to industry: When stopping light vehicles, workers must not place themselves at risk of interactions with heavy vehicles. To achieve positive communication, a clear direct message must be given. Additionally, the person receiving the message must actively reply with a clear understanding of the message. Supervisors should be continually monitoring positive communications compliance during every radio call on their shift. [Work Health and Safety Regulation 2017](#) clauses 35 & 36 requires higher order risk controls be implemented and administrative controls such as positive communication, only be used when no higher order controls can be implemented. Controls such as equipment segregation and proximity awareness systems should be implemented before positive communication only systems are considered.

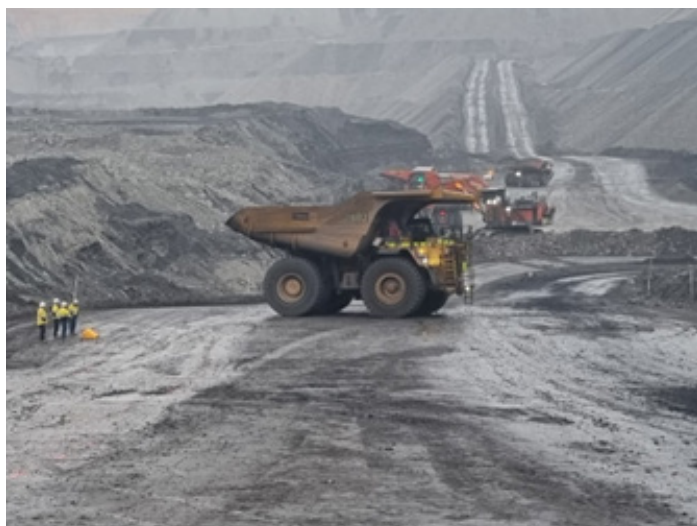
Summary: An empty CAT789 truck was descending a ramp. Rain had started to fall about 30 minutes earlier. As the operator rounded a left-hand bend towards the bottom of the ramp the truck lost traction at slow speed, resulting in the truck sliding about 50 m down the ramp, crossing the centre line, and ending up rotating 90 degrees.

Picture 5.
Truck rotated on wet ramp.

Comments to industry: Situational awareness is a key control when operating mobile equipment. Adequate supervision, training, job planning and risk assessments should be considered and completed before undertaking tasks. Procedures to assess the adverse effects caused by changes in weather and road conditions should be communicated to workers and implemented to prevent incidents. Following a recent awareness campaign on vehicle interactions the Regulator published a [YouTube video](#) that can be used for training purposes and toolbox talks. Mine operators are encouraged to use this resource.

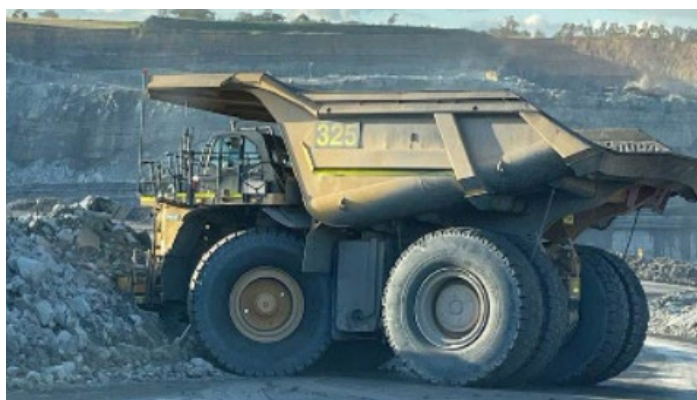
Summary: A haul truck hit a windrow after losing traction while driving down a ramp. The road had been recently watered. The operator believed the offside tyres were in the dry line but when they applied the retarder brake the truck began to slip.

Picture 6.
Haul truck in windrow.

Comments to industry: Workers must operate vehicles at a speed that is appropriate to the prevailing conditions. Engineering controls that minimise the risk of loss of control should be considered, including the use of speed limiting devices, speed monitoring and alarms. This incident highlights the importance of having appropriately designed and maintained windrows, bunds and edge protection.

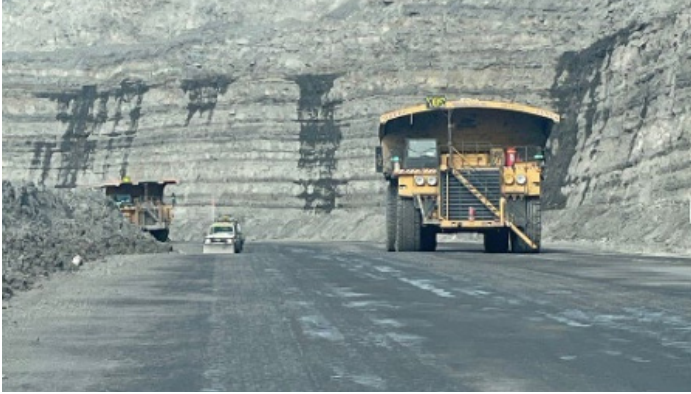
Summary: A loaded haul truck narrowly avoided a collision with a parked-up light vehicle with one person aboard. The driver stopped to observe an excavator through a drainage gap in the windrow a short distance beyond a blind corner on the main haul road. The haul truck operator noticed the collision avoidance system (CAS) identify the vehicle on the in-cab screen and assumed it was on a lower bench. The haul truck continued around the corner and saw the light vehicle parked up. The operator took evasive action as there were no oncoming vehicles and crossed onto the wrong side of the haul road to prevent a potential collision with the parked light vehicle. The haul truck was brought to a stop with the retarder because the haul road had been watered.

Picture 7.
Scene of vehicle near miss.

Comments to industry: The risk of a fatality from interactions between light and heavy vehicles is well known. Light vehicle drivers should be continually reminded of their obligations when driving on haul roads. Mine operators must ensure all roadways, intersections and park-up areas are designed, constructed, and maintained to safely manage interactions between mobile plant and light vehicles.
