# Quarterly safety report

October to December 2024

This quarterly health and safety performance report has been prepared by the NSW Resources Regulator for mine and petroleum site operators in NSW. It contains industry and sector specific information, in addition to information regarding hazards. Wherever possible, trends and patterns have been identified.

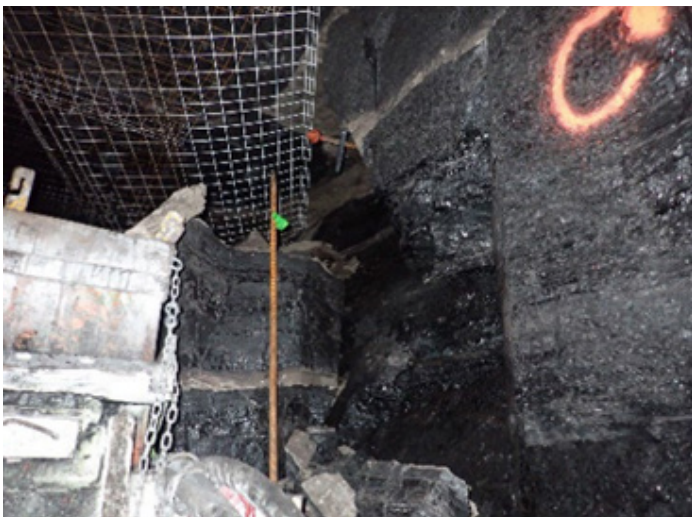
Picture 1.  
Rib fall in panel

### Dangerous incident | IncNot0047788 – Rib fall in mains panel

**Summary:** A large rib fall of about 5 m long x 3.1 m high x 1.2 m deep occurred when cutting in a herringbone mains panel. No one was present on the side of the continuous miner where the fall occurred, although a worker was on the opposite side platform. It did not appear to be a lubricated fault (greasy back). Rib support consisted of 1.2 m bolts at about 2.2-2.4 m above the floor.

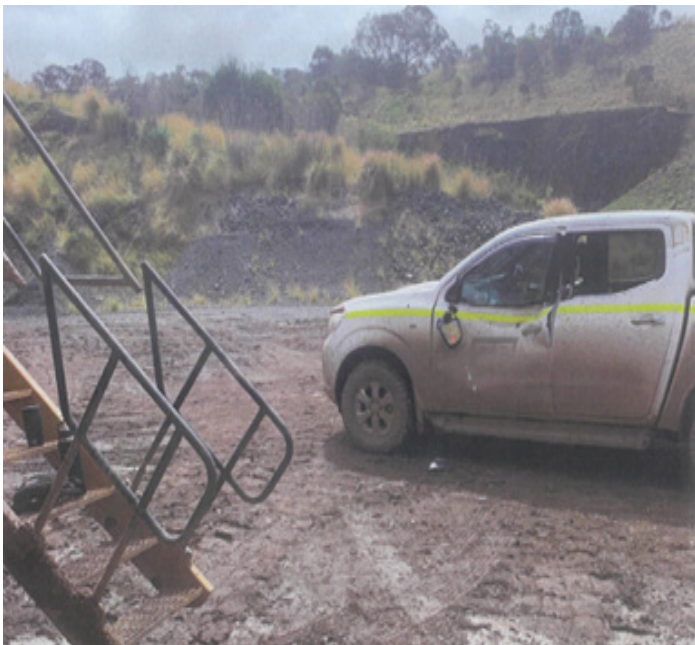
Picture 2.  
Truck ladder and damaged light vehicle

### Dangerous incident | IncNot0047769 – Haul truck and light vehicle collision

**Summary:** A supervisor pulled up near a stationary haul truck to pick up the operator. The operator, unaware of the nearby light vehicle, moved the truck forward several metres to realign it, contacting the light vehicle with the ladder, which was in the lowered position. The supervisor assumed the truck was parked up when he stopped in front of it.

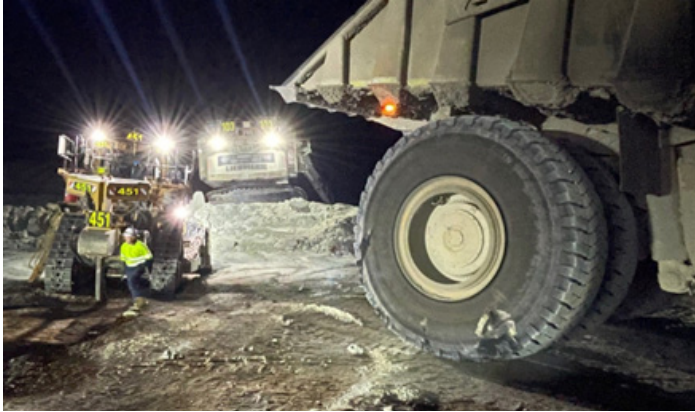
Picture 3.  
Dozer and truck interaction showing tyre  
scuff marks

**Summary:** A dozer was cleaning up around a dig face when a haul truck reversed into place. The truck contacted the dozer on the drivers offside. The truck driver breached the mine’s procedure by positioning the rear of the truck towards the loading unit prior to the bucket being presented.

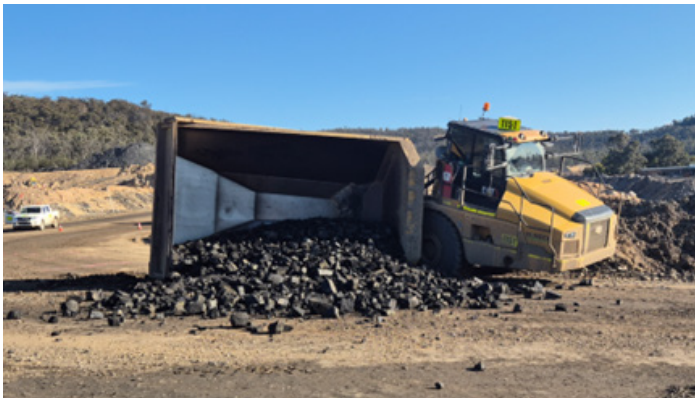
Picture 4.  
Rolled articulated dump body with  
spilled material

**Summary:** An articulated truck rolled its dump body while negotiating a bend. The cabin remained upright, and no one was injured.

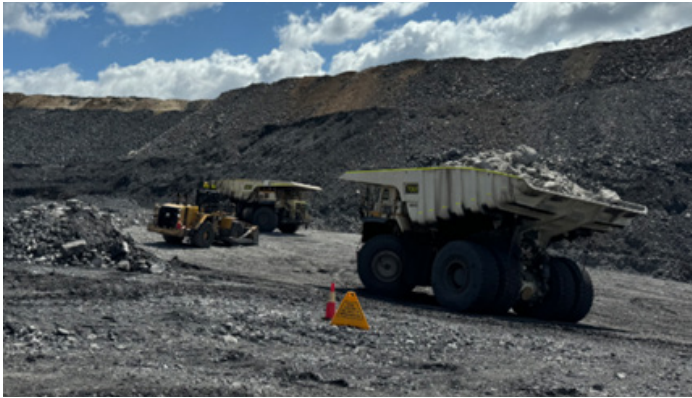
Picture 5.  
Laden haul truck stopping position

**Summary:** A loaded haul truck exceeded its retard window while descending an 8% ramp. The truck reached a speed of 60 kph before the operator made an emergency application of the service brake. The truck stopped within an estimated distance of 300 m. A working wheel dozer was positioned about 30-40 m from where the haul truck stopped.

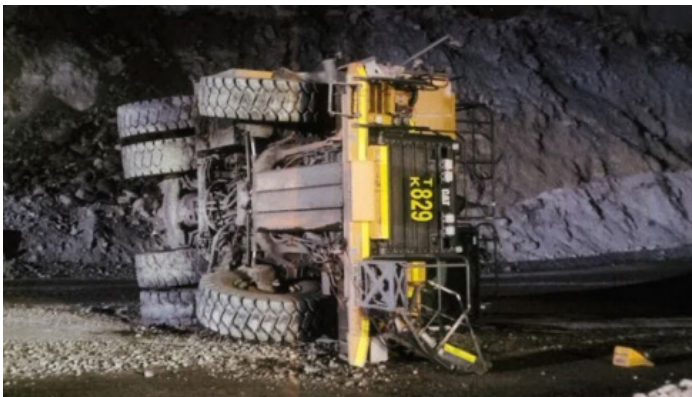
Picture 6.  
Overturned service cart

**Summary:** A service cart overturned when completing a U-turn. The cart transitioned from a wet to a dry line and overturned onto its left side. There were no injuries to the operator. Speed has been established as a major contributing factor.

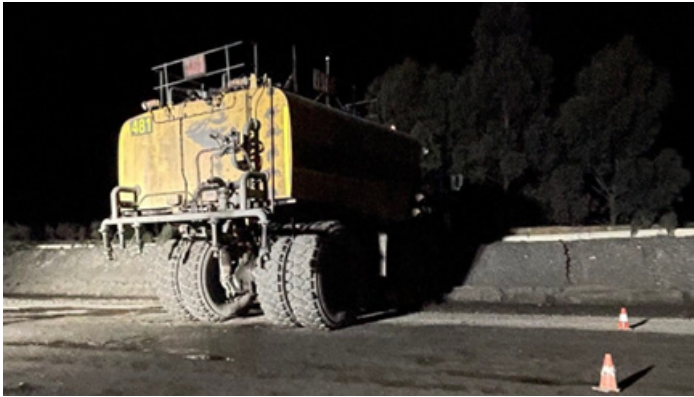
Picture 7.  
Water cart stopped on windrow

**Summary:** A water cart lost steering as it was negotiating a bend in the haul road. The water cart collided with a windrow while attempting an emergency stop. The failure was caused by low hydraulic oil level due to an undetected leak. The design did not include a low hydraulic oil reservoir level warning to alert the operator.

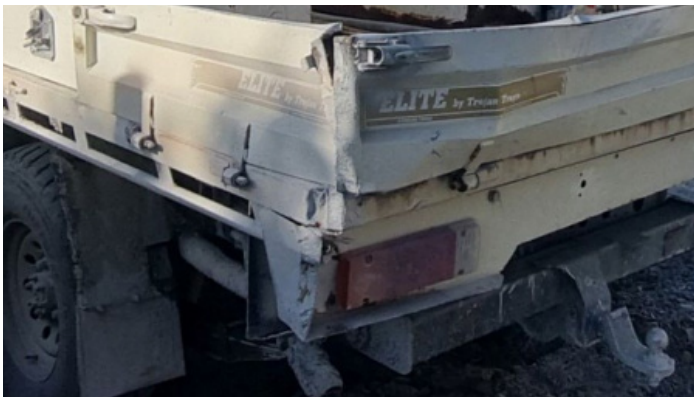
Picture 8.  
Damage to rear of light vehicle

**Summary:** A technician who was operating a light vehicle was rushing to arm barriers for a tele-remote system and failed to park the vehicle correctly before exiting it. The vehicle immediately rolled backwards about 13 metres before hitting a wall. The technician had applied the handbrake but left the vehicle running, not in gear and not parked into the wall. During the incident, the technician ran to the vehicle and tried to re-enter the cabin, but it was moving too fast.

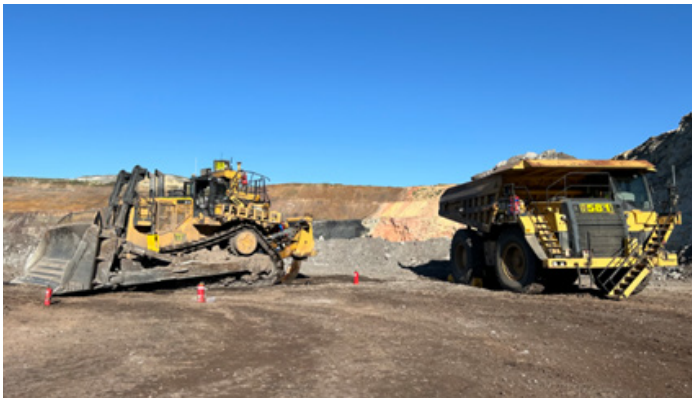
Picture 9.  
Vehicles parked after collision

**Summary:** A laden dump truck and a dozer collided while both were reversing on a dump. The offside rear corner of the dump truck dovetail collided with the left-hand, rear corner of the dozer. Both operators were uninjured in the incident.

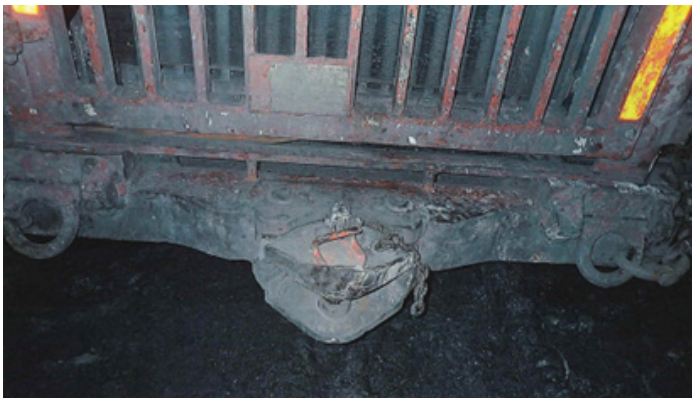
Picture 10.  
LHD collision damage

**Summary:** Two load-haul-dump machines (LHDs) collided underground. The first LHD, heading outbye, stopped at 56 cut-through to allow another vehicle to shunt past. The second LHD, in third gear and carrying a concrete kibble, failed to notice the parked LHD and collided into its rear. The scene was not preserved immediately. The operator of the first LHD, which was hit, experienced minor discomfort and was treated on site.

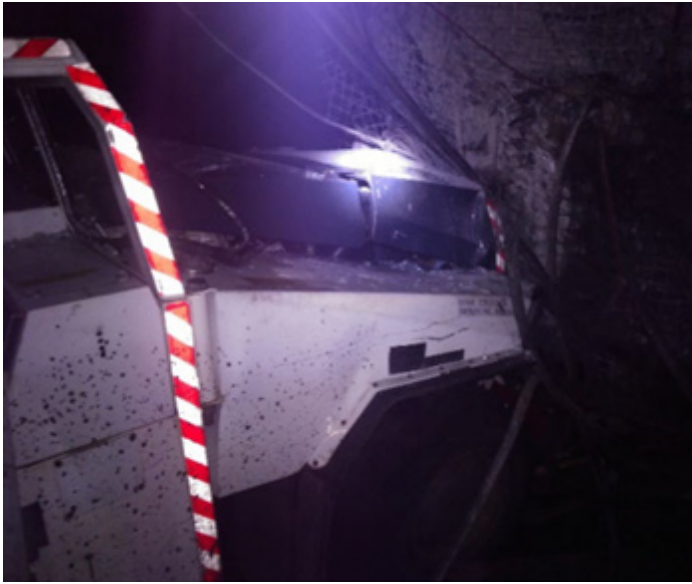
Picture 11.  
Collision damage at intersection

**Summary:** A worker was driving in an underground mine vehicle when he had a micro sleep. He woke up just before there was a collision, but when he went to brake, his foot missed the brake pedal. The vehicle collided with the corner of an intersection he was approaching. It was the worker's second night shift in 3 months.

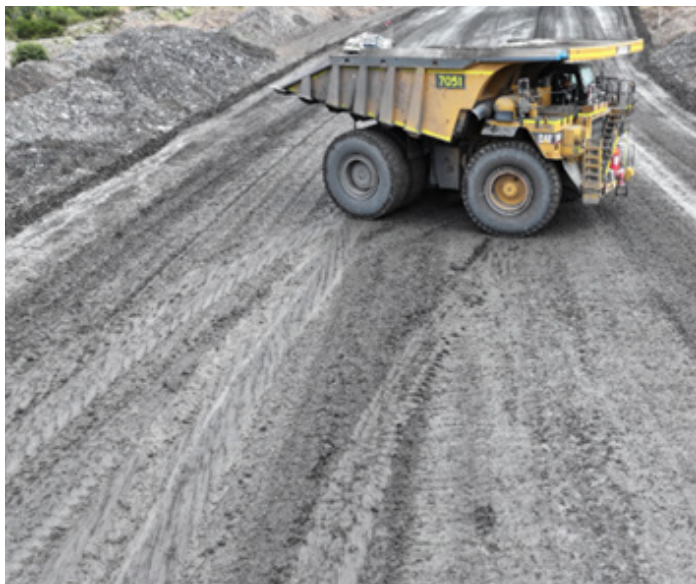
Picture 12.  
Dump truck spun on wet road

**Summary:** An empty rear dump truck slid 90 degrees clockwise while descending a ramp following wet weather. Rainfall on the previous night had resulted in a wet haul road surface. The wet weather trigger action response plan (TARP) was implemented limiting speed to a maximum of 30kph. After hauling laden onto the dump, the operator commenced the return run. On descent of a short section on the access road, the truck lost traction. It slid at low speed for about 50 metres before rotating clockwise and stopping in the middle of the road. The truck crossed the centre line of the road at this point.

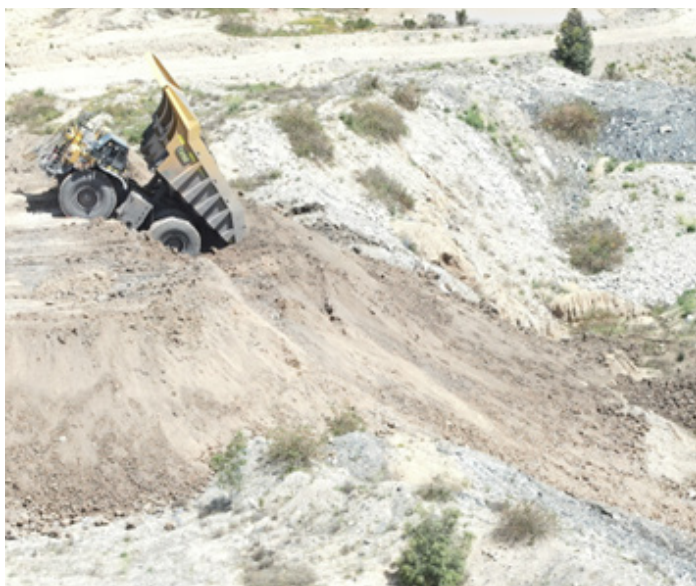
Picture 13.  
Slumped material and truck

**Summary:** A rear dump truck reversed up to a tip head and began discharging its load when the tip edge slumped, causing the rear of the truck to sink with the slumped material. The dump slumped at a slow rate. The operator exited the vehicle and was uninjured.

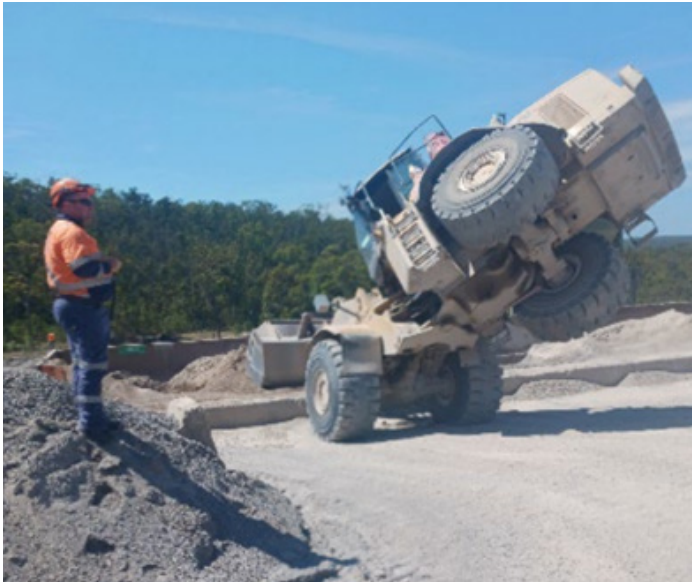
Picture 14.  
Stricken LHD with rear wheels off the ground

**Summary:** A laden load haul dump (LHD) machine's rear wheels left the ground while the machine was being operated. The operator was removed from the cab of the machine with the assistance of an elevated work platform. A slight slope leading to the bins, that had built up over time, may have contributed to the vehicle tipping forward.

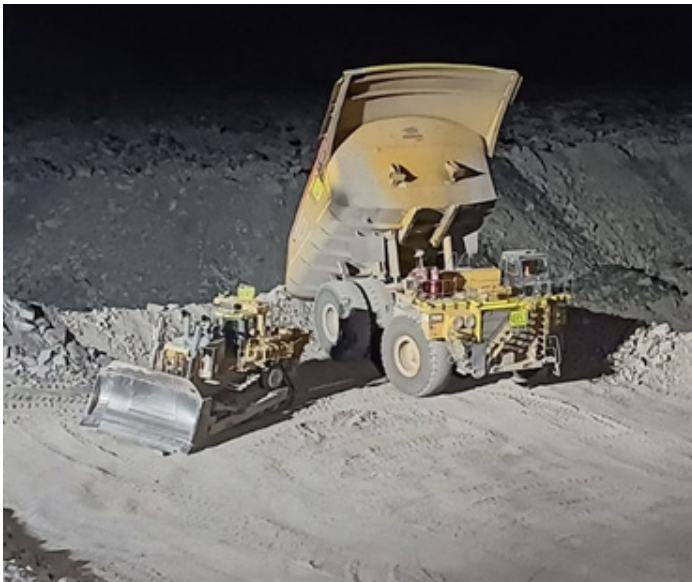
Picture 15.  
Scene of location and vehicles involved

**Summary:** A dozer and dump truck collided despite the dozer operator identifying the presence of the truck just before impact and attempting to track forward to avoid a collision. The dozer was side cutting a narrow dump when the dump truck entered the dump without establishing positive communication.

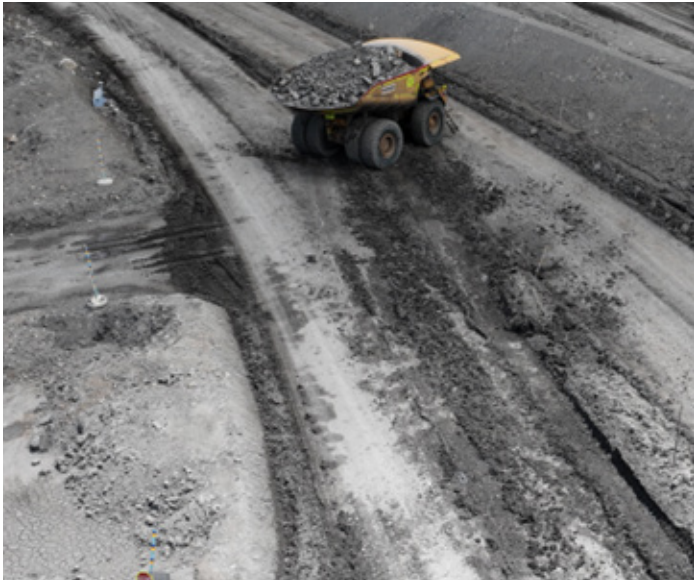
Picture 16.  
Drone view of truck after incident

**Summary:** A loaded haul truck drove into mud in the centre of a road and lost control before making contact with a centre bund and crossing the centreline of a road. The truck, being driven by a trainee operator, was travelling down a ramp of about 6% at 46 kmh when the incident occurred.

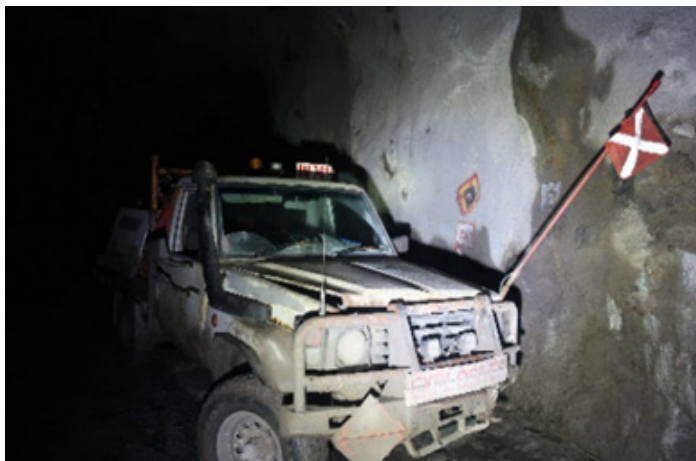
Picture 17.  
Light vehicle at wall

**Summary:** A worker alighted from a light vehicle in an underground area and went to the upside of the vehicle, leaving it unattended. The light vehicle rolled away about 20 metres before colliding with the wall of the opposite drive. The operator then drove the vehicle back up the drive.

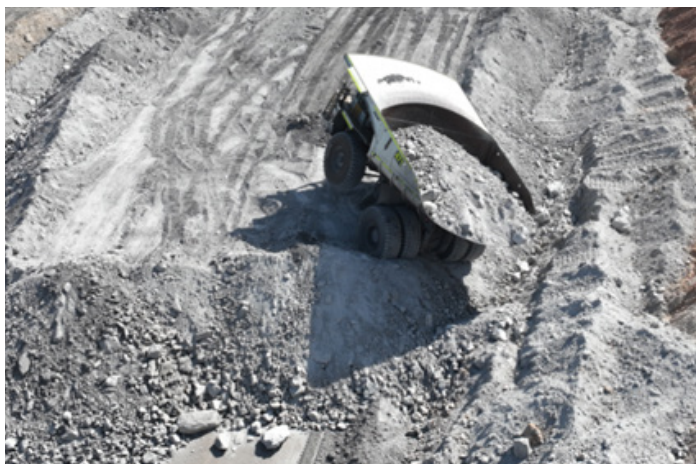
Picture 18.  
Slumped truck with raised wheel

**Summary:** During the process of tipping a load, the position 5 and 6 wheels of a haul truck slumped, causing the position 1 wheel to raise about 1.5 metres off the ground.

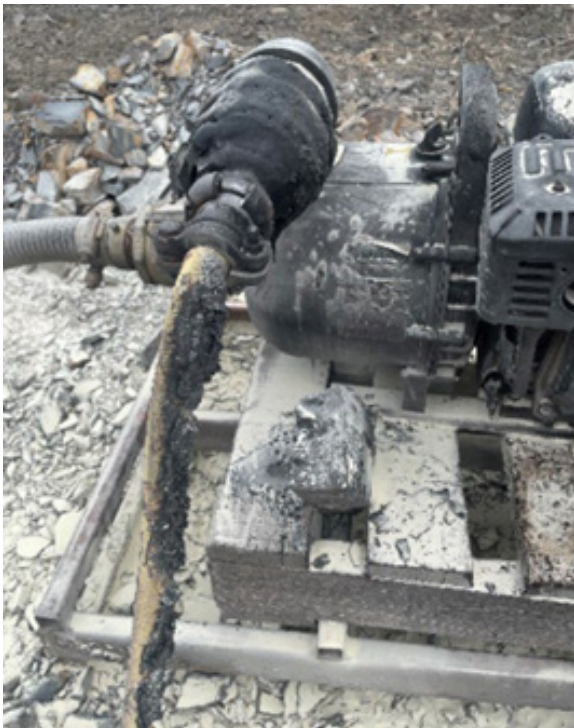
Picture 19.  
Charred pump after ignition incident

### Serious injury | IncNot0047878 – Serious burns as petrol-powered pump ignited

**Summary:** A worker suffered serious burns when the fuel being used to refill a petrol-powered pump ignited.

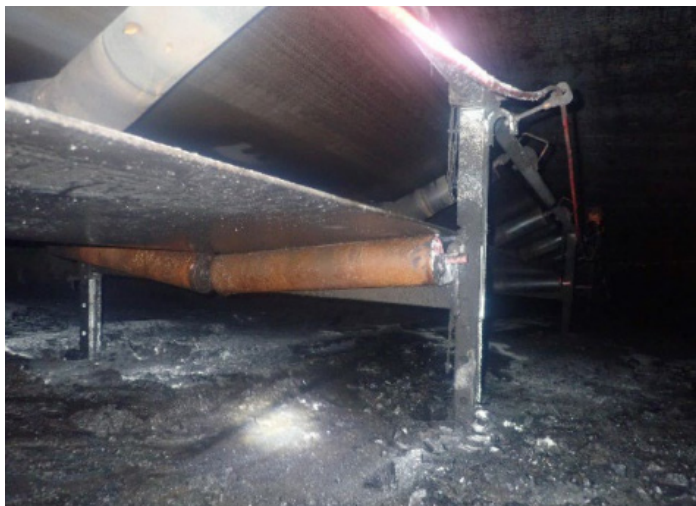
Picture 20.  
Smoke damage on conveyor structure

**Summary:** A deputy discovered a collapsed return roller on a panel conveyor belt at an underground coal mine. The deputy stopped the belt, applied a fire extinguisher and isolated the area with a fire watch in place. A preliminary investigation was initiated, and the incident was reported to the Regulator. Immediate corrective actions included replacing damaged structure legs and rollers and conducting a full review of the conveyor risk assessments and fire management plan. Three days later, smoke and embers were detected on the conveyor directly outbye the earlier incident. This was caused by the belt making contact with a restrained grease line. The conveyor had wandered beyond its intended path, with wander switches failing to trip. All belts were shut down, and a full inspection was ordered. The incident prompted a detailed audit of conveyor systems, investigation of wander switch functionality, and a review of installation procedures.
