# Weekly incident summary

## Week ending 11 April 2025

This incident summary provides information on reportable incidents and safety advice for the NSW mining industry. To report an incident to the Resources Regulator: phone 1300 814 609 24 hours a day, 7 days a week.

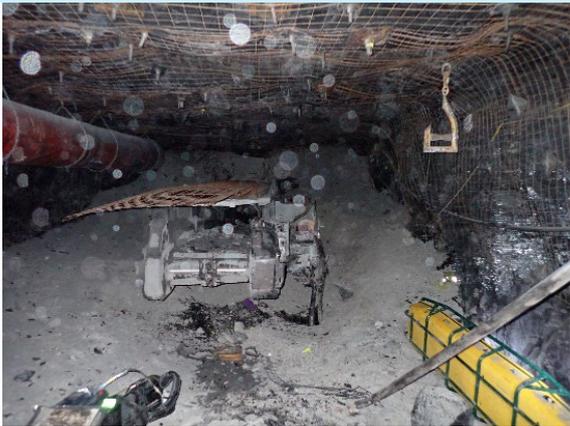
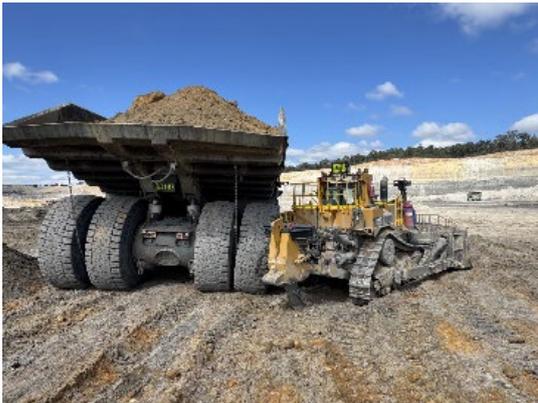
Incident type	Summary	Comments to industry
<p data-bbox="124 645 368 674">Dangerous incident</p> <p data-bbox="124 689 320 719">IncNot0048912</p> <p data-bbox="124 734 368 763">Open cut coal mine</p> <p data-bbox="124 779 405 853">Roads or other vehicle operating areas</p>

<p data-bbox="464 645 1023 752">A dozer collided with the position 6 tyre of a loaded haul truck on an active dump causing the tyre to blow out.</p> <p data-bbox="464 775 1034 1104">The dozer operator expected the truck operator to dump on the left-hand side of the tip face. The truck operator went to the right-hand side of the tip face following a previous truck dump position. There was no communication between the operators on the correct dump position for the truck. The dozer operator was aware the truck was on the dump.</p>

<p data-bbox="1066 645 1465 1088">The consequences of vehicle operators not establishing positive communications with other vehicle operators can, and has been, fatal. Despite the prevalence of site procedures, operator training and the introduction of driver assistance systems, many operators continue to ignore the importance of following basic procedures.</p> <p data-bbox="1066 1111 1453 1290">Operators have a responsibility to establish positive communications every time they interact with another vehicle.</p> <p data-bbox="1066 1312 1433 1491">Other plant operating nearby should be sighted and visual contact should be maintained where possible while manoeuvring at the tip face.</p> <p data-bbox="1066 1514 1449 1621">Visual aids and segregation should be implemented before relying on procedural controls.</p>

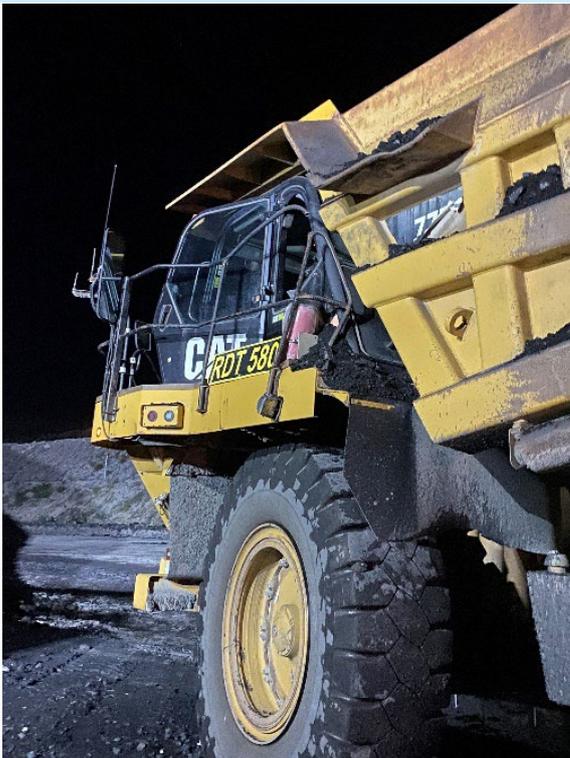
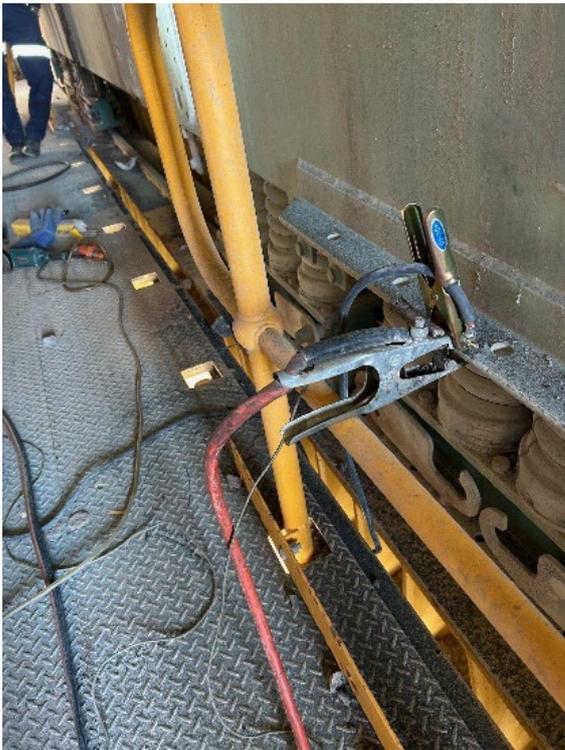
<p>before commencing loading activities outside daylight hours.</p>
<p>Dangerous incident IncNot0048930 Underground metals mine</p>	<p>A boilermaker suffered an electric shock while operating a metal inert gas (MIG) welder at the screen building. The boilermaker was leaning against the screen while welding, creating an earth path from his elbow to the screen.</p>

<p>Mine operators should verify that workers carrying out welding activities have identified appropriate earthing points, their personal protection equipment (PPE) is dry, and they are appropriately trained. Welding machines must be isolated when not in use.</p> <p>Appropriate electrical protection must be in place on all portable electrical equipment. Portable equipment leads should be regularly tested and tagged. Any leads with visible damage should be repaired or discarded before use. Refer to:</p> <ul style="list-style-type: none"><li>• <a href="#">Technical reference guide – Hot work (cutting and welding) at mines and petroleum sites.</a></li><li>• <a href="#">Safety bulletin SB19-03 Welding-related electric shocks increase</a></li></ul>
